# Webb Bridge Park Drainage Study

City of Alpharetta, Georgia

June 8, 2012

**Manhard**  
CONSULTING

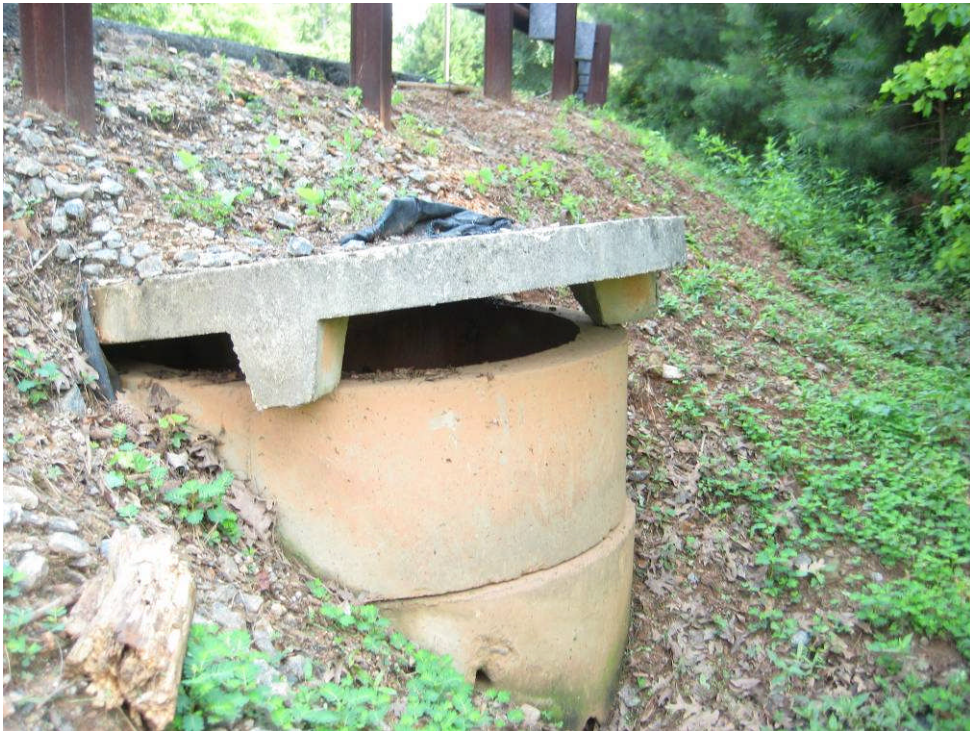
PHOTO D: manhole in need of repair

Option 2: This option involves the replacement of the concrete manhole lid.

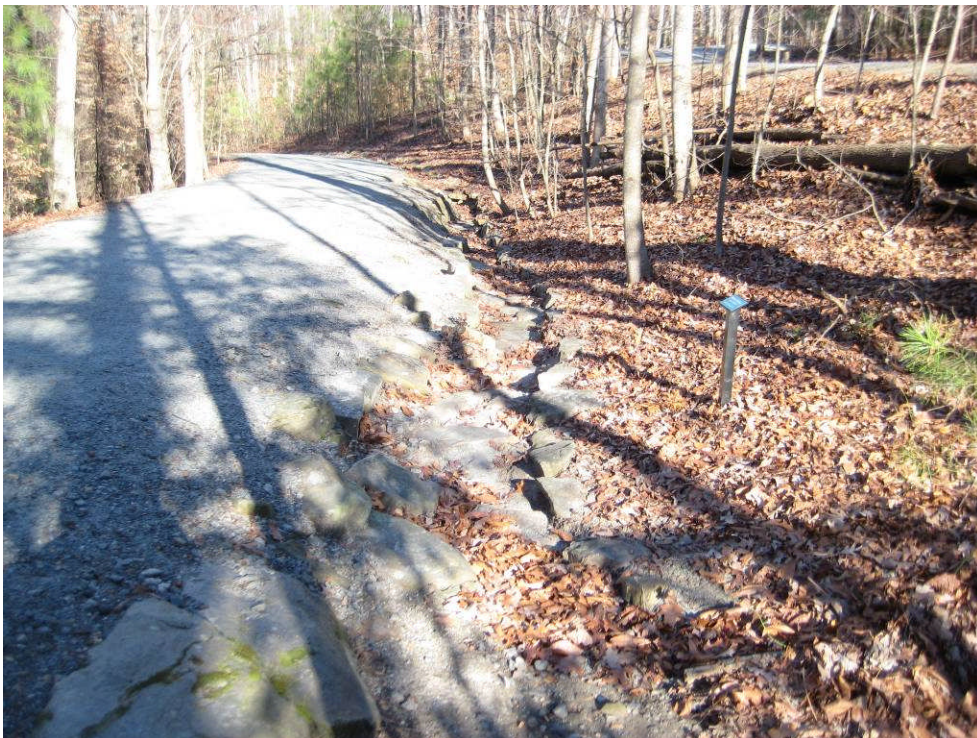
PHOTO D2: at location of pipe outfall from eastern trail, looking downslope at rock-lined ditch
