Long Indian Creek Watershed Improvement Plan

City of Alpharetta

January 30, 2017

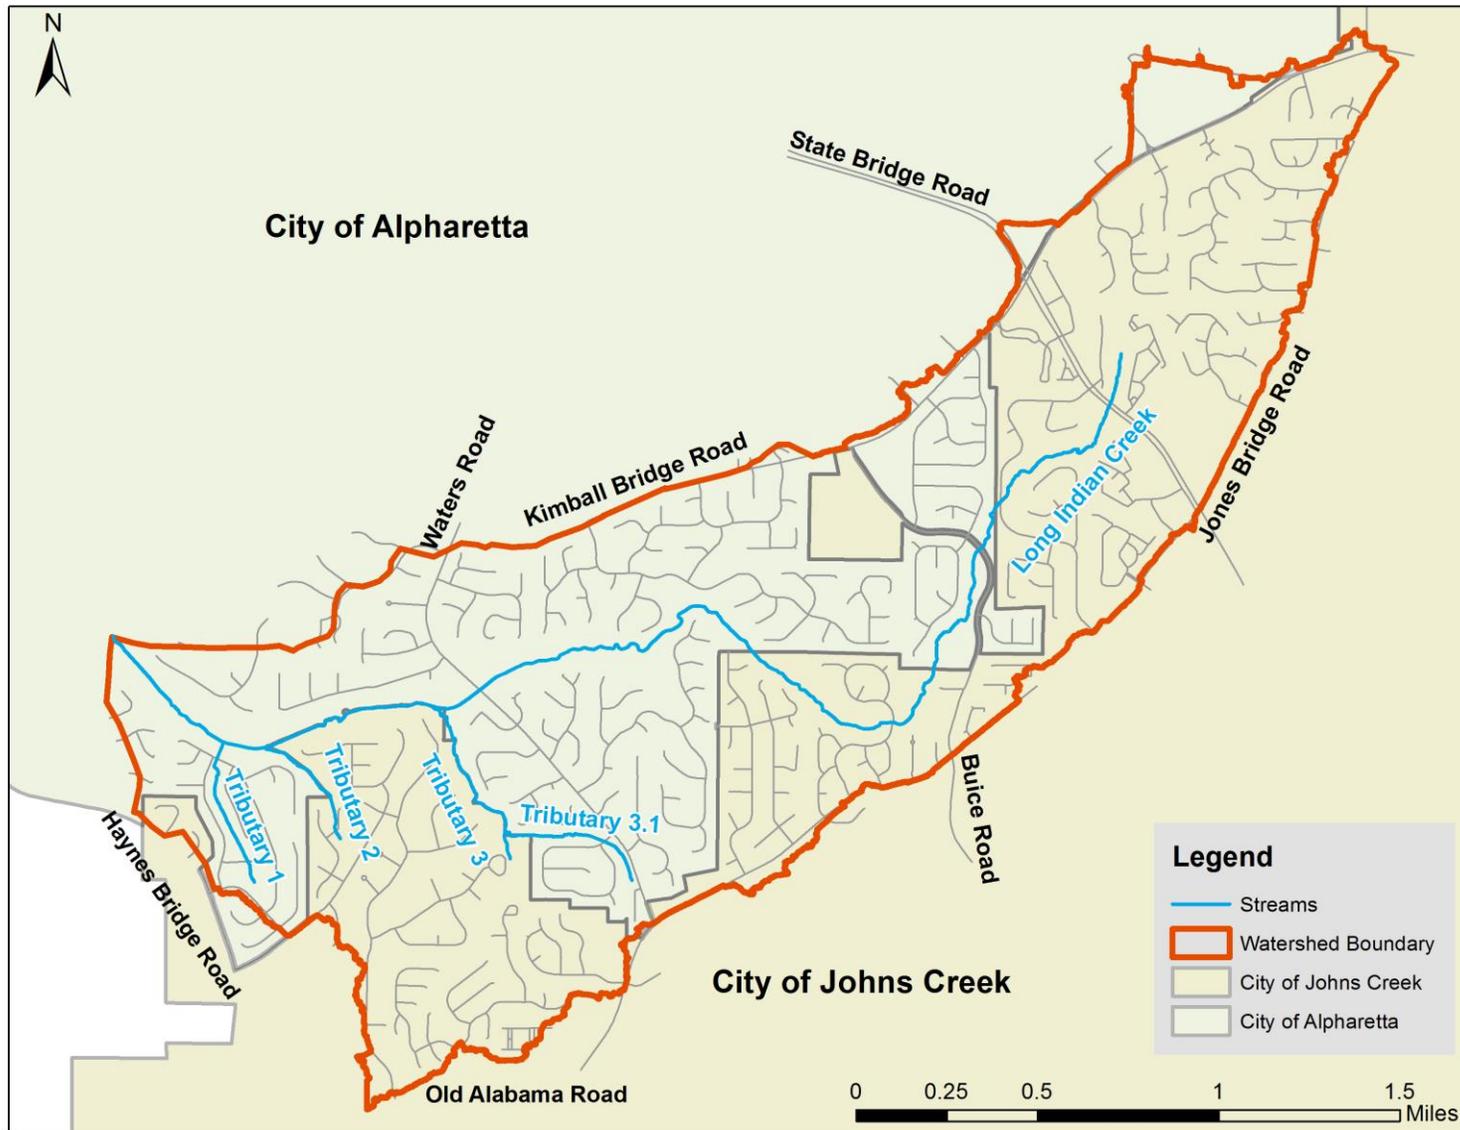
Figure 2.1 - Long Indian Creek and its watershed boundary.

Long Indian Creek drains 3.6 square miles within the Cities of Alpharetta and Johns Creek, and it flows for approximately 4 miles before emptying into Big Creek. There are three main tributaries that flow into Long Indian Creek. They are named Long Indian Creek Tributary 1, Long Indian Creek Tributary 2, and Long Indian Creek Tributary 3. Long Indian Creek Tributary 1 has the furthest downstream confluence with Long Indian Creek, and Long Indian Creek Tributary 3 has the furthest upstream confluence. Additionally, there is a stream called Long Indian Creek Tributary 3.1 that flows into Long Indian Creek Tributary 3. The names and lengths of the tributaries to Long Indian Creek are shown in **Table 2.1** and a detailed image of the watershed can be seen in **Figure 2.1** in the previous section.

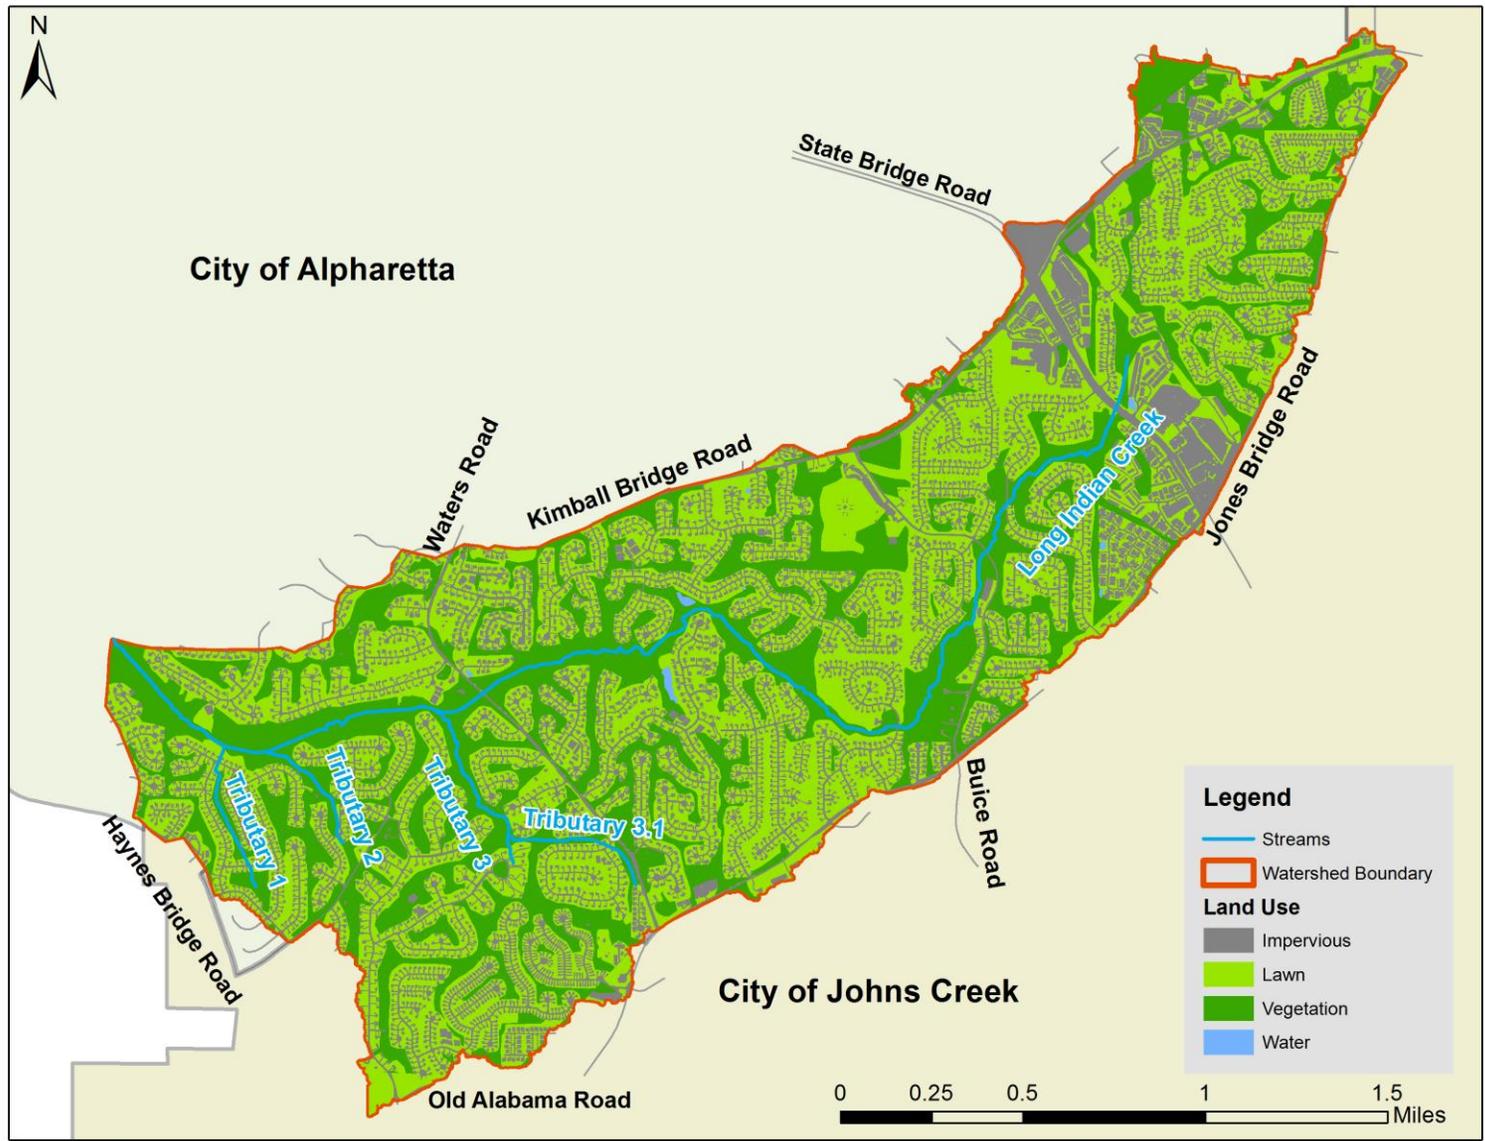
Figure 2.6 - Long Indian Creek Watershed Existing Land Use.

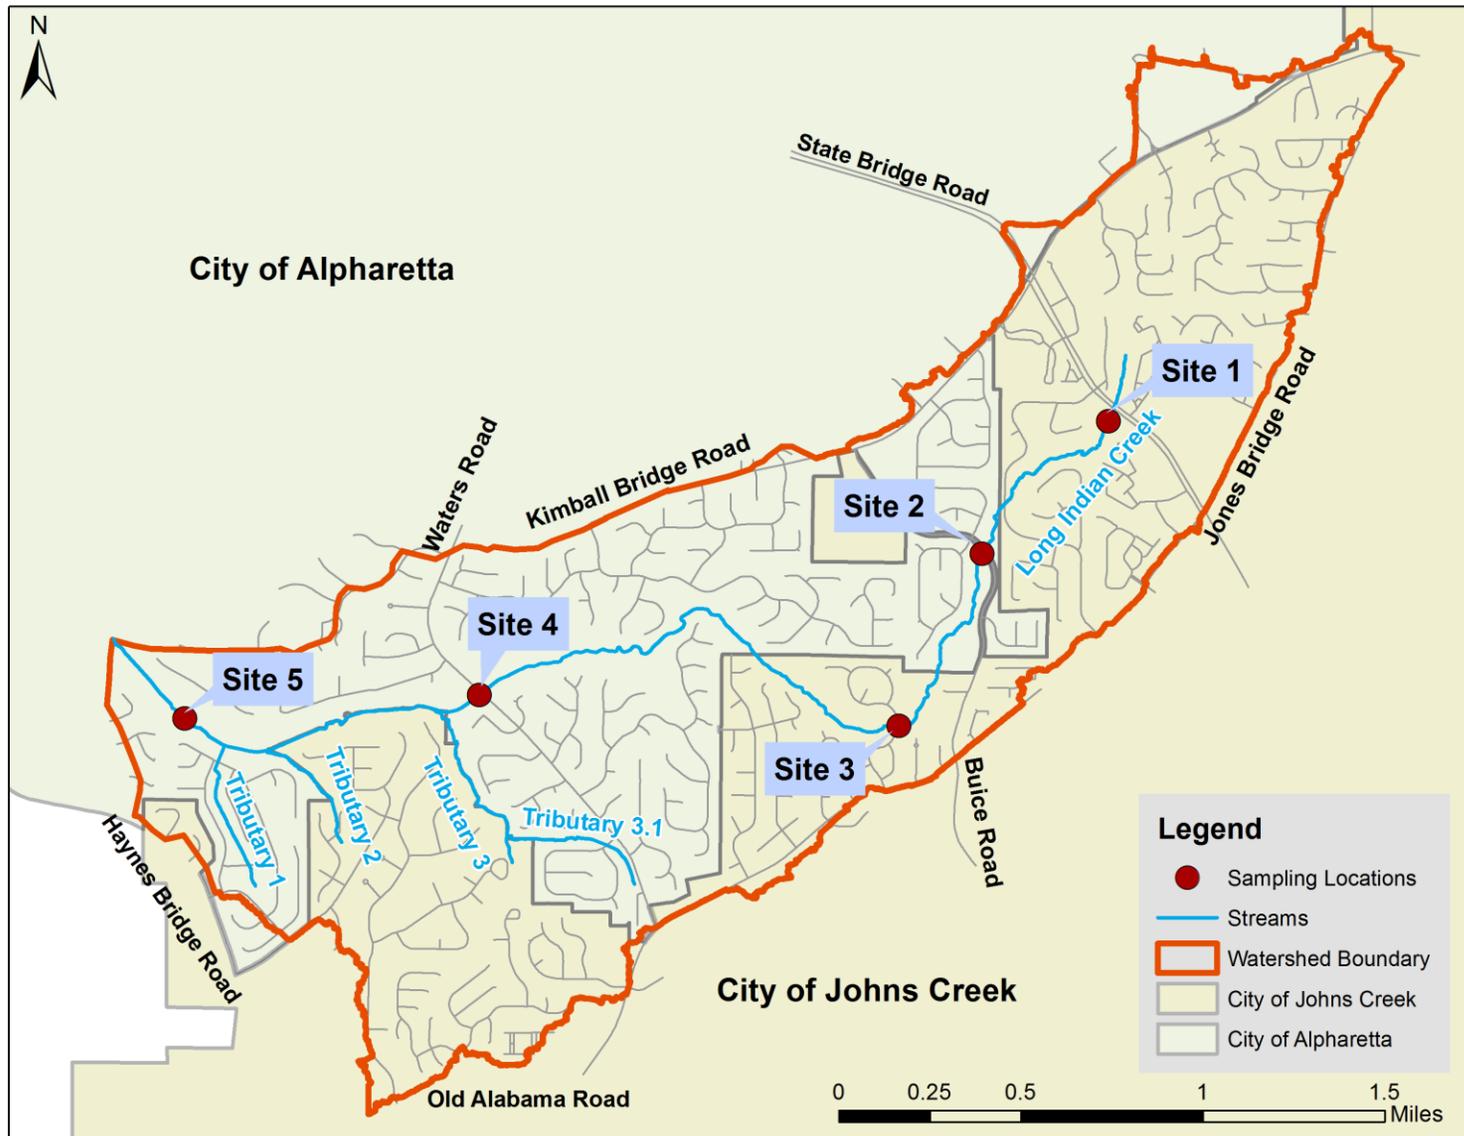
Figure 3.1 - Fecal coliform sampling locations for Long Indian Creek. Consistent sampling between Alpharetta and Johns Creek began in 2014.

The sampling locations are shown in **Figure 3.1**. Furthermore, Fulton County is conducting water quality monitoring for fecal coliform on Long Indian Creek at Waters Road (Site 4). All the results of these monitoring efforts have been combined in section 3.3.1 Fecal Coliform Monitoring Results of this report.

Further, the Dewberry Team measured stream cross-sections and performed habitat assessments and bank erosion hazard indexes at the five sampling sites showing in **Figure 3.1**. The cross-section measurements are needed to compute the entrenchment ratio and width-depth ratio for the Rosgen Stream Classification System. Additionally, the cross-sections can be compared to any historical or future stream cross-section measurements in order to assess channel erosion/deposition and migration.

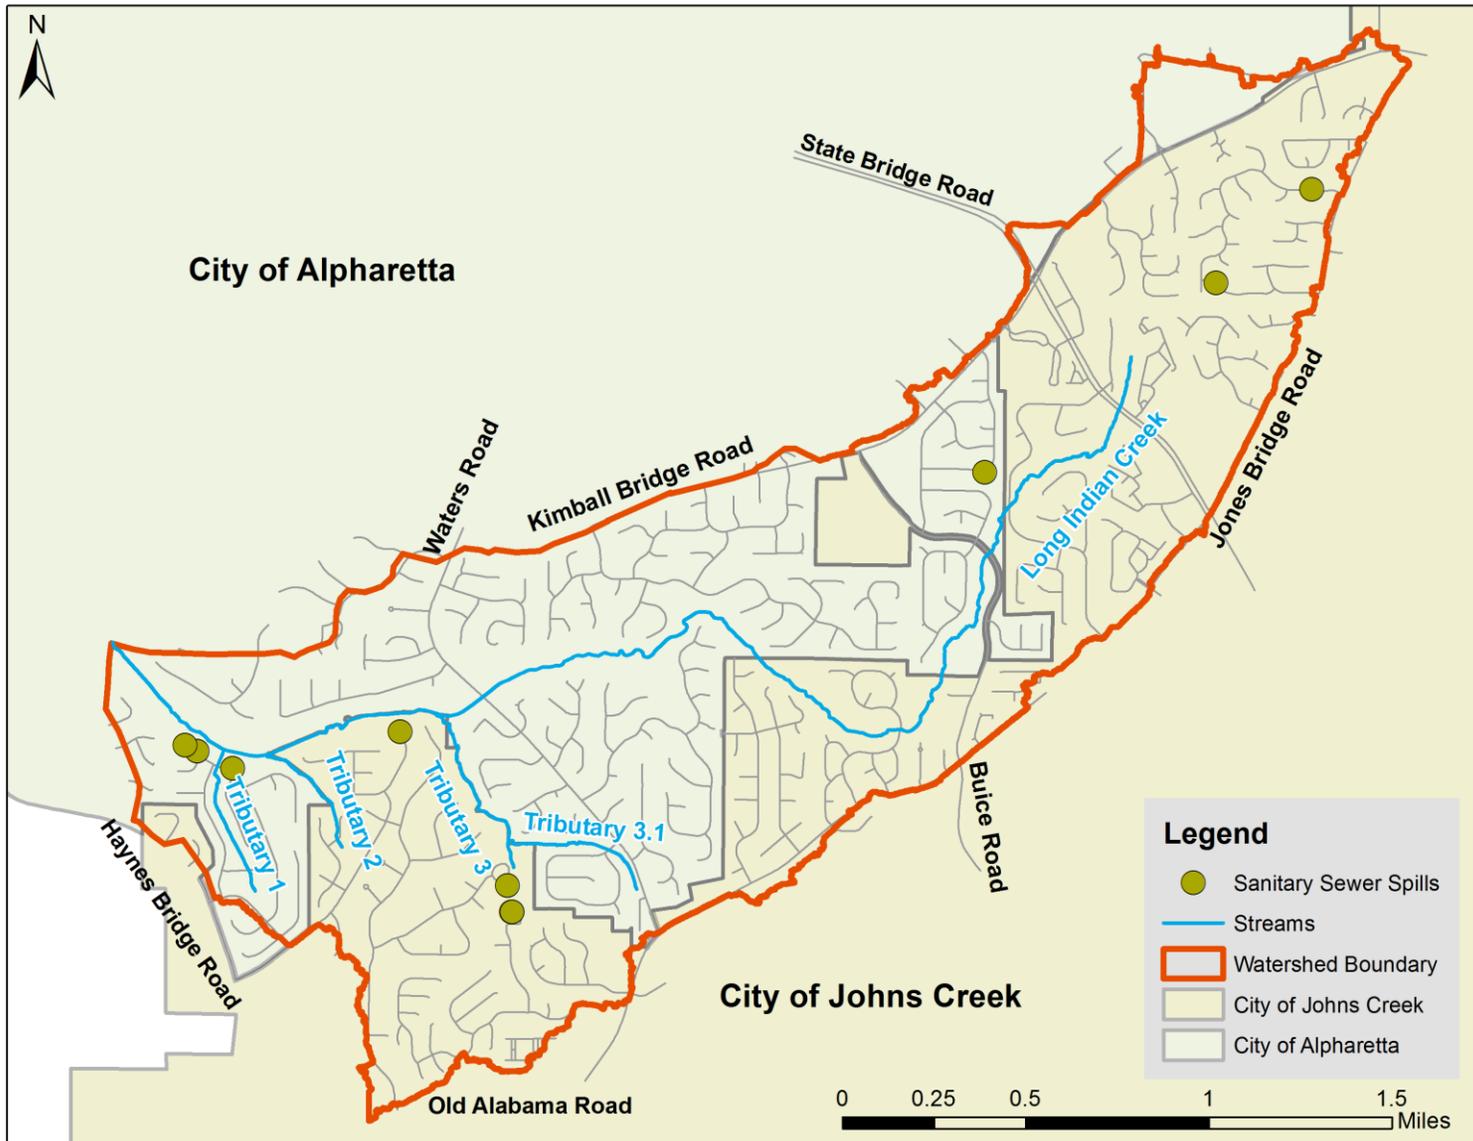
Figure 3.2 - Locations of sanitary sewer spill reported by Fulton County. No spills have been reported since February 2007.

Fulton County provided a record of sanitary sewer spills that have occurred within the Long Indian Creek Watershed. The spill dates range from October 1997 to February 2007. No spills were reported by the County after 2007. Additionally, all spills were reported as minor. **Figure 3.2** provides a map of the cataloged sanitary sewer spills. Although Long Indian Creek Watershed has not suffered an SSO in many years, it is important to remain vigilant of potential infiltration into the sanitary system and support a robust maintenance system to ensure the sanitary sewer system does not suffer future SSOs.

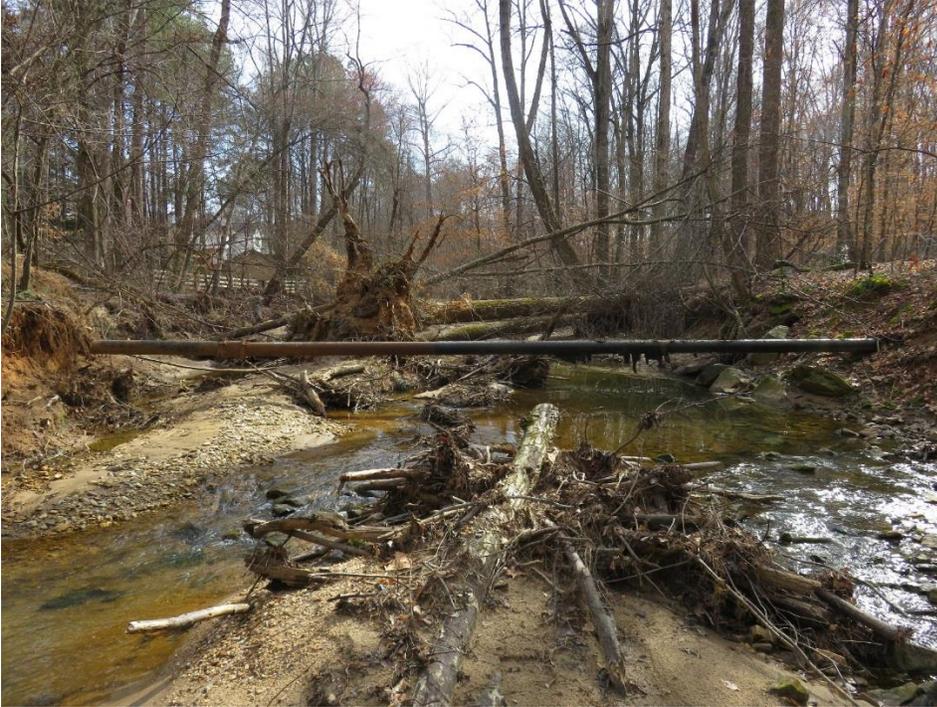
Figure 3.3 - A sanitary sewer pipe exposed due to channel and bank erosion. A large root ball can be seen behind the pipe and is an indication of the size of debris that can be transported in Long Indian Creek in storm events. Debris of this size could easily damage the exposed pipe.

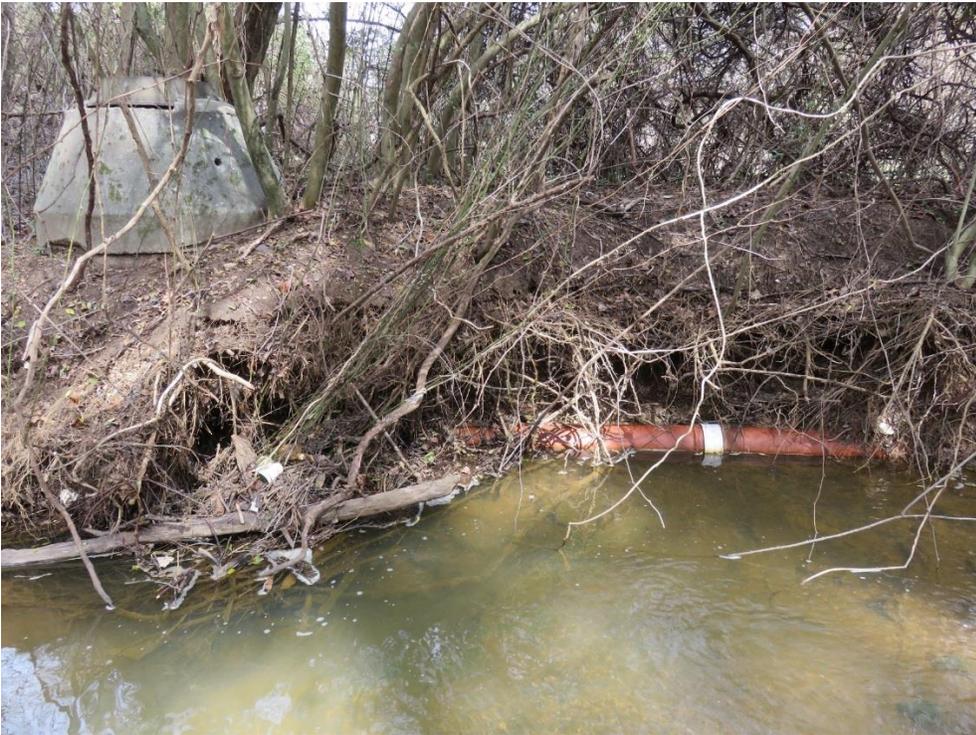
Figure 3.4 - A sanitary sewer pipe running parallel to the stream has been exposed due to bank erosion. This pipe is subject to damage in storm events. Additionally, a damaged manhole can be seen on the bank of the stream. Further bank erosion could compromise the manhole.

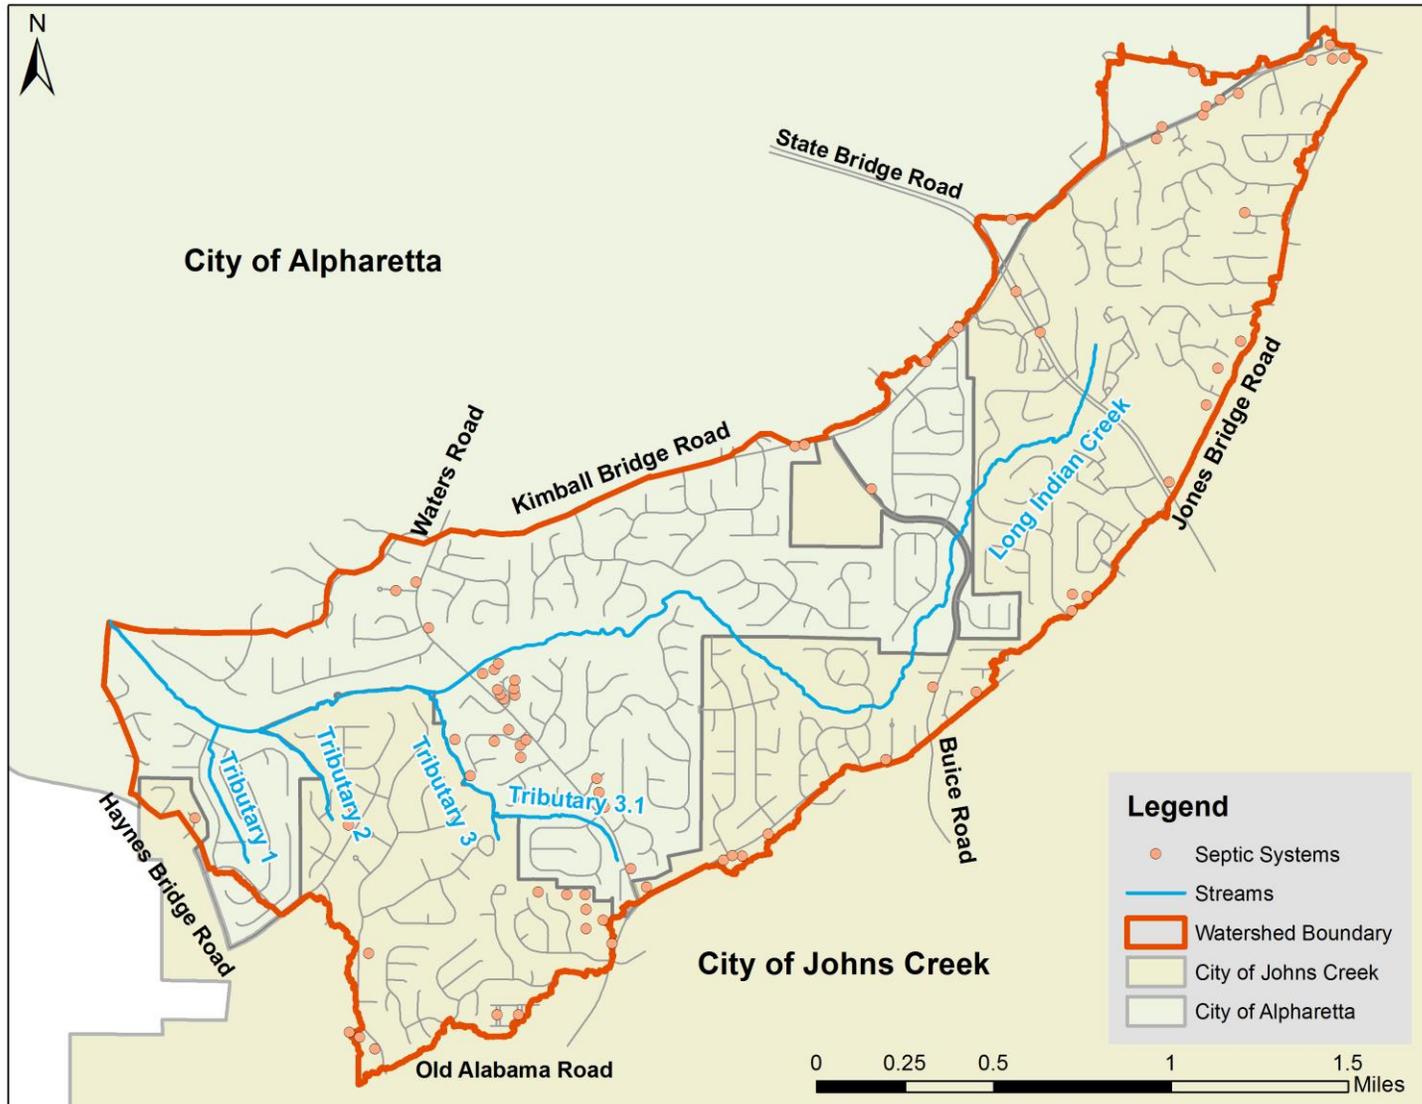
Figure 3.5 – Probable locations of septic systems within the Long Indian Creek Watershed. Dewberry actively worked with Fulton County’s Department of Water Resources, Finance Department, and Department of Health and Wellness to identify these locations.

Dewberry actively worked with Fulton County’s Department of Water Resources, Finance Department, and Department of Health and Wellness to identify locations of septic systems in the Long Indian Creek Watershed. Information received from various County Departments was verified through visual inspect of the neighborhoods to pinpoint the most likely locations of septic tanks in the watershed. Based on this analysis 75 potential septic systems were identified within the watershed. Septic systems are primarily located in older neighborhoods in the south-western part of the watershed near Waters Road. Several systems may also be found along Jones Bridge Road and Kimball Bridge Road where there are several older properties. The existence and condition of these septic tanks was not confirmed in this report. However, the age of the developments suggest that many of the septic systems may be 20-years or older and may be contributing to the local contamination if not properly maintained. Even if the septic system is newer and within its design life, it still has the potential to contribute to local contamination if located or operated inappropriately. **Figure 3.5** provides a map of probably locations of septic systems within the Long Indian Creek Watershed.

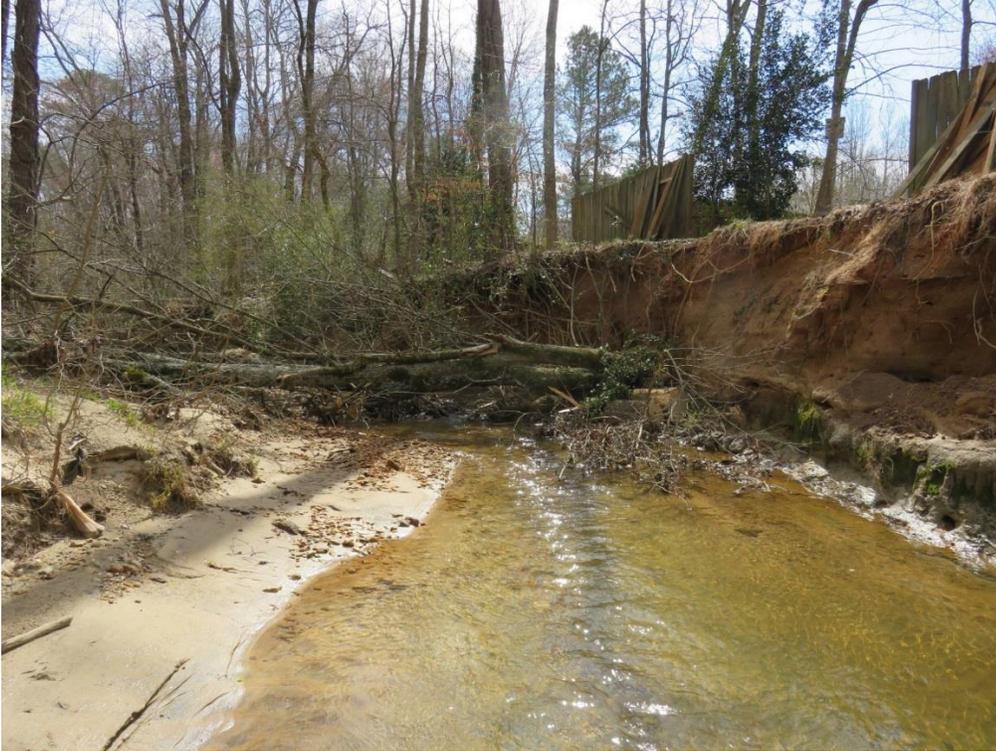
Figure 3.6 - Severe bank erosion has caused channel migration and has impacted a homeowner's fence on the stream bank.

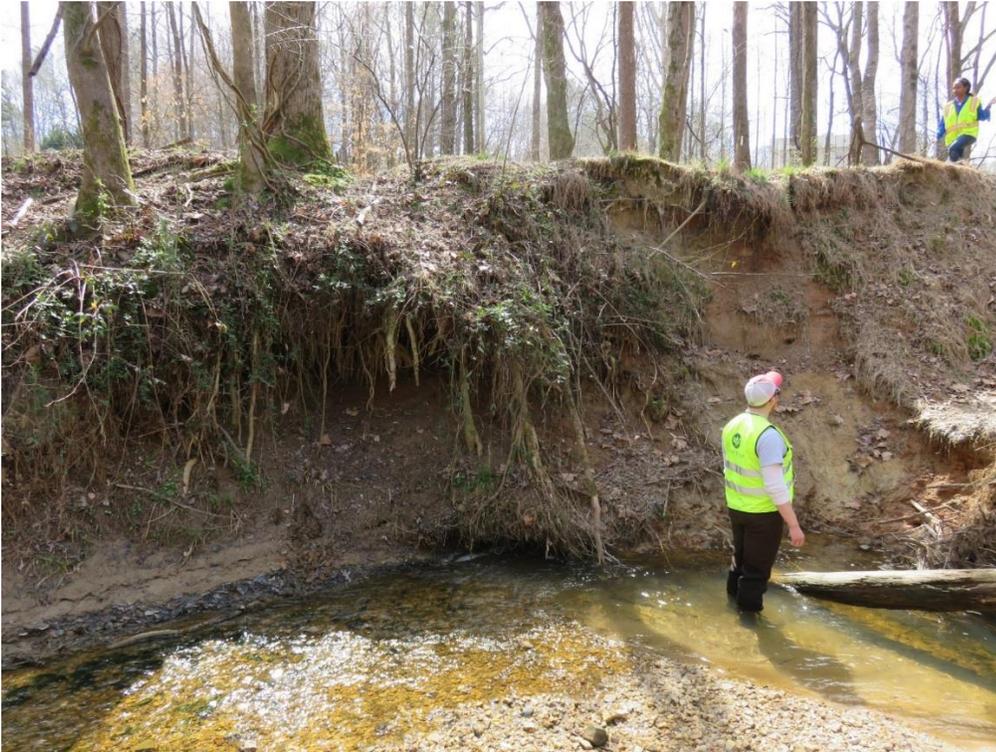
Figure 3.7 - Excess flows and velocities have incised channel, creating nearly vertical banks that are approximately 10 feet high. Altered Stream Geomorphology

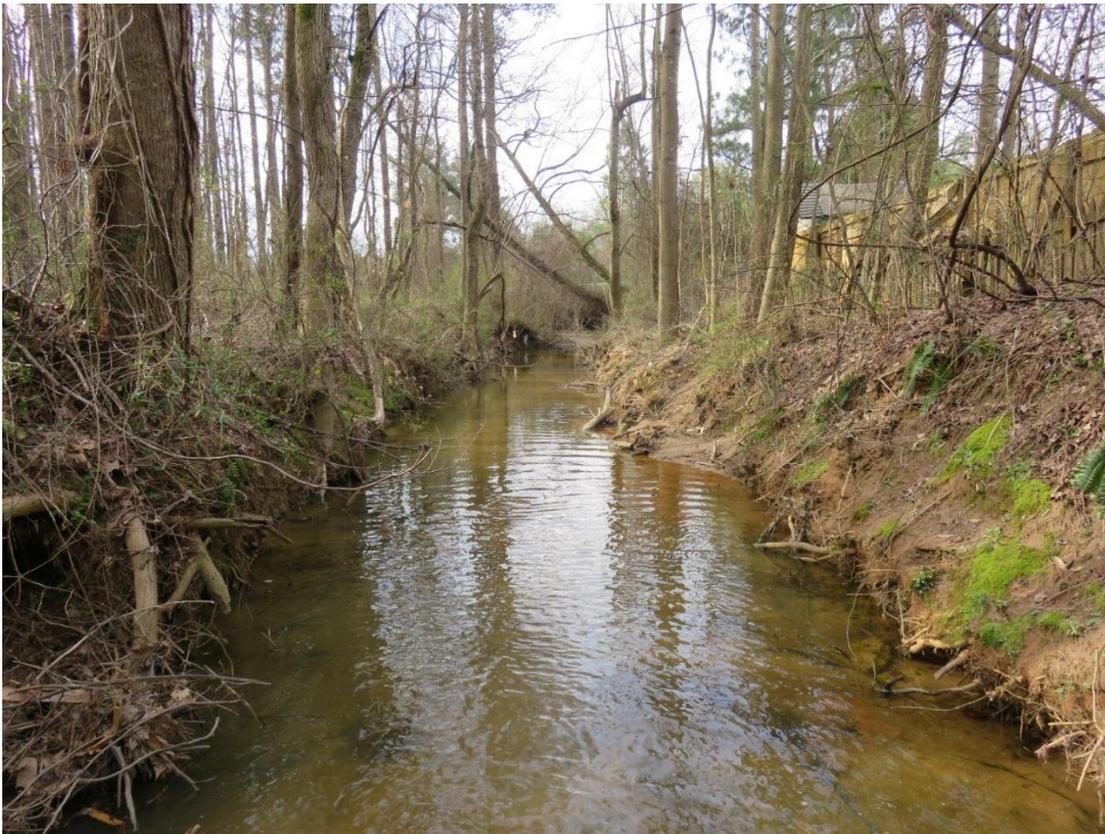
Figure 3.8 - A segment of straighten streamway prior to entering a culvert. Streamways were straightened to reduce flood risk and channel migration around bridges and culverts. Reduction of the riparian buffer can be seen on the right side of the stream.

Another alteration that was noticed in some areas of the watershed was the loss of the natural riparian buffer zone. In some neighborhoods, lawns extended to the very edge of the stream bank, allowing no buffer zone to prevent dog waste, fertilizer, and other pollutants from running off directly into the stream. Further, the lack of trees along the stream banks can cause increased erosion due to the lack of root mass to stabilize the banks. Additionally, natural habitats provided by tree roots are removed when the natural riparian buffer is eliminated.

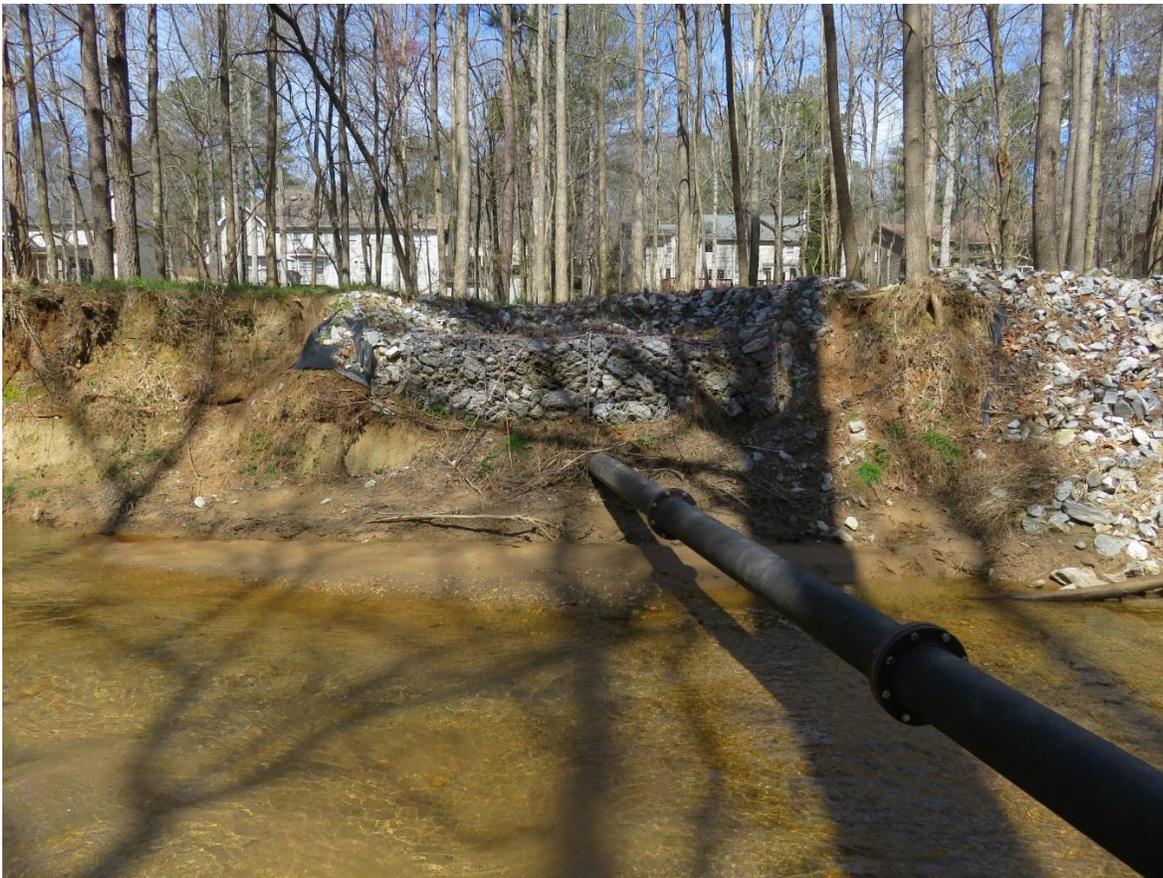
Figure 3.9 – Gabion baskets have been installed along the stream bank to protect the sanitary sewer pipe. Riprap has been installed to the right of the pipe to further protect against increased stream bank erosion.

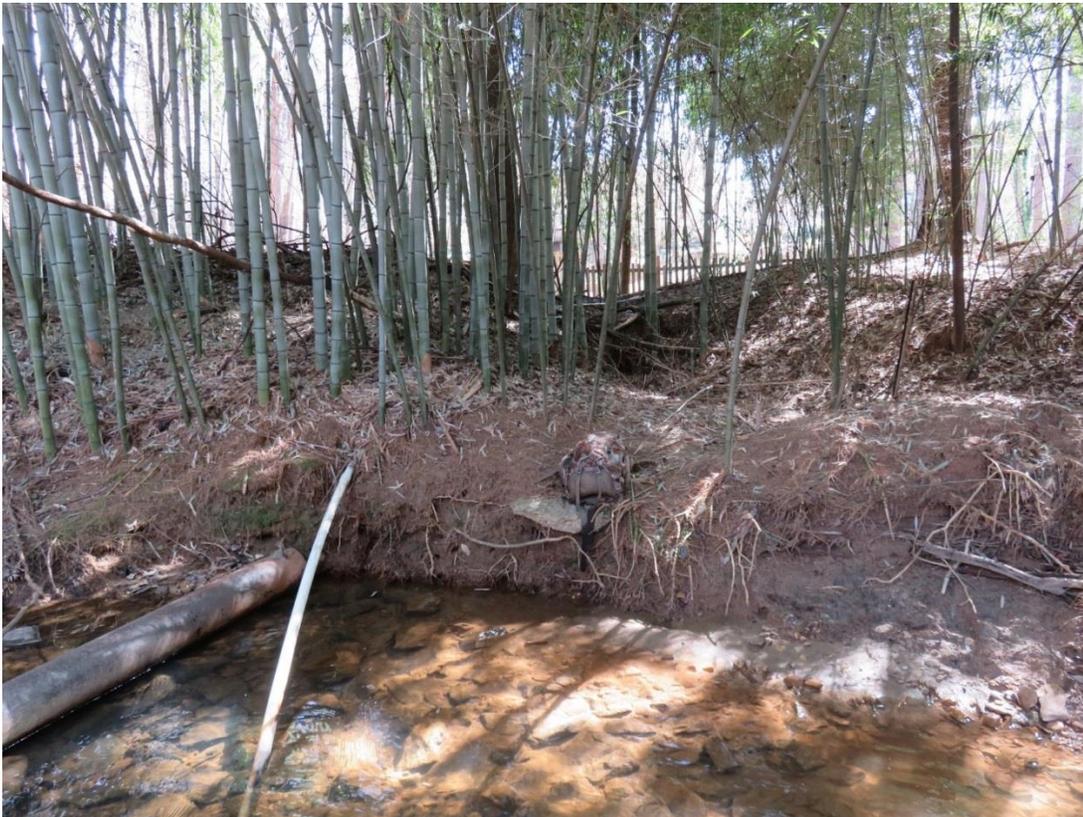
Figure 3.16 - Bamboo thicket surrounding an exposed sanitary sewer pipe on the bank of Long Indian Creek. The shallow root system of the Bamboo plants can be seen on the exposed bank. Field Data Collection

Bamboo was another invasive species seen in the Long Indian Creek Watershed (*Phyllostachys aurea*); however, it was less common than Privet or Russian Olive, and the clumps were contained to smaller areas along the stream banks. Bamboo is an evergreen plant that can grow as tall as 16 to 40 feet (Invasive Plant Atlas, 2016). Despite the height of bamboo plants, the root system is only 2 to 3 feet deep, providing very little stabilization for riparian soils along stream banks (Bamboo Garden, 2016). Bamboo is spread by rhizomes that can form dens, monocultural thickets that displace native plants and are difficult to remove (Invasive Plant Atlas, 2016). **Figure 3.16** shows an example of bamboo found along the stream bank of Long Indian Creek. The thicket has surrounded a sanitary sewer pipe that has been exposed due to bank erosion. Due to the limited soil stability provided by Bamboo, erosion around the sanitary sewer pipe is likely to continue.

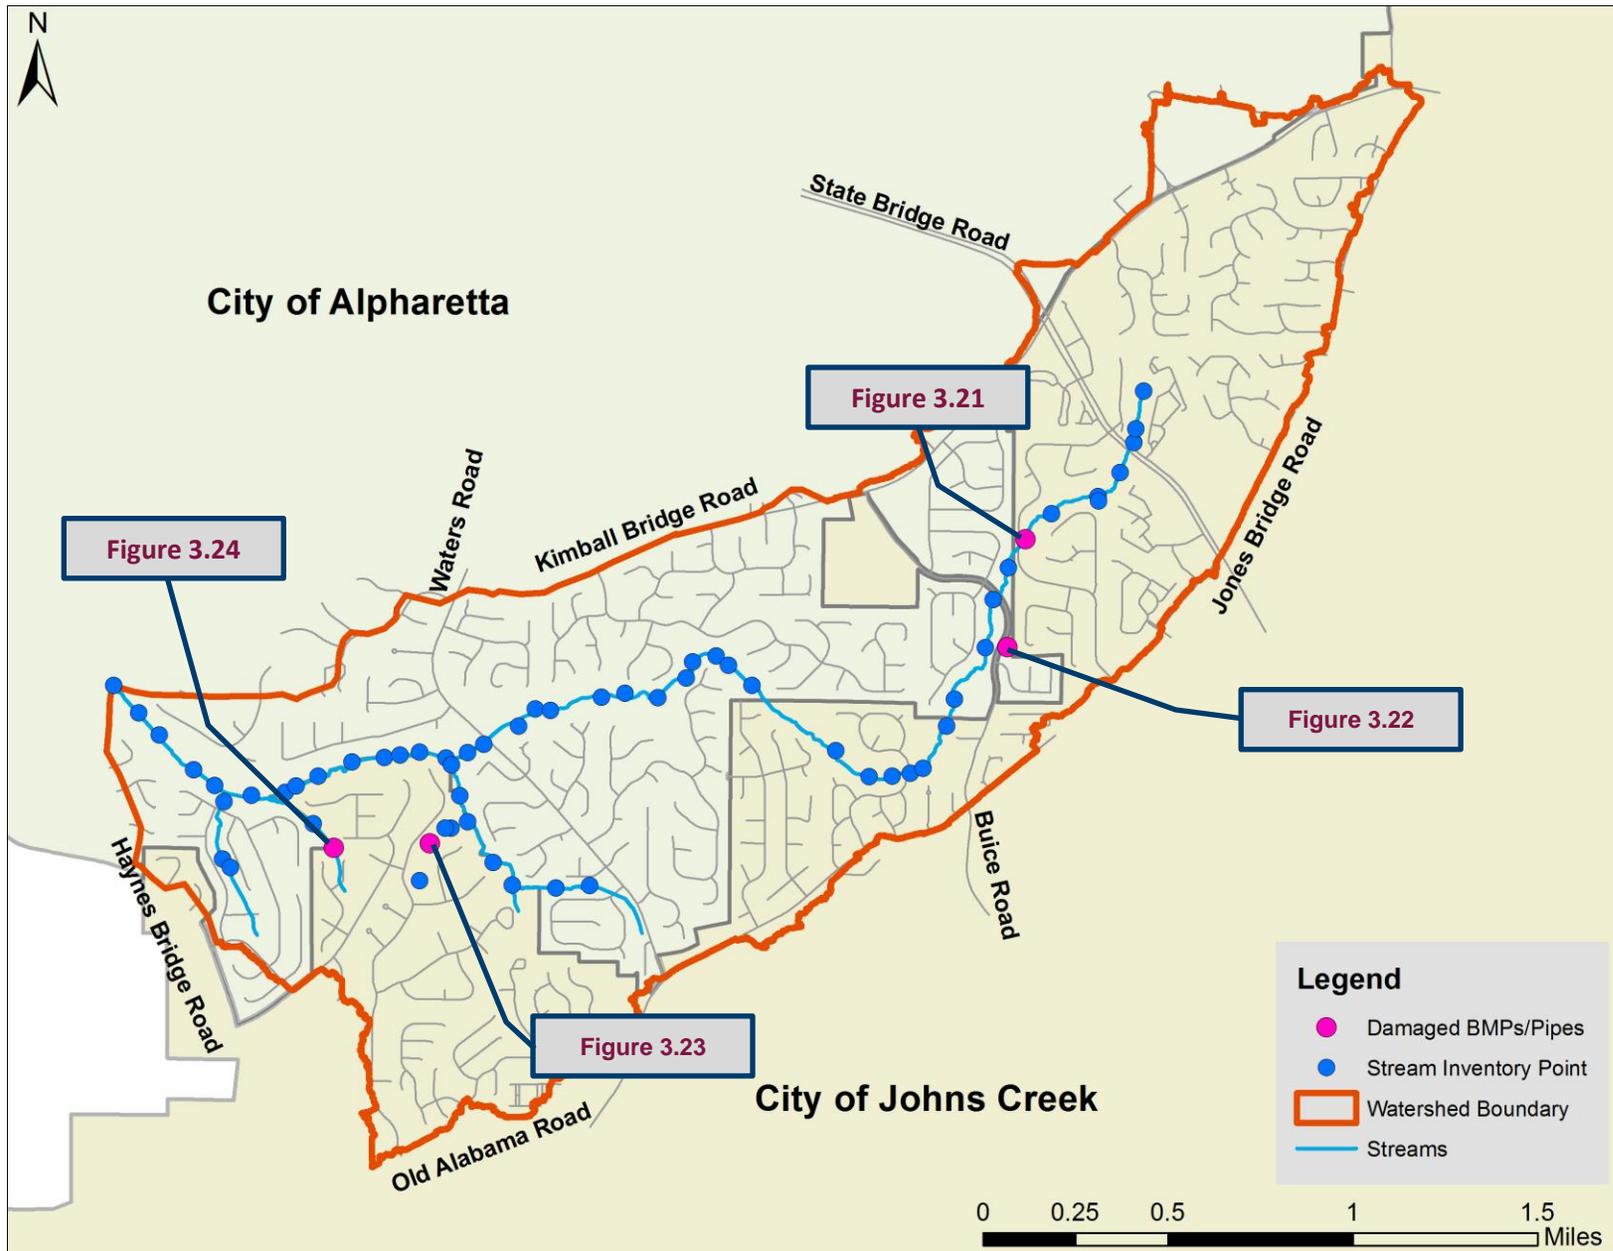
Figure 3.20 – Damaged BMPs and pipes discovered in the Long Indian Watershed. The following photos provide insight into the type of damage.

Other information gathered from field reconnaissance included locations of exposed pipes crossing the stream (**Figure 3.19**), damaged BMPs and pipes (**Figure 3.20**), and other areas of concern including beaver dams, debris, and trash found in the stream (**Figure 3.25**). When possible, images (**Figure 3.21 to Figure 3.24** and **Figure 3.26 to Figure 3.28**) have been included after maps to demonstrate the issues seen in the watershed.

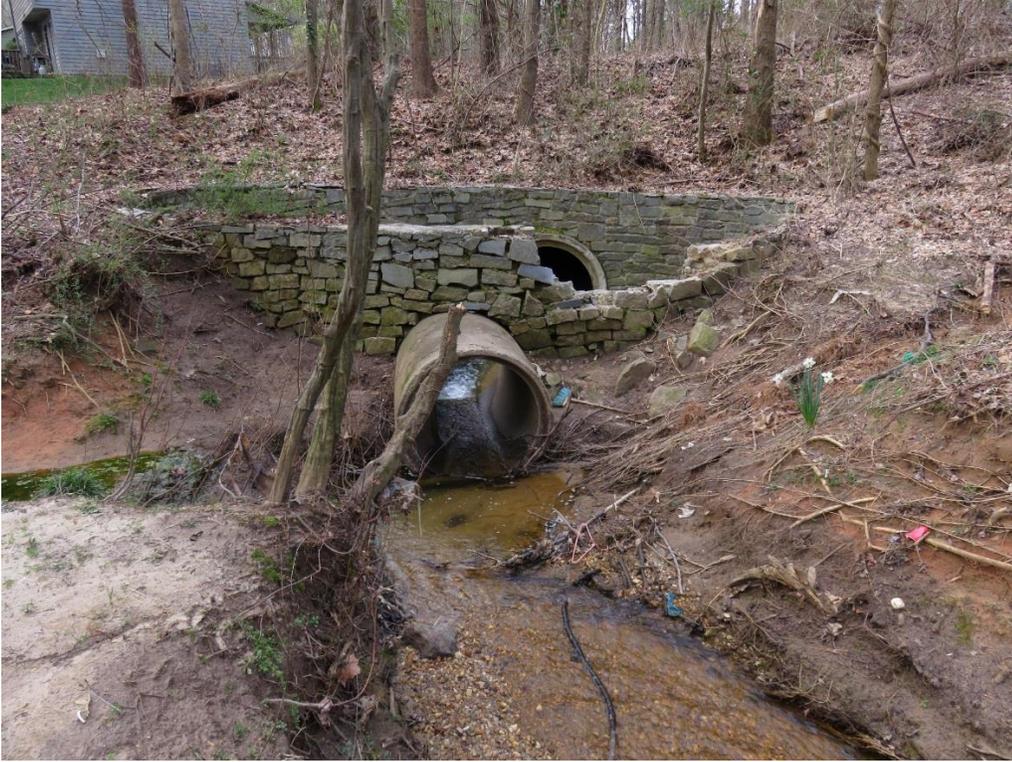
Figure 3.21 – A damaged BMP found outleting into Long Indian Creek. The flow attenuation provided by the BMP has been compromised by the damage.

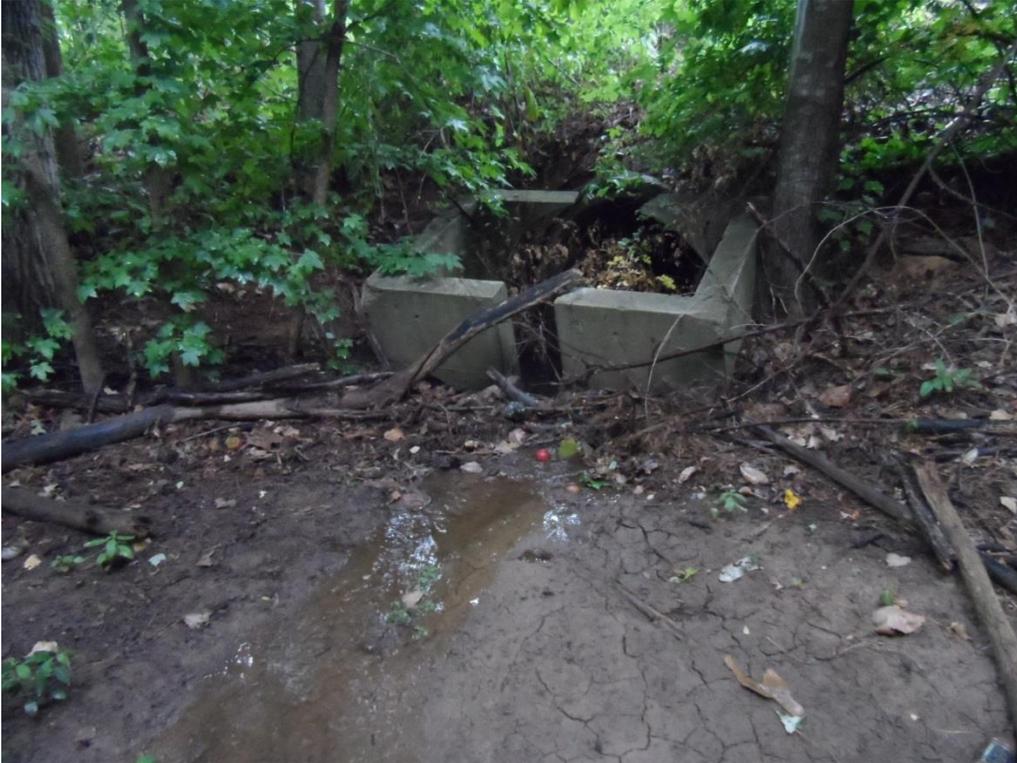
Figure 3.22 – Sedimentation in a BMP found in a neighborhood detention pond leading into Long Indian Creek. The flow attenuation provided by the BMP has been compromised by the sedimentation.

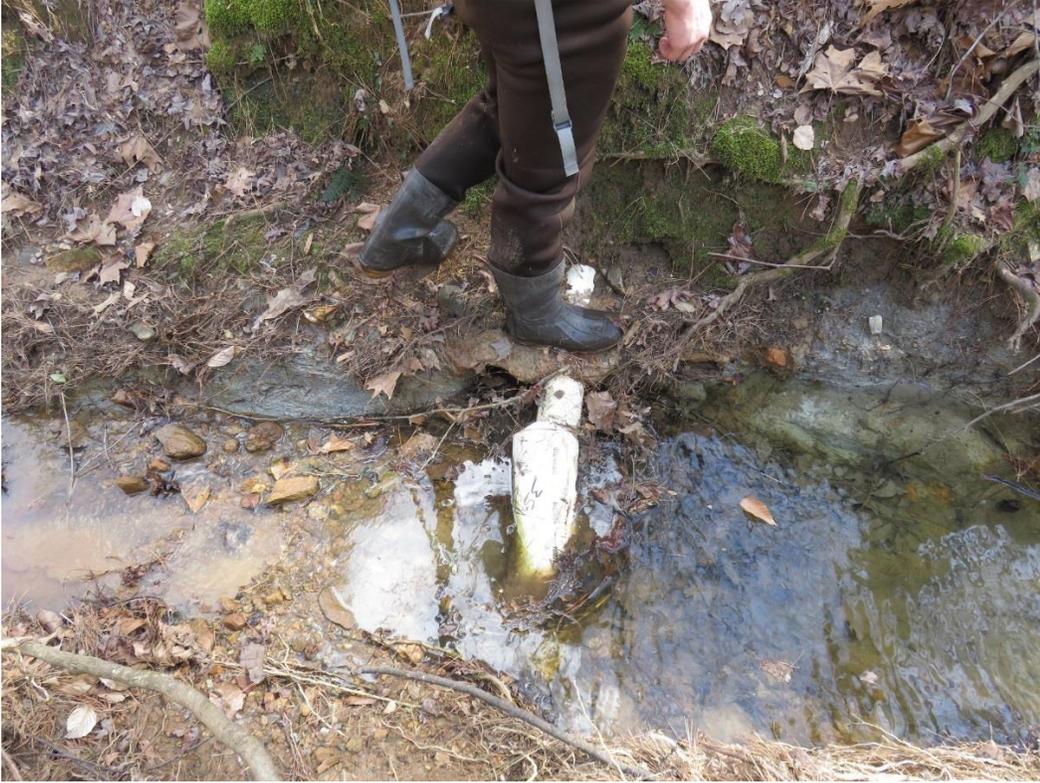
Figure 3.23 – A broken sewer connection found in a Tributary of Long Indian Creek.

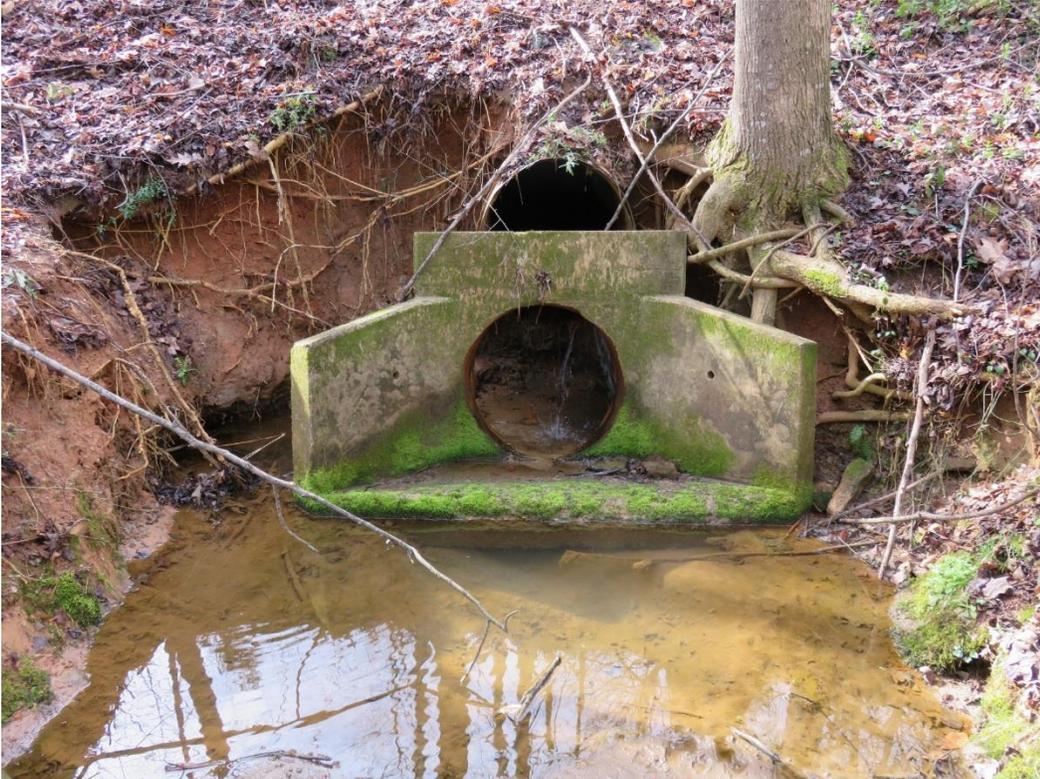
Figure 3.24 – A damaged pipe infrastructure. The headwall has become disconnected from the pipe due to scouring under the headwall.
