Long Indian Creek Watershed Improvement Plan

City of Alpharetta

January 30, 2017

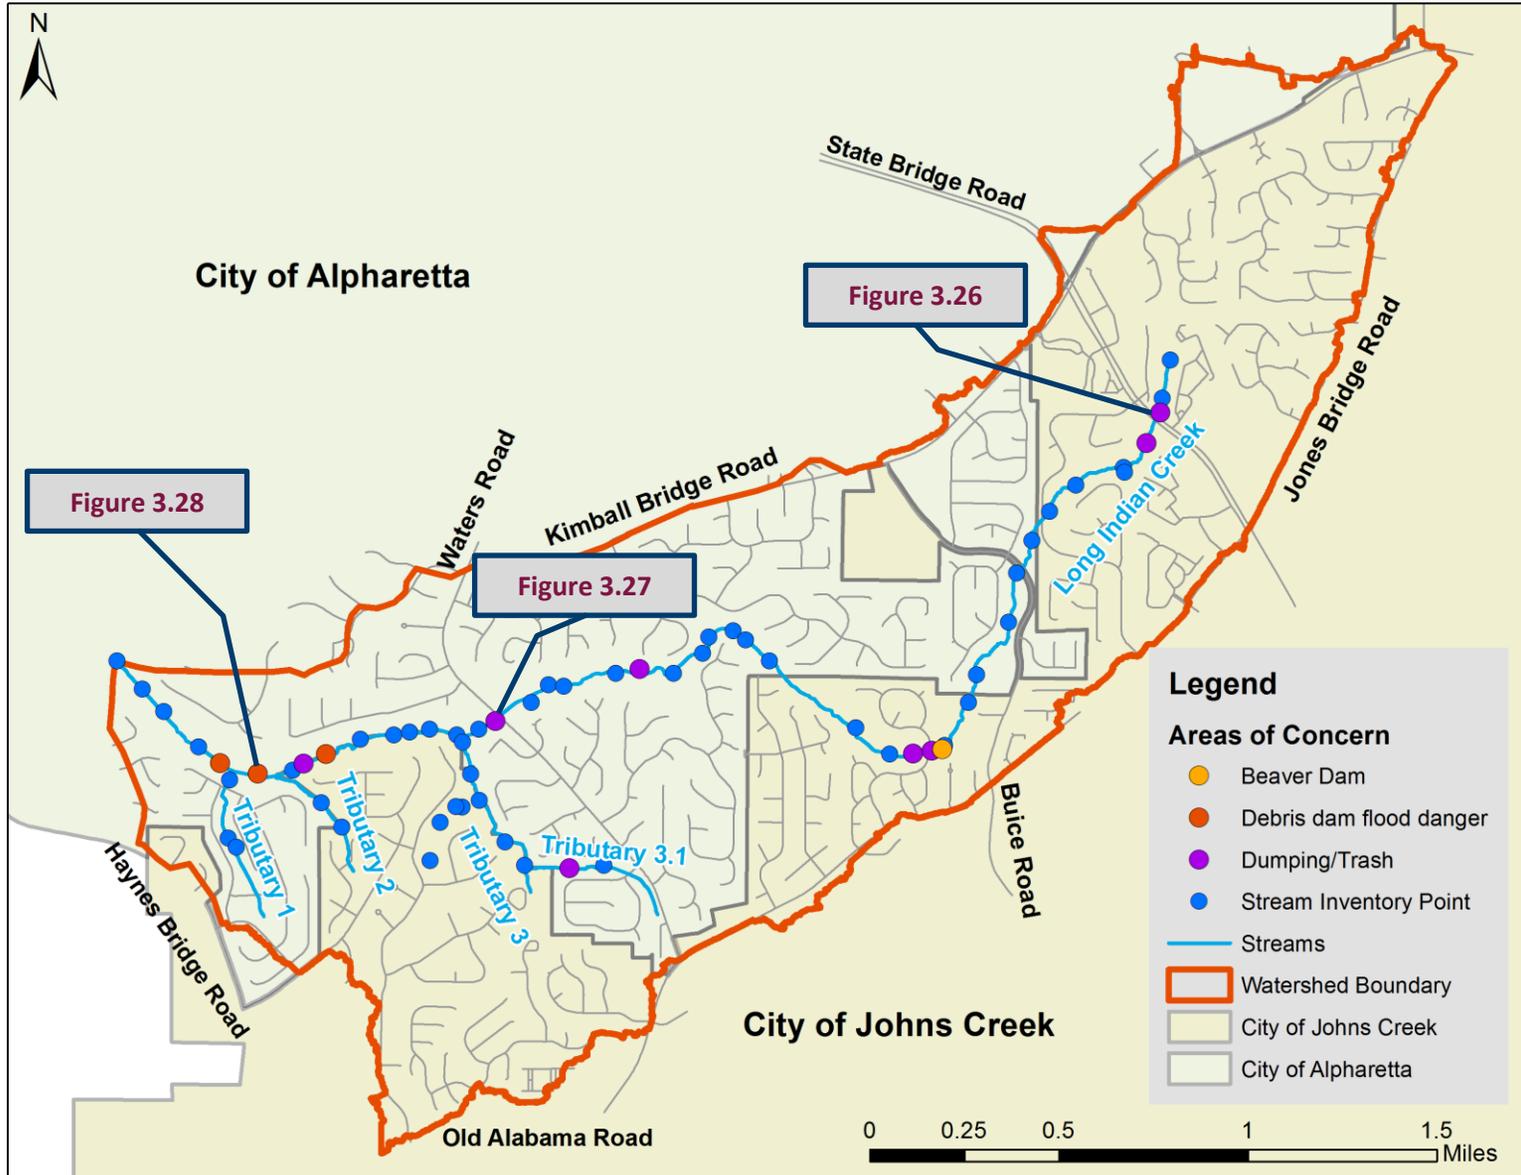
Figure 3.25 – Other areas of concern in Long Indian Creek. The most common/major issues noticed in the creek were debris dams, dumping/trash, and a beaver dam located just north of where Willow Meadow Circle crosses Long Indian Creek.

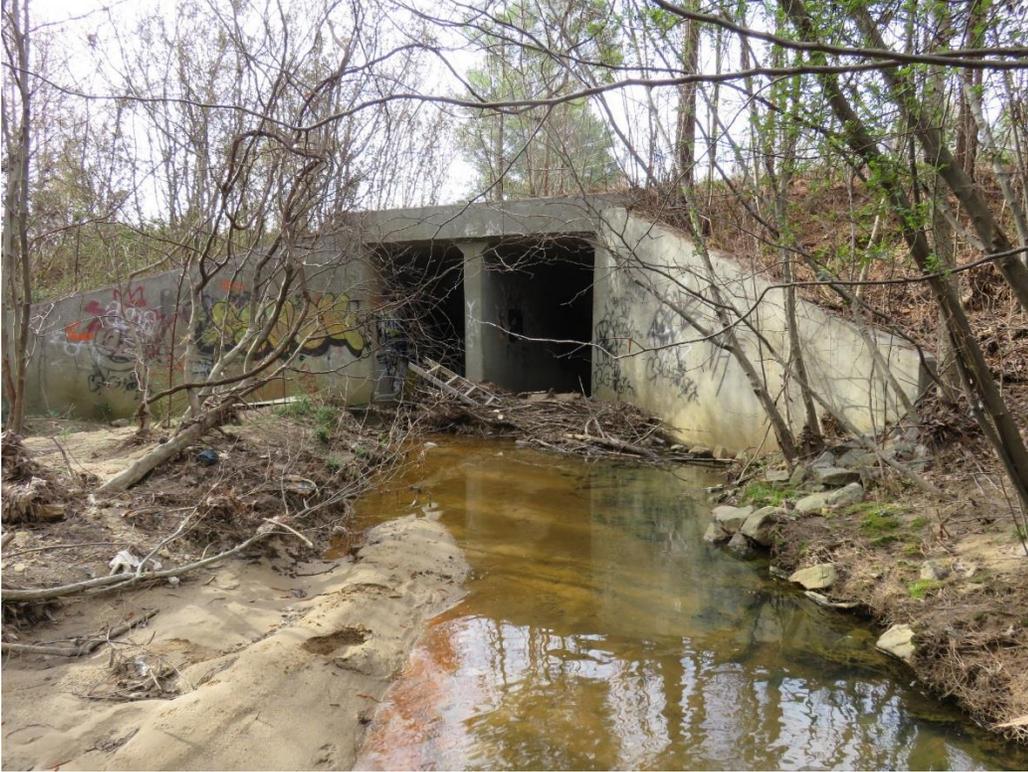
Figure 3.26 – Debris and trash blocking the entrance to the culvert. The debris could be a flooding concern and/or could damage the culvert during a flood event.

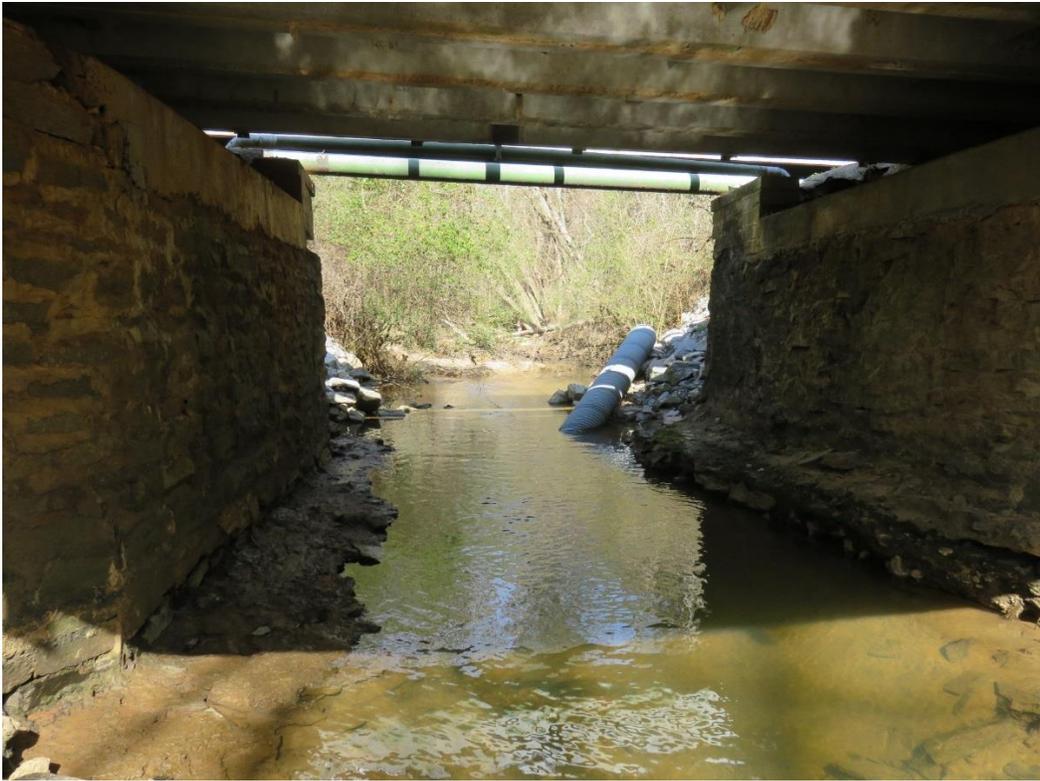
Figure 3.27 – A corrugated metal pipe is lodged under the bridge for Waters Road.

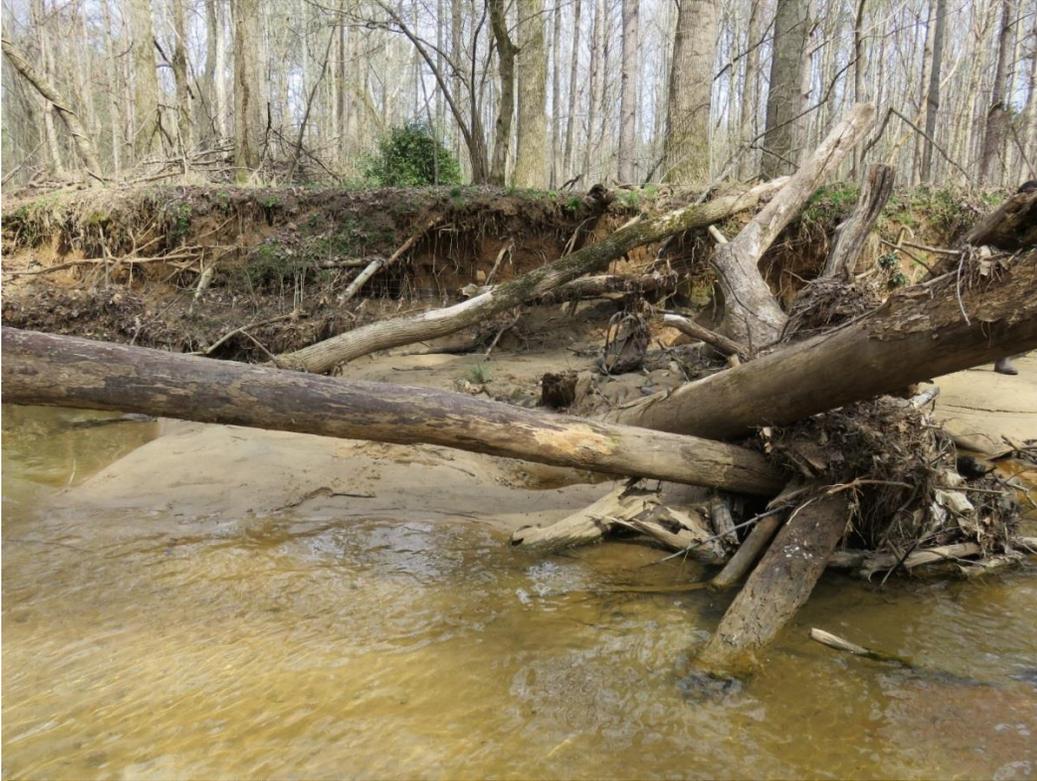
Figure 3.28 – A large debris dam has formed in Long Indian Creek. The debris dam is a flooding concern as it could cause a large flood hazard if it traps more debris, further blocking the flow of water, or is suddenly dislodged during a flooding event.

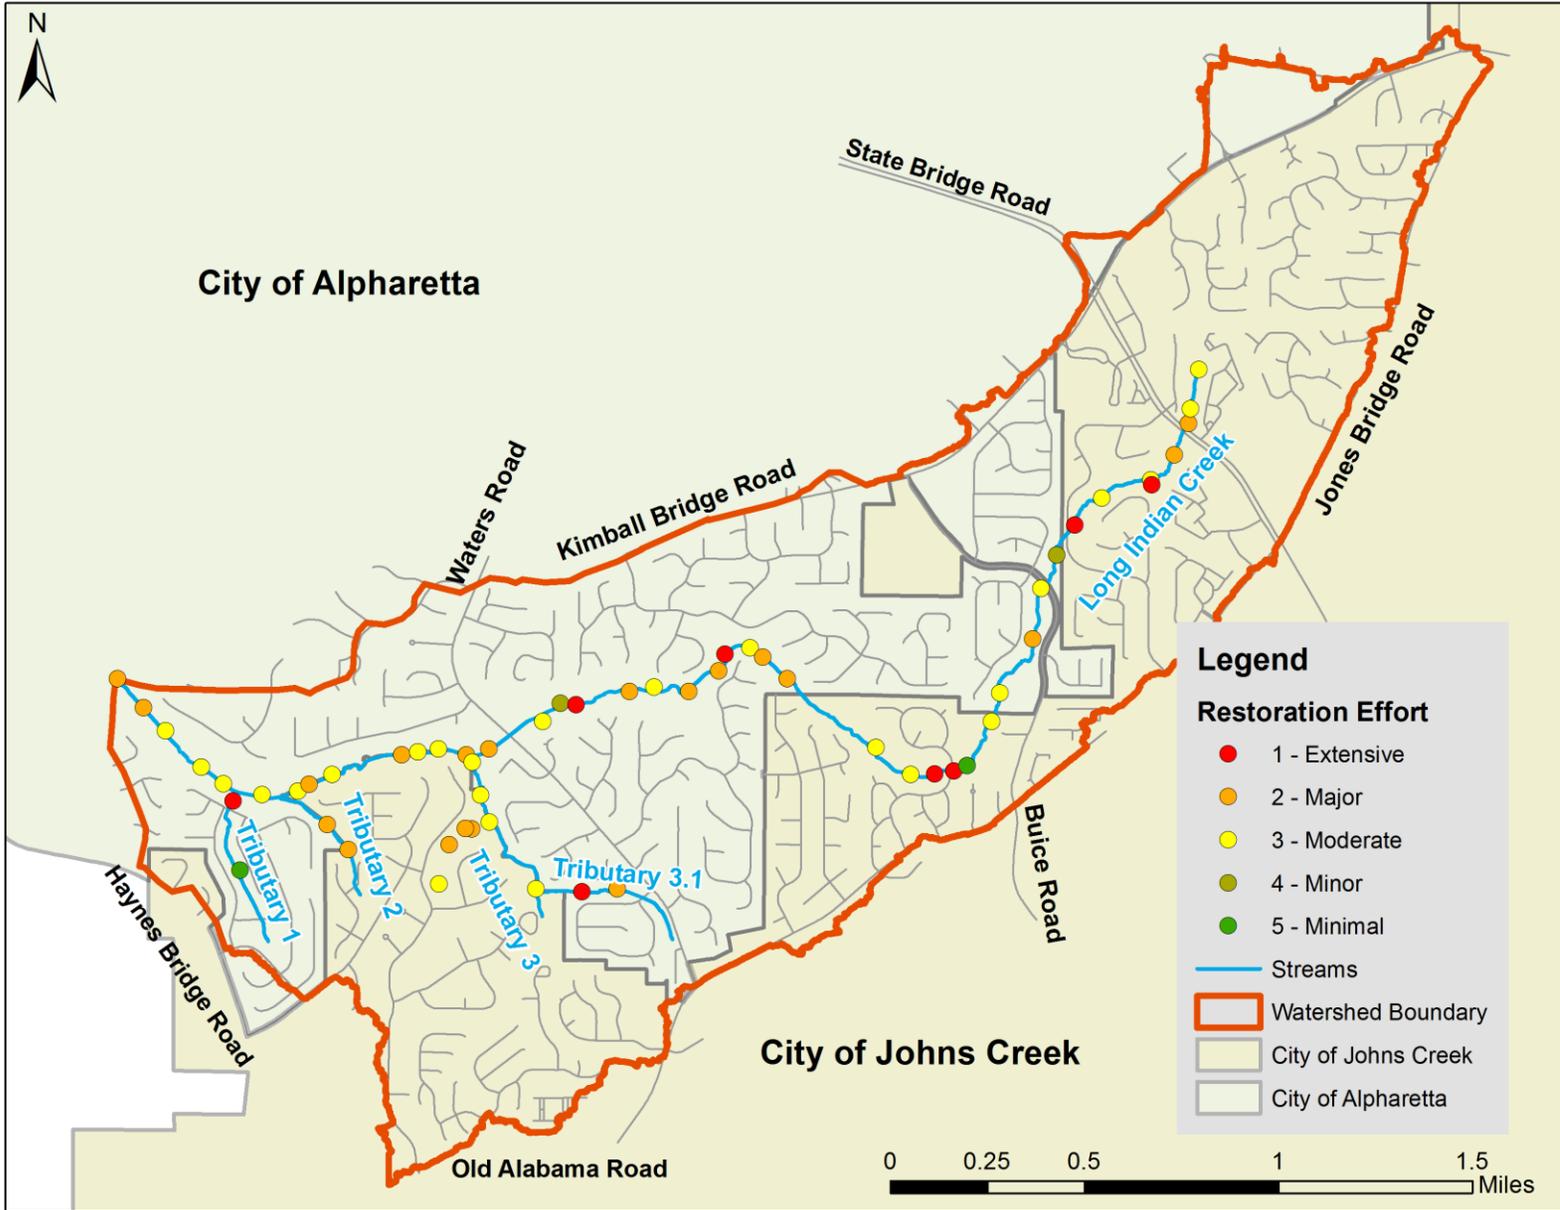
Figure 3.29 – Restoration effort required by each stream inventory point to implement restoration measures.

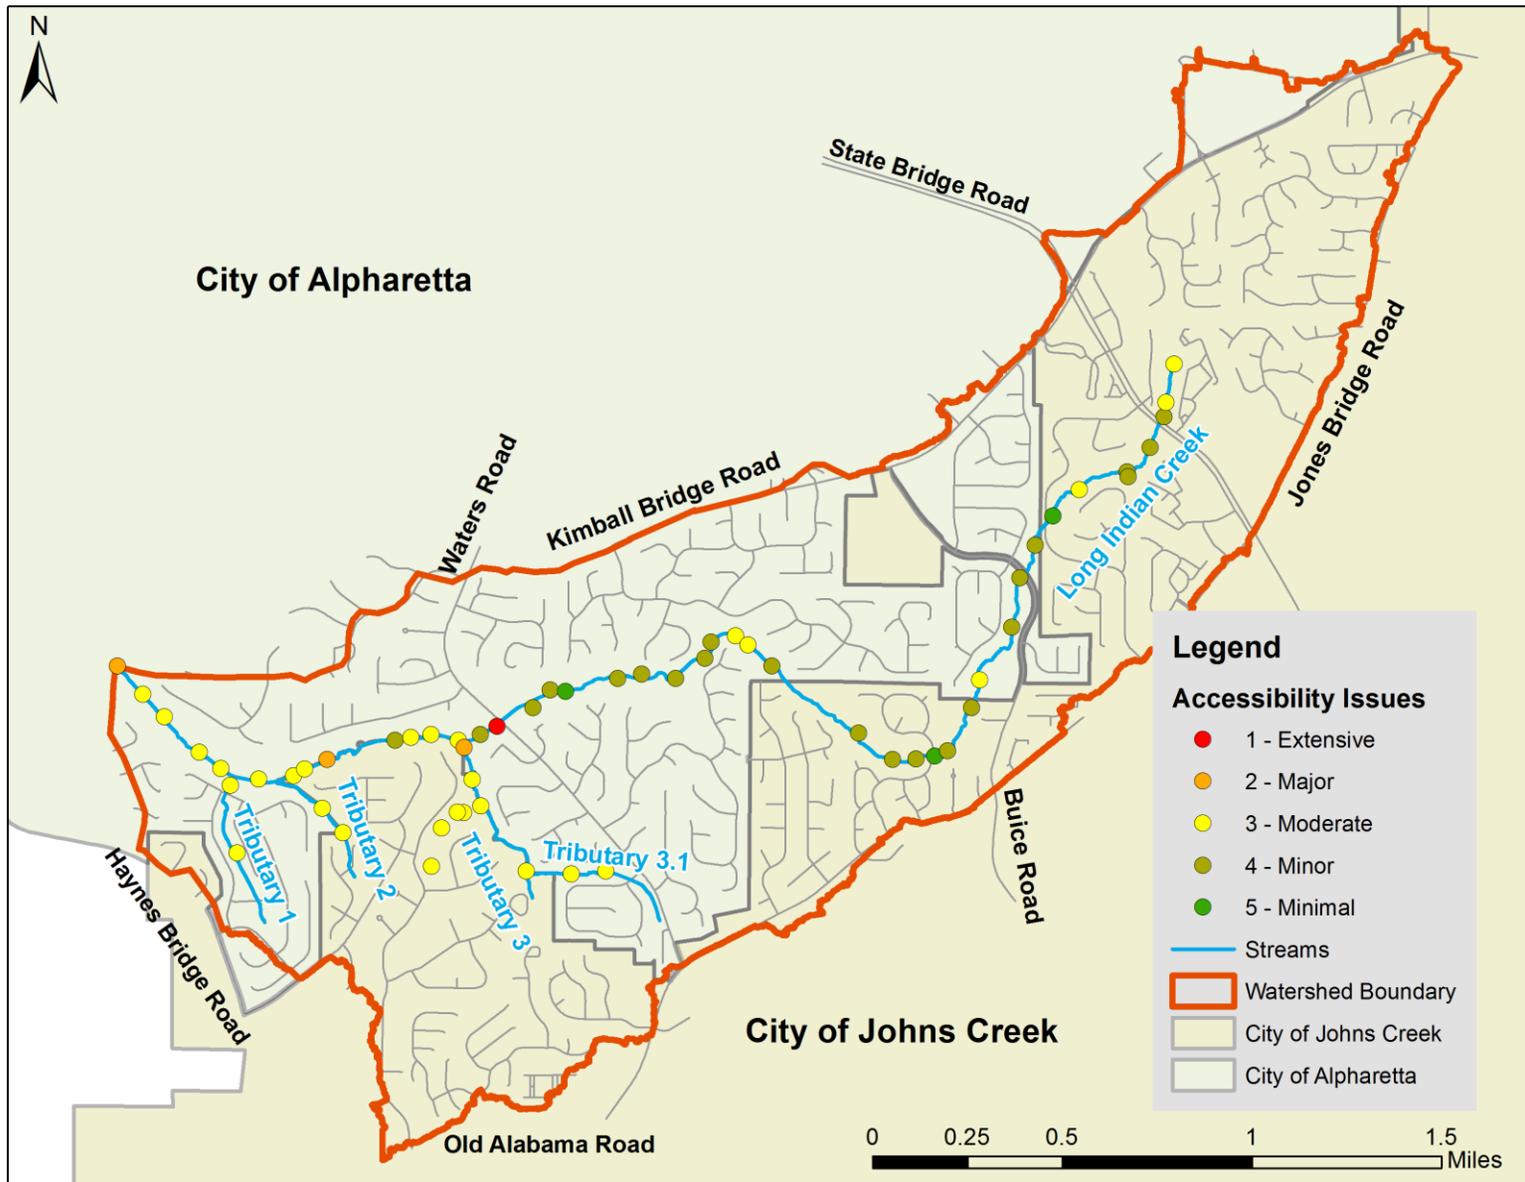
Figure 3.30 – Accessibility issues likely to be encountered at each stream inventory point in order to implement restoration measures.

Table 3.3 to **Table 3.5** provide definitions and explanations for abbreviations and terminology seen in **Figure 3.29** to **Figure 3.32**.

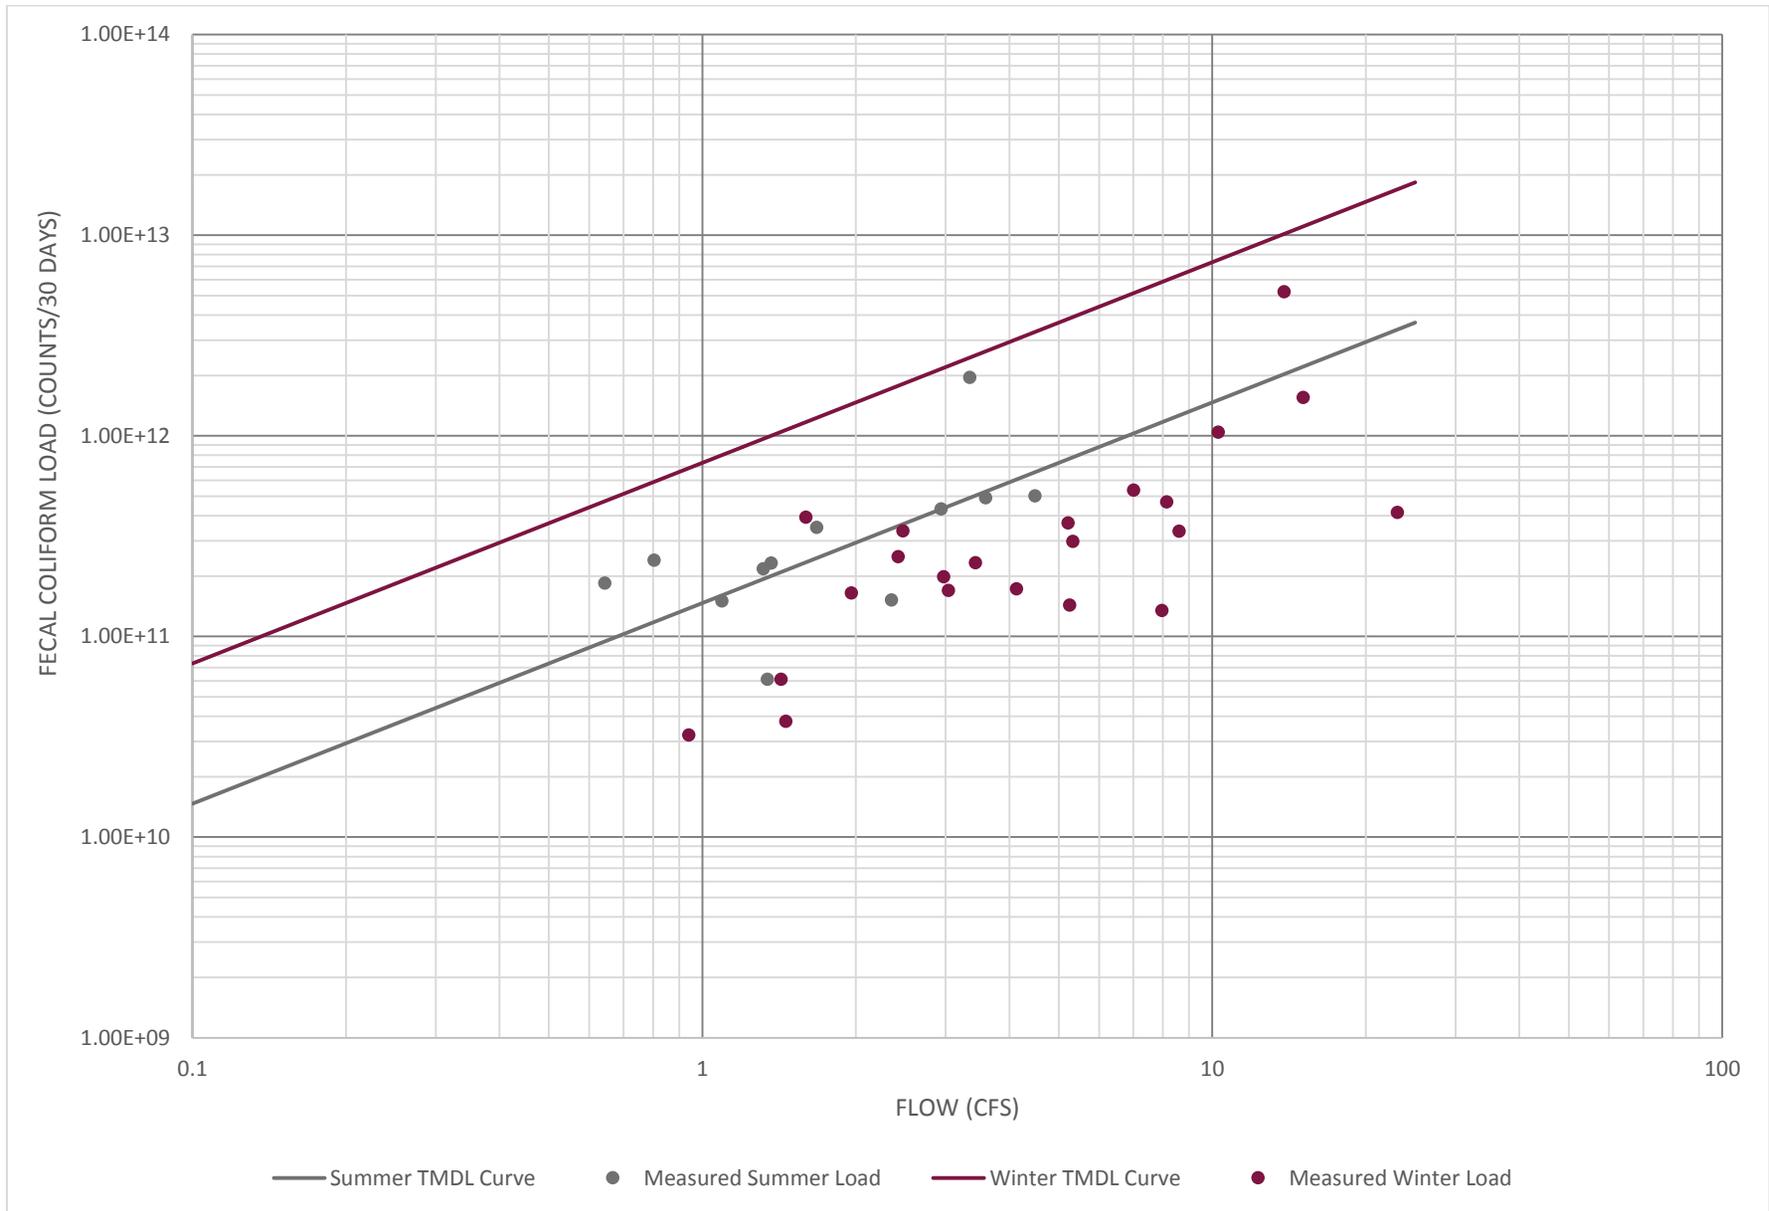
Figure 3.33 - Comparison of summer and winter TMDL curves to measured data from Long Indian Creek.

The points in **Figure 3.33** represent the measured fecal coliform counts for each of the five sites for every sampling month. In agreement with **Table 3.11**, **Figure 3.33** shows seven measured summer load points exceeding the summer TMDL curve and no measured winter load points exceeding the winter TMDL curve. However, the values displayed in **Figure 3.33** differ from those in **Table 3.11** because the values from **Table 3.11** have been converted from daily geometric means to monthly fecal coliform loads measured in total fecal counts per 30 days. The monthly fecal coliform loads displayed in **Figure 3.33** are provided in **Table 3.14**.

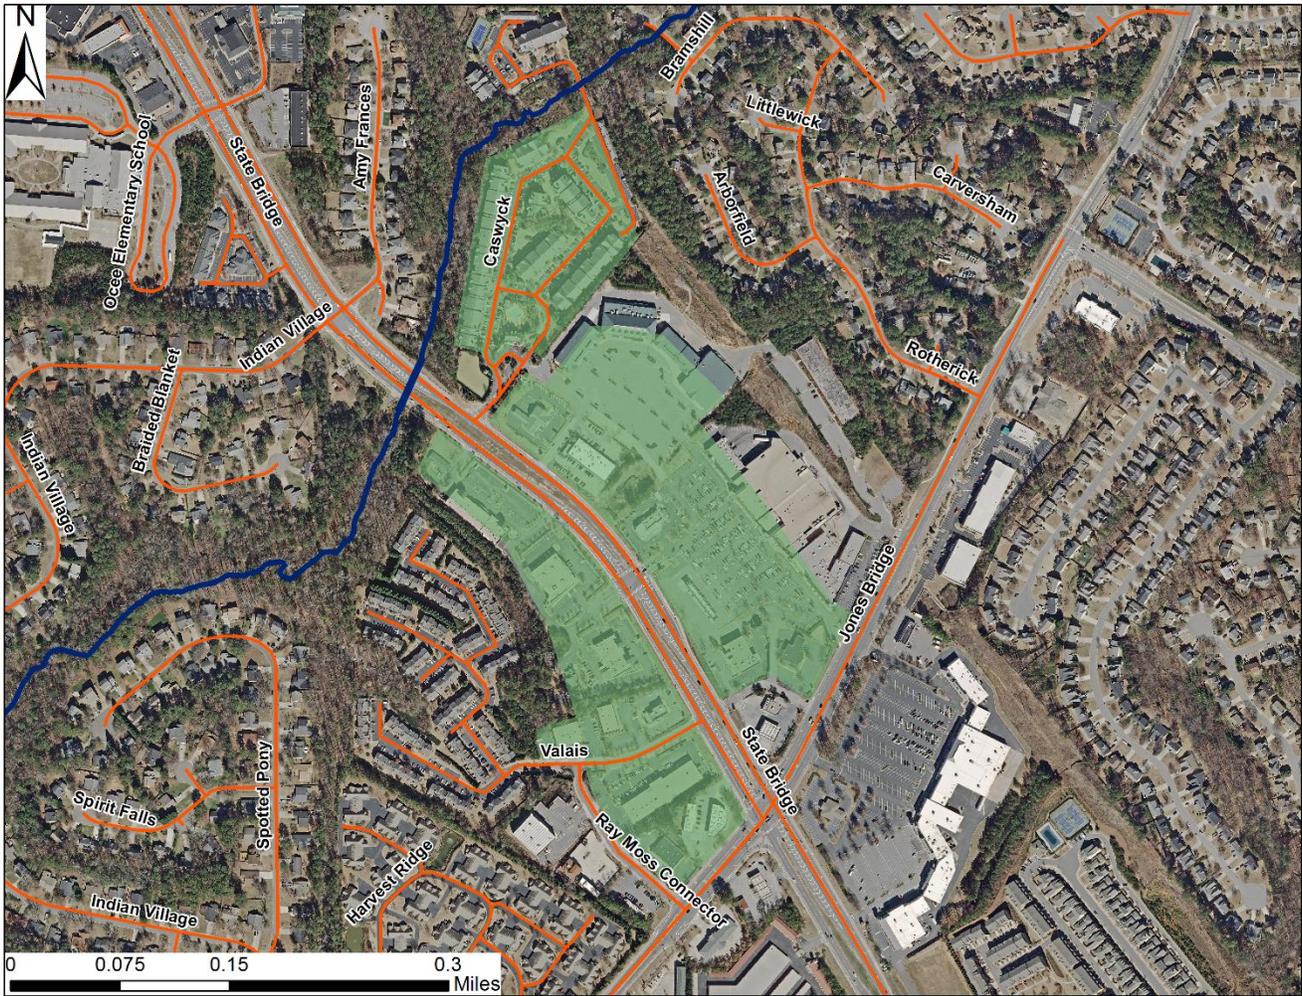
Figure 4.2 - 'Hotspot' locations for pet waste identified in the City of Johns Creek. It is recommended that dog waste stations be installed in the areas covered by green polygons. Dog waste stations in these areas are included in the Scenario 2 and Scenario 3 models

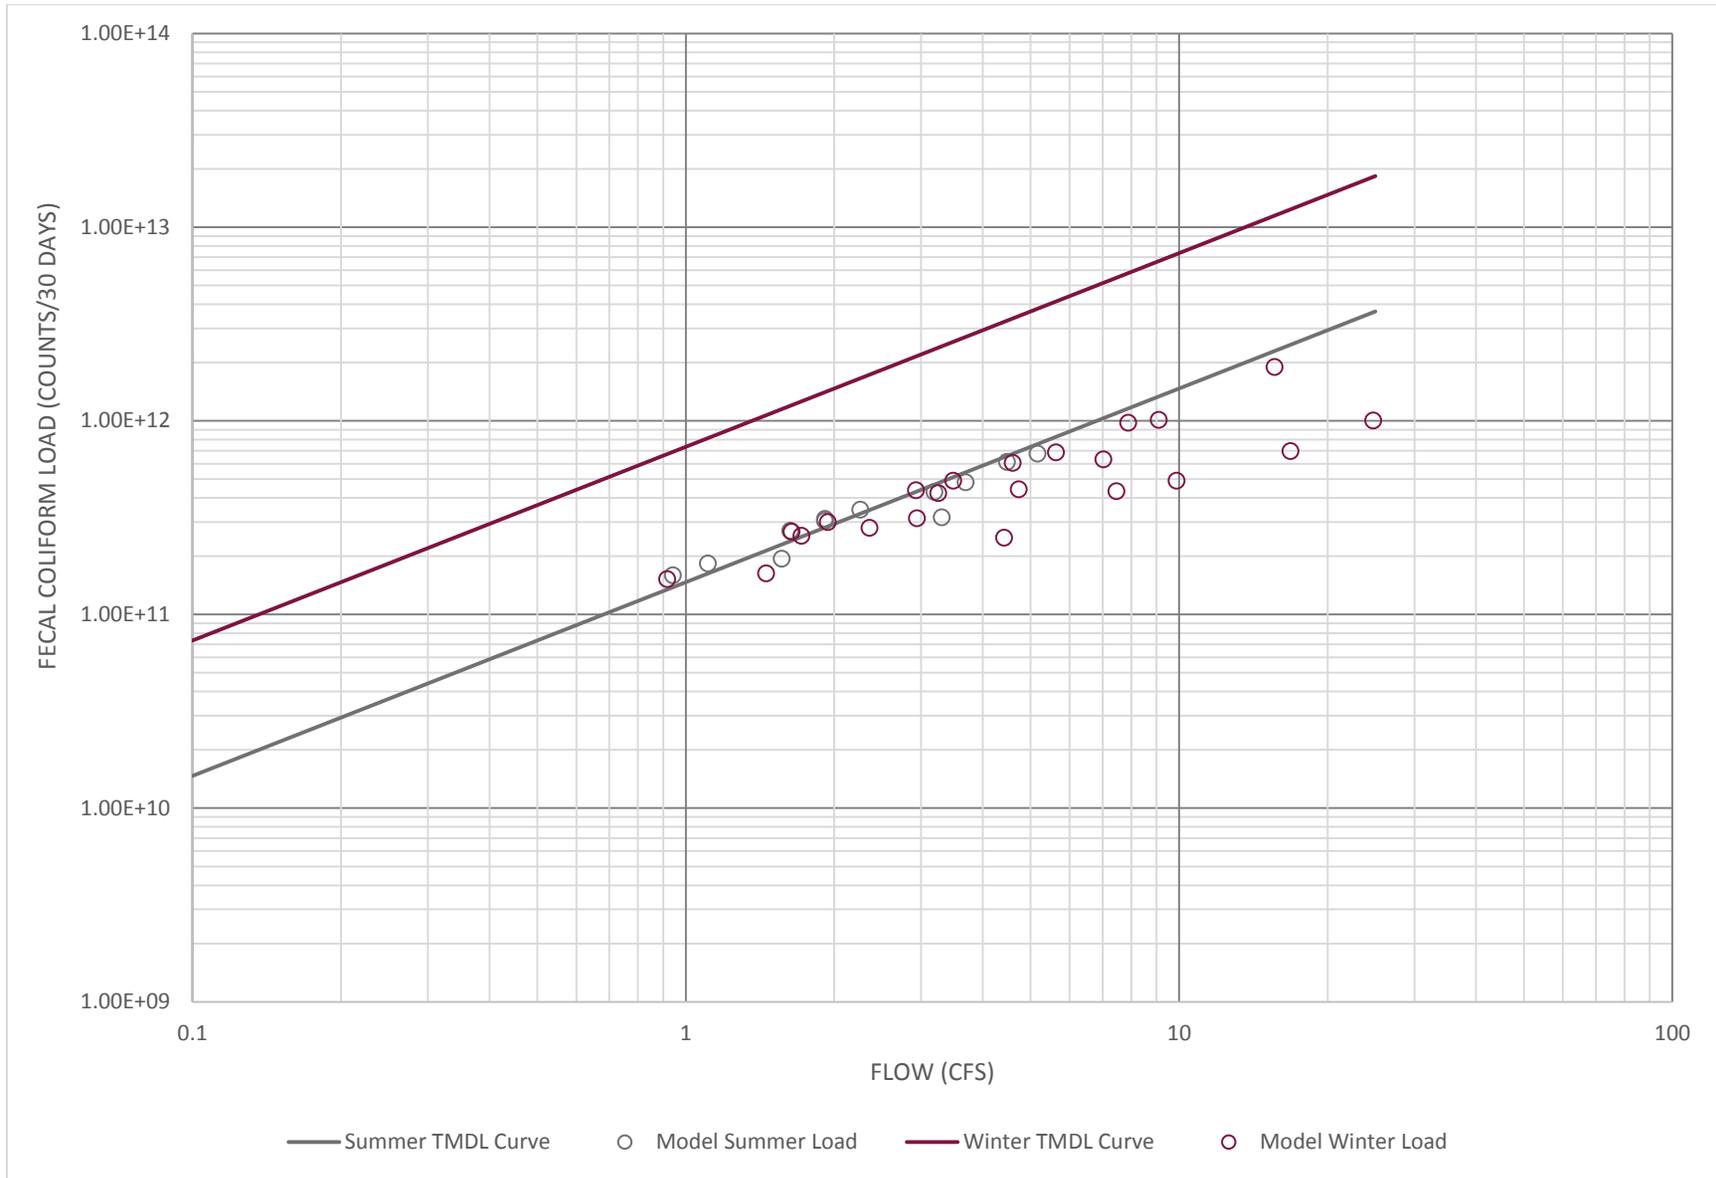
Figure 4.3 - 30-day fecal coliform load versus flow for Scenario 1. The top line represents the winter TMDL and the gray line represents the Summer TMDL. Red circles correspond with modeled winter values, and gray circles correspond with modeled summer values.

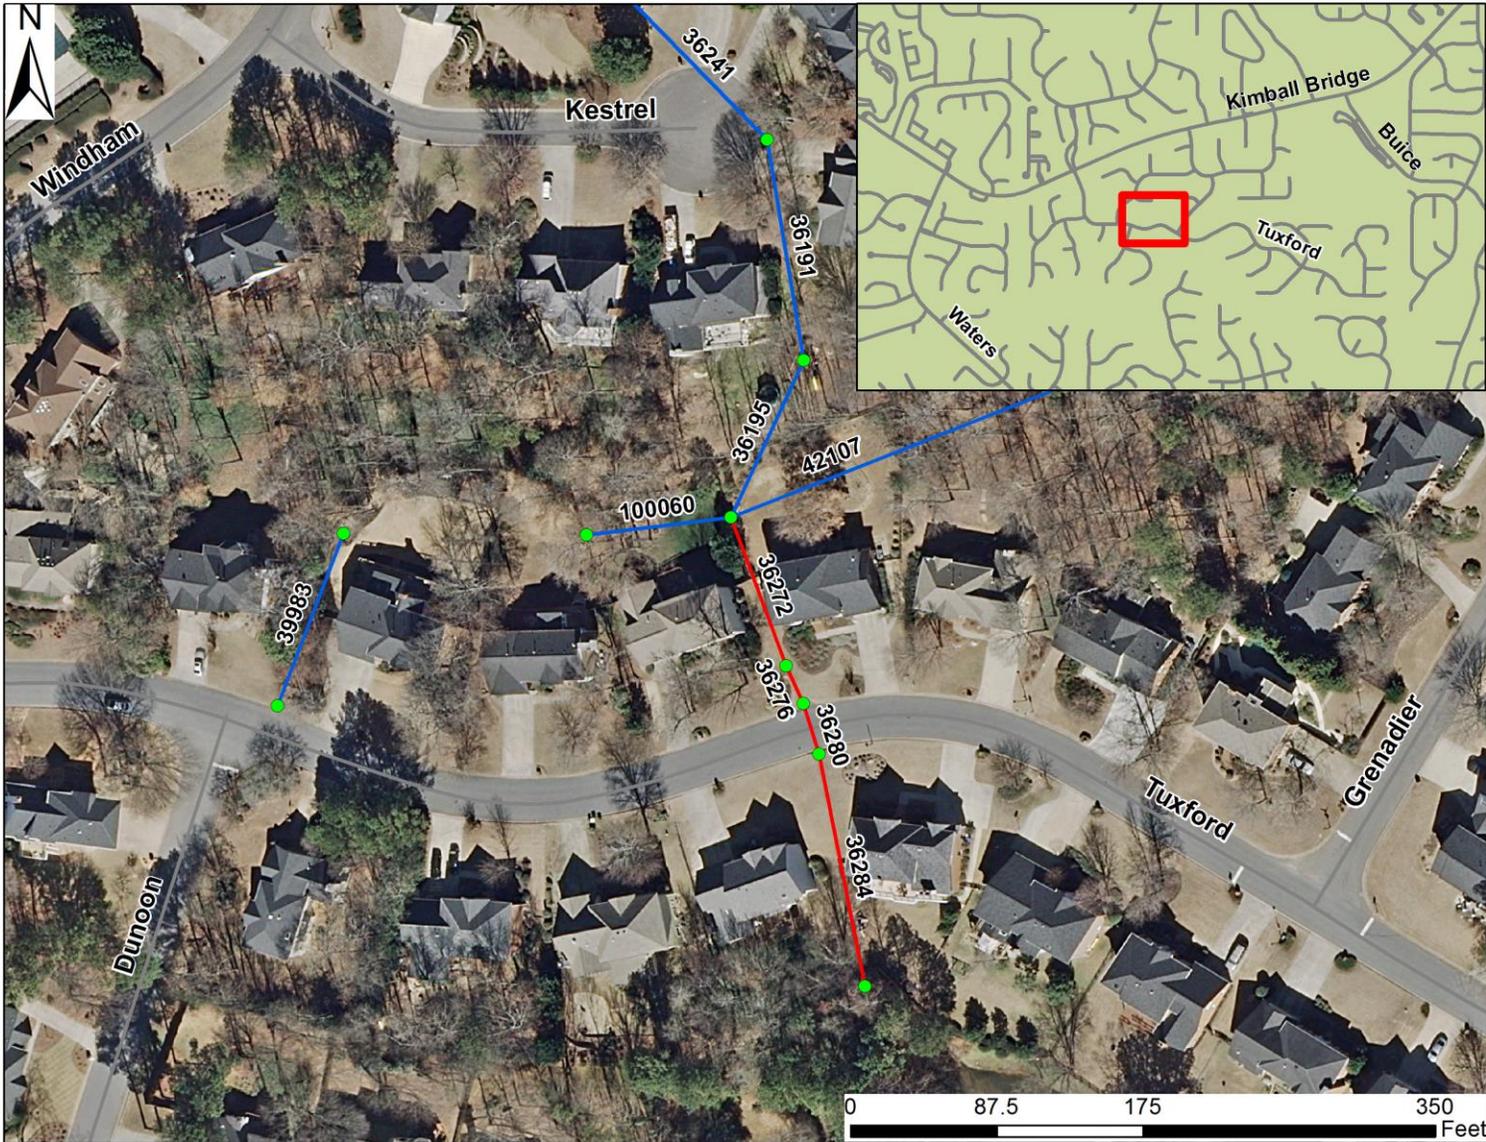
Figure 4.7 - Location of the Tuxford Neighborhood and its existing stormwater system. Red pipes do not meet the 25-year level of service, and blue pipes do meet the 25-year level of service. Pipe Facility ID Numbers are displayed next to each pipe and can be related to the upgrade scenario tables and the system analysis database.

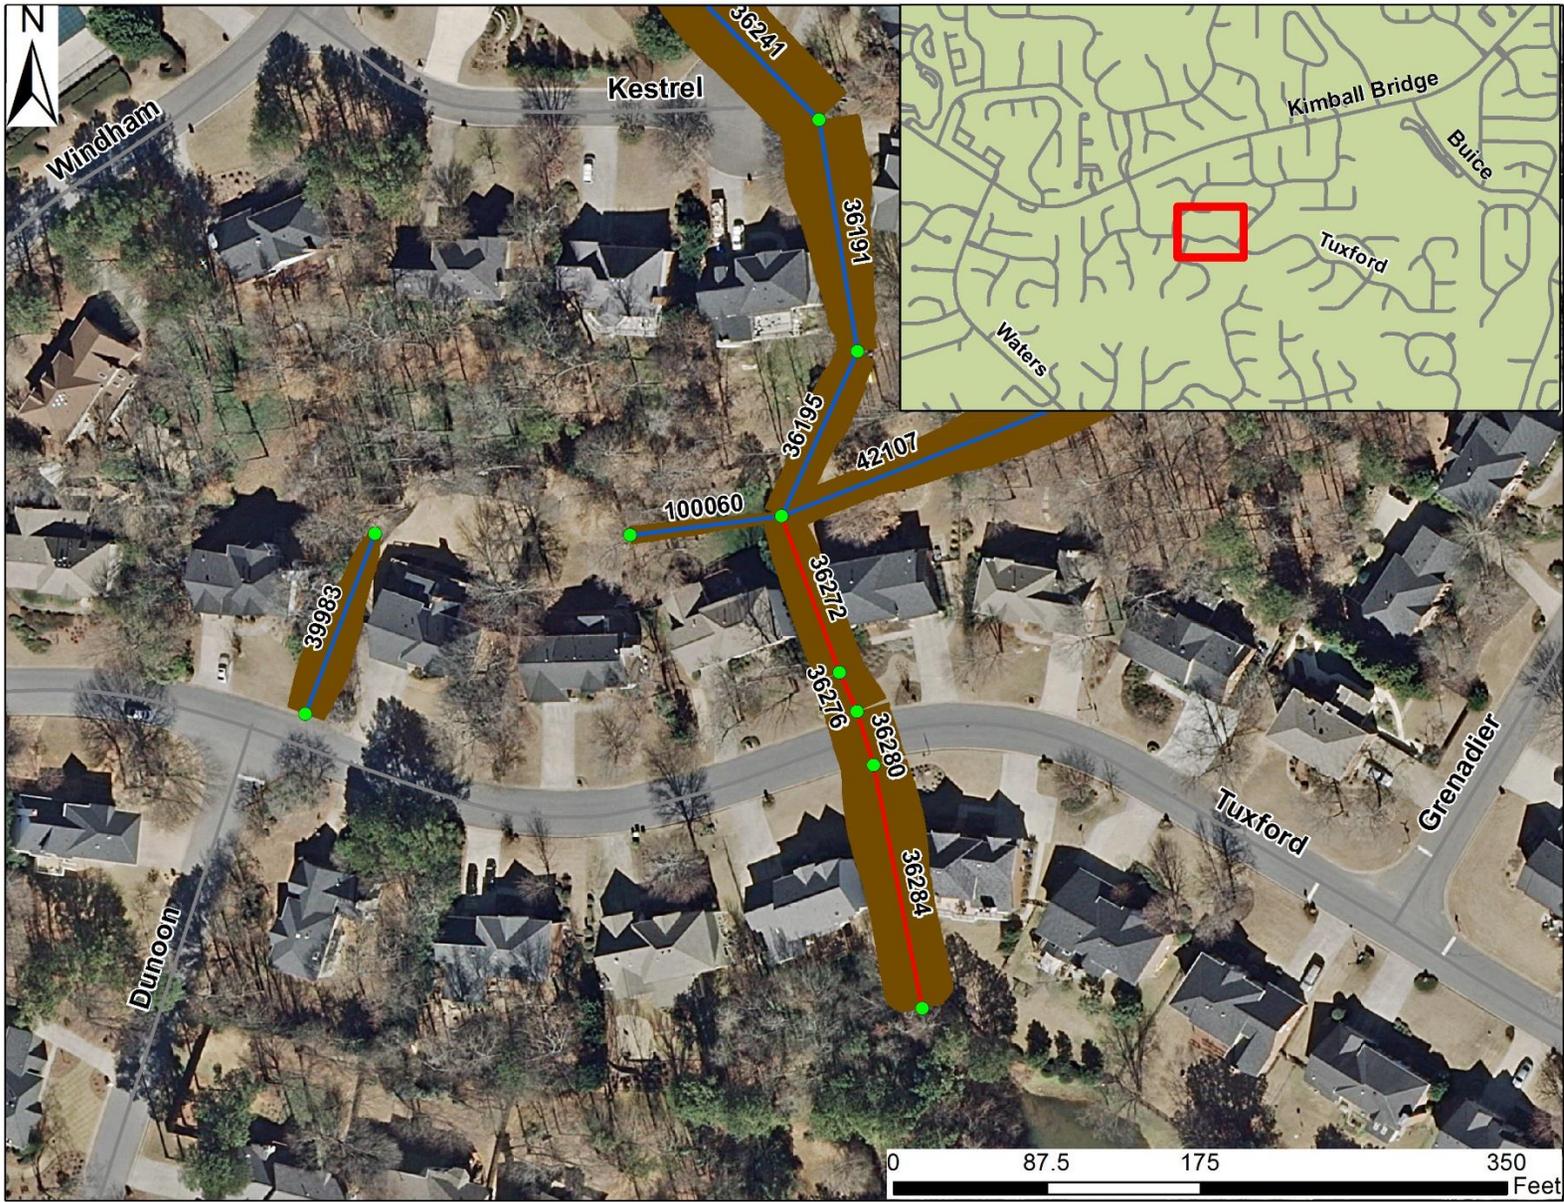
Figure 4.8 - Trench cuts are shown as brown polygons. The area that the polygon covers is the approximate area required for a trench cut to replace each pipe.

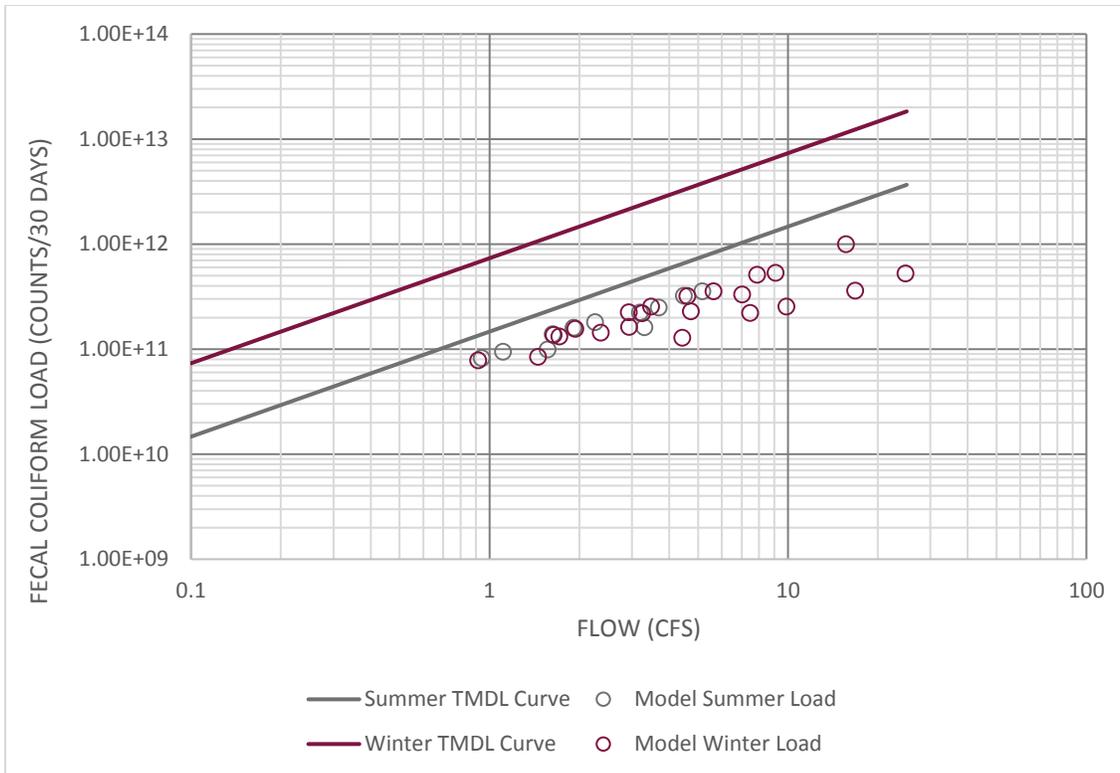
Figure 4.5 - 30-day fecal coliform load versus flow for Scenario 3. The top line represents the winter TMDL and the gray line represents the Summer TMDL. Red circles correspond with modeled winter values, and gray circles correspond with modeled summer values.

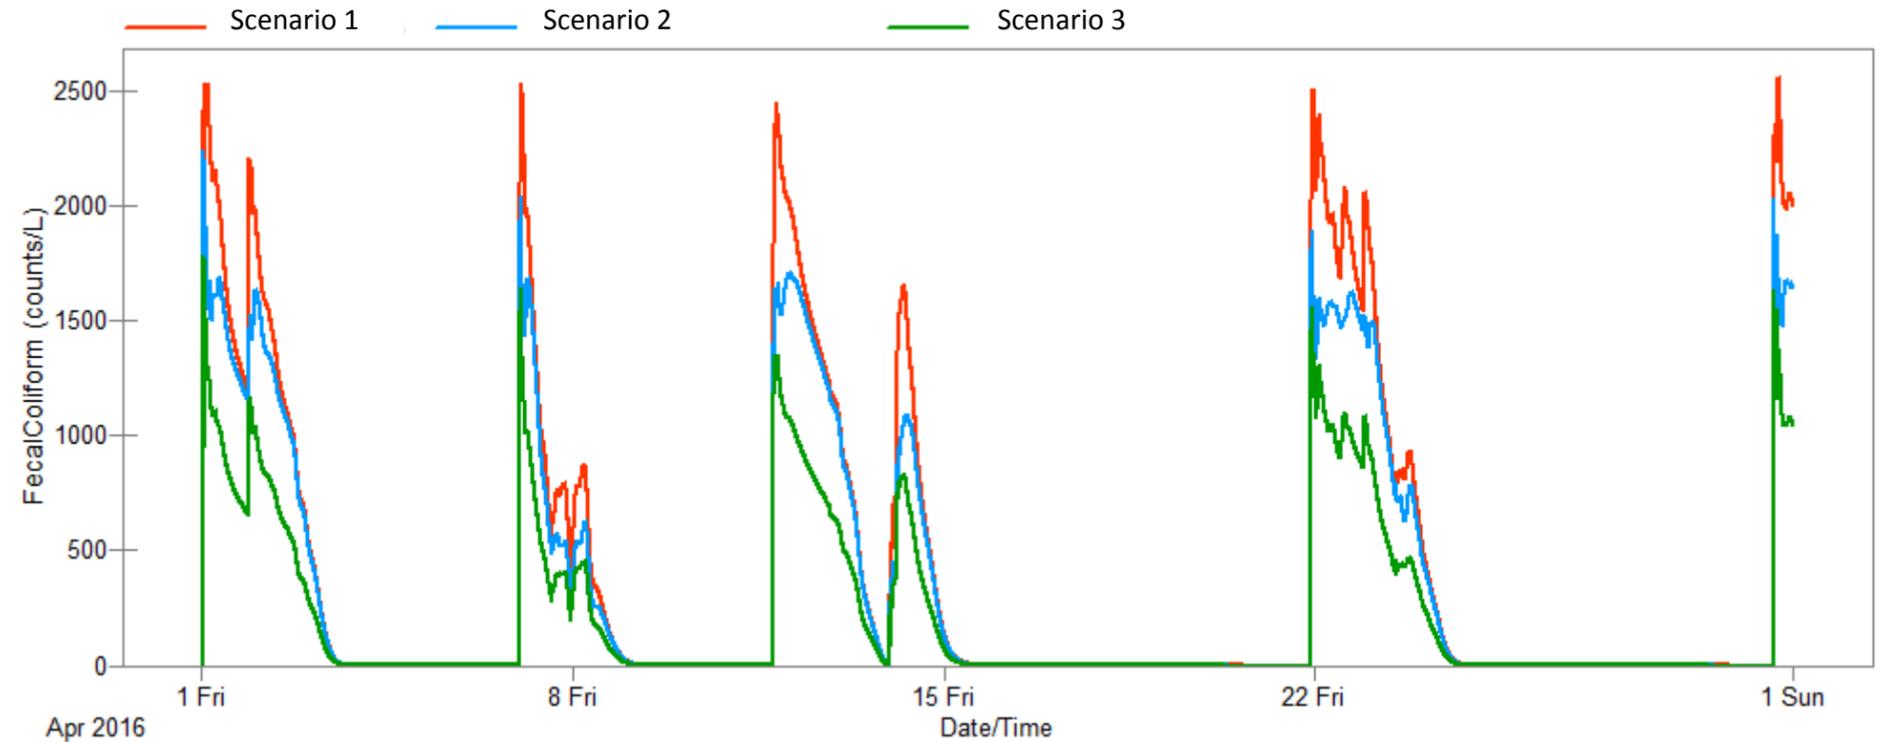
Comparison of expected fecal coliform loads for Scenarios 1, 2, and 3 at the furthest downstream sampling site based on sampling results from April 2016. For April 2016, Scenario 2 is expected to reduce fecal loading by 19% and Scenario 3 is expected to reduce fecal loading by 47% at the most downstream site.

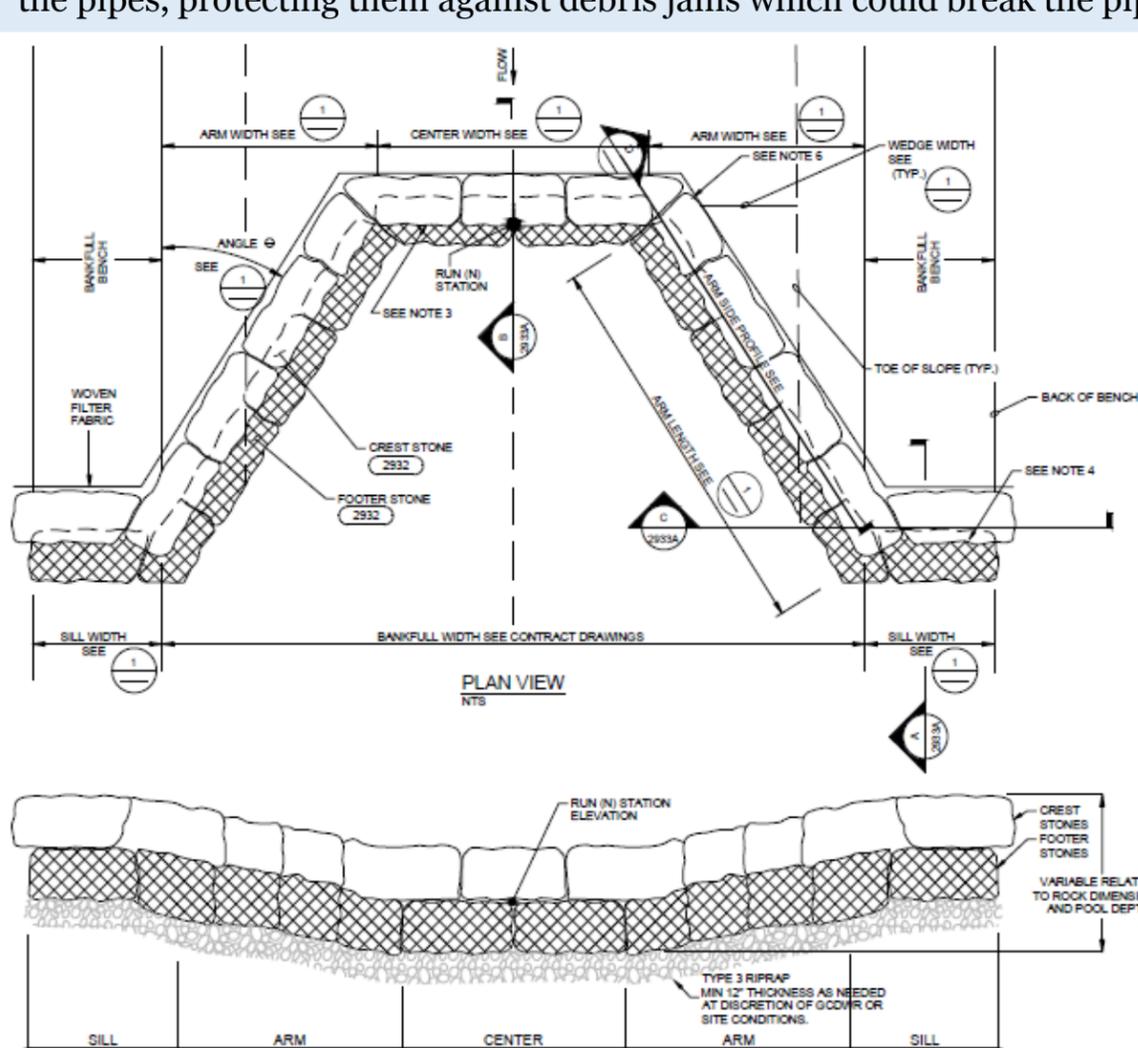
A typical cross vane detail that would be installed to protect sanitary sewer infrastructure

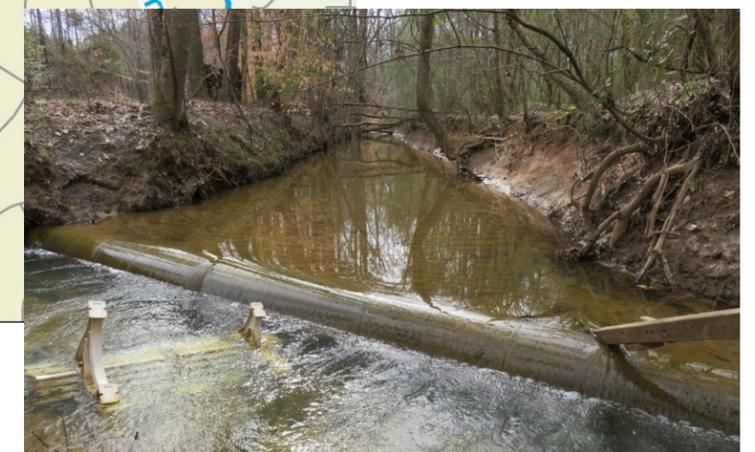
Exposed pipe located at 600 feet upstream of the confluence.

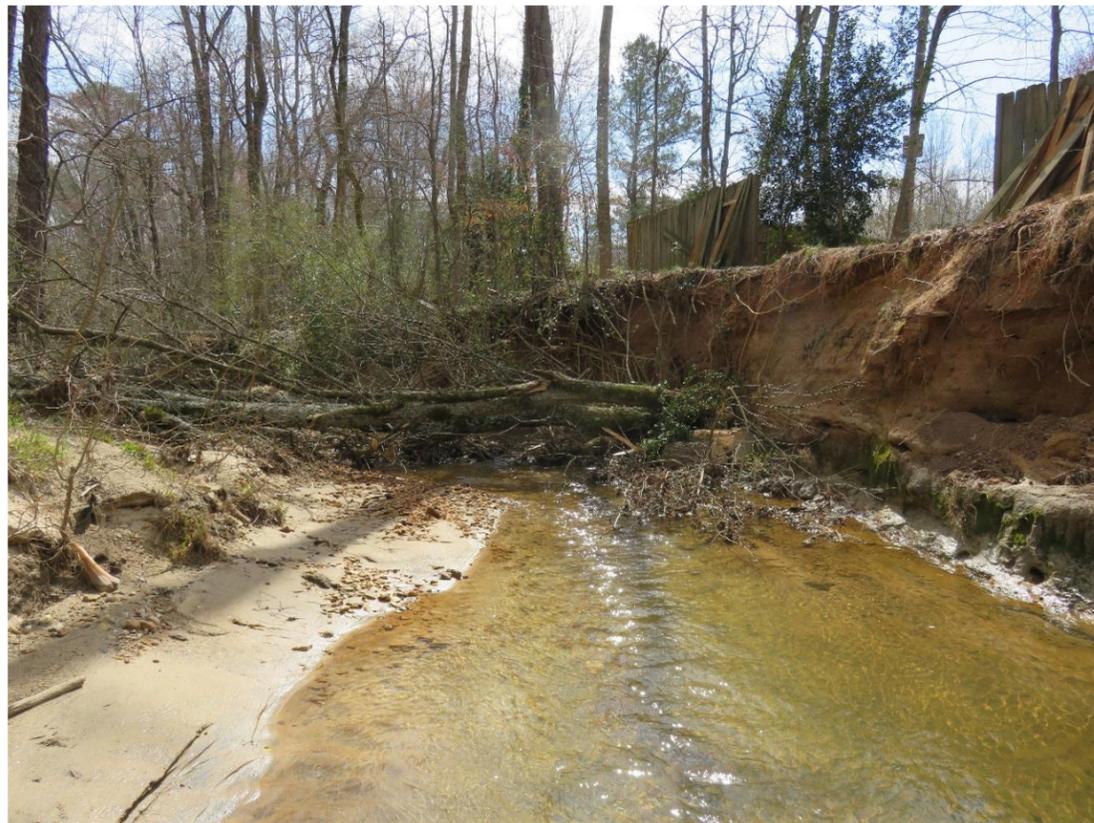
A severely incised bank typical of the lower section of Long Indian Creek.

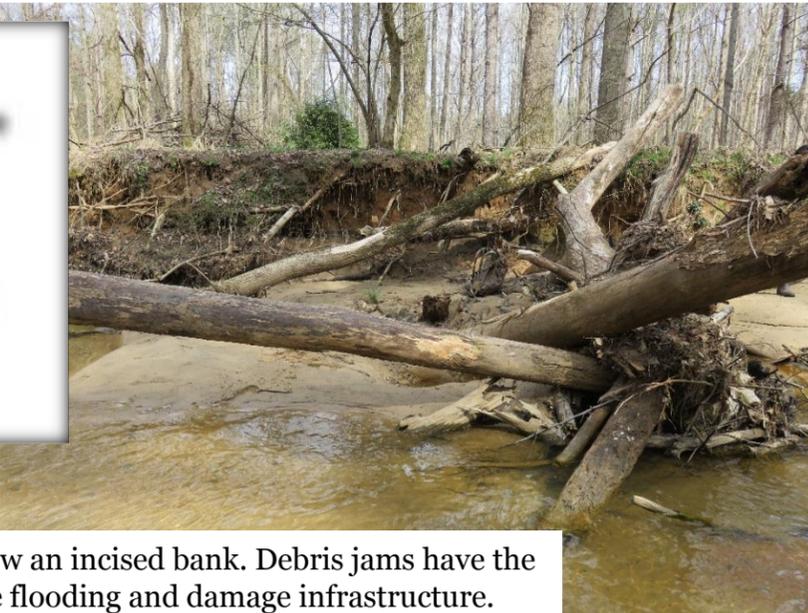
A debris jam below an incised bank. Debris jams have the potential to cause flooding and damage infrastructure.
