Long Indian Creek Watershed Improvement Plan

City of Alpharetta

January 30, 2017

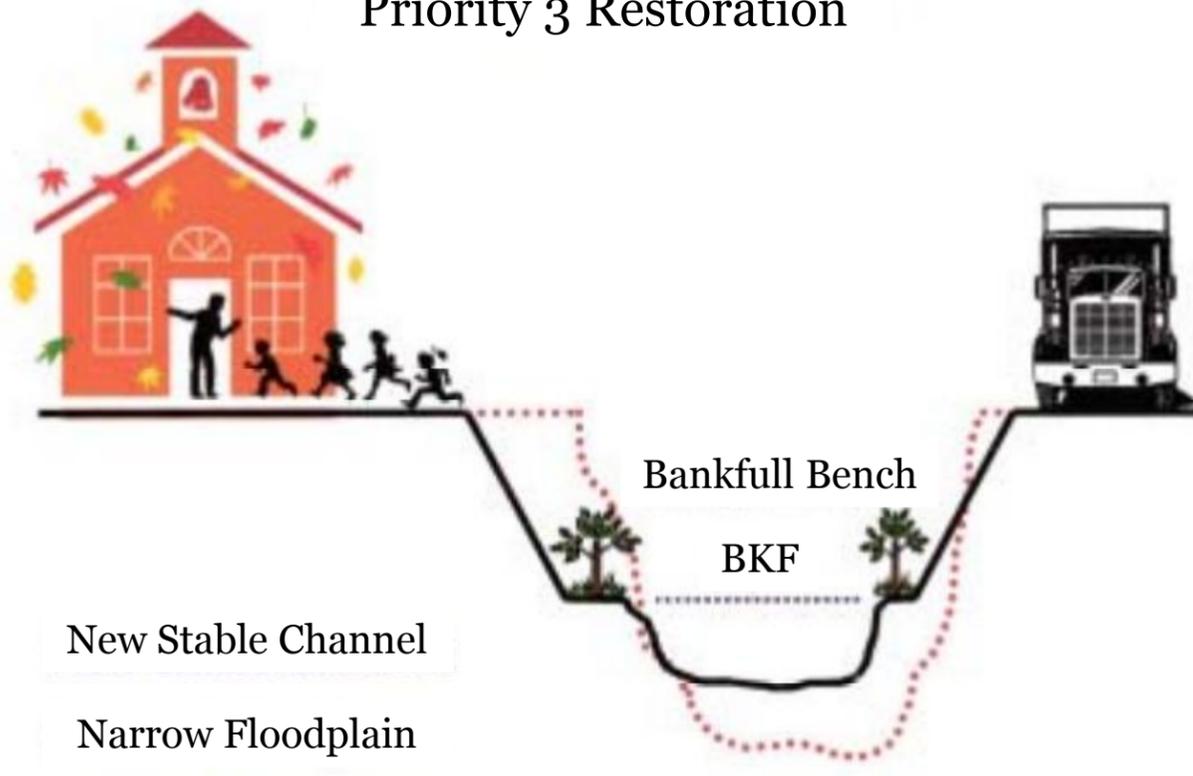
Graphic showing the construction of stabilized banks to help reconnect the stream with its historic floodplain (FWS, 2016).

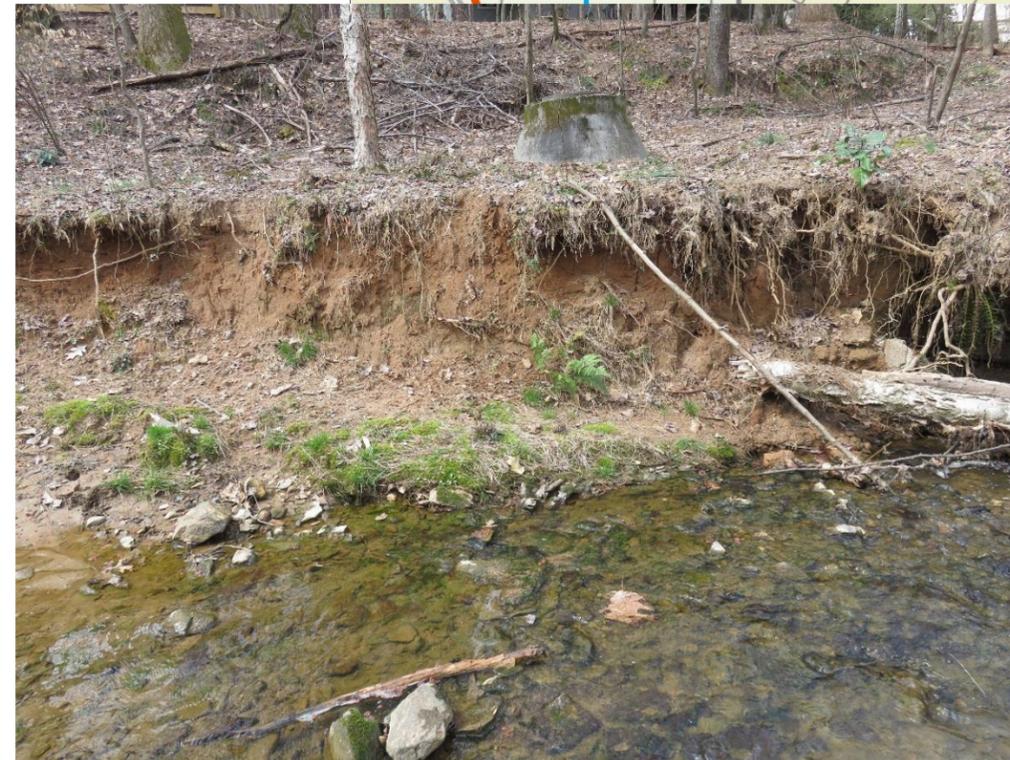
An incised stream bank that has migrated laterally towards sanitary sewer running parallel to the stream. Further, migration could compromise the infrastructure.

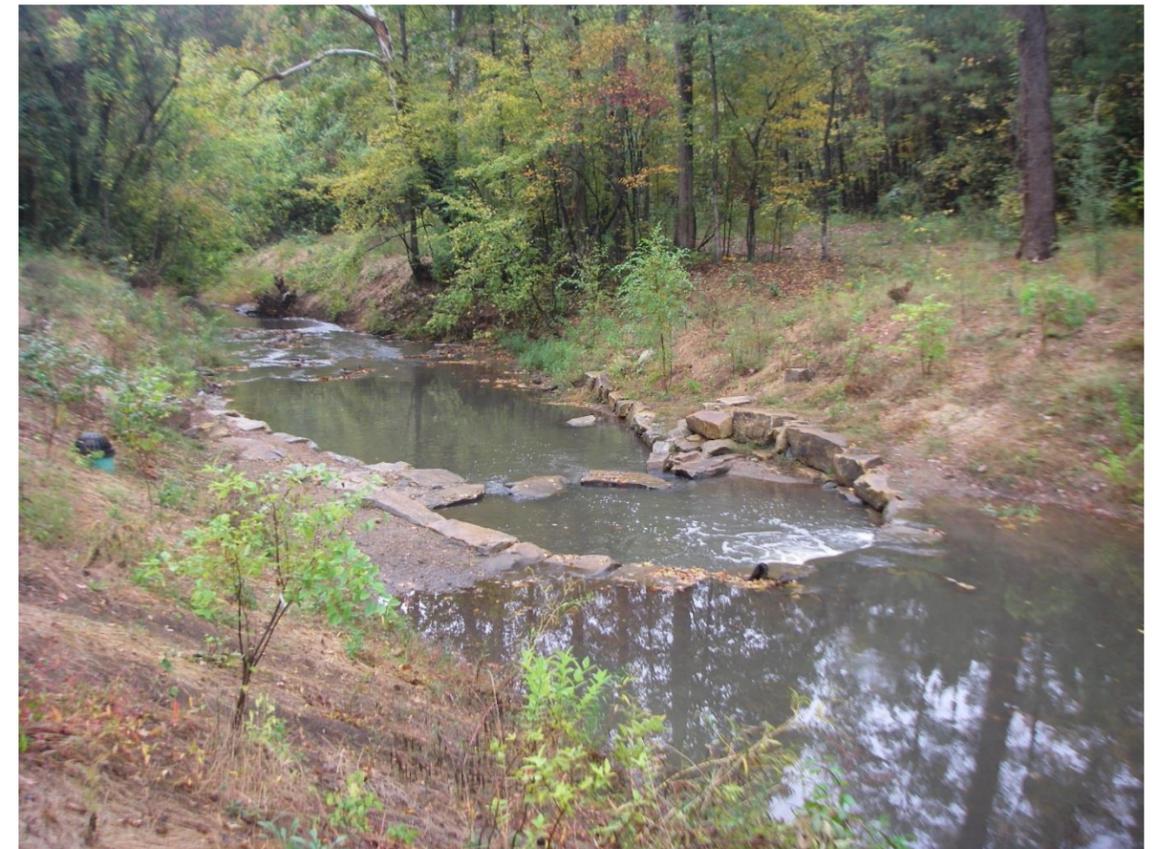
A sample cross vane from a completed project. The cross vane would be placed just downstream of the exposed sanitary sewer pipe. This would provide grade control for the stream, and protect the sanitary sewer pipe from future damage during flooding events.

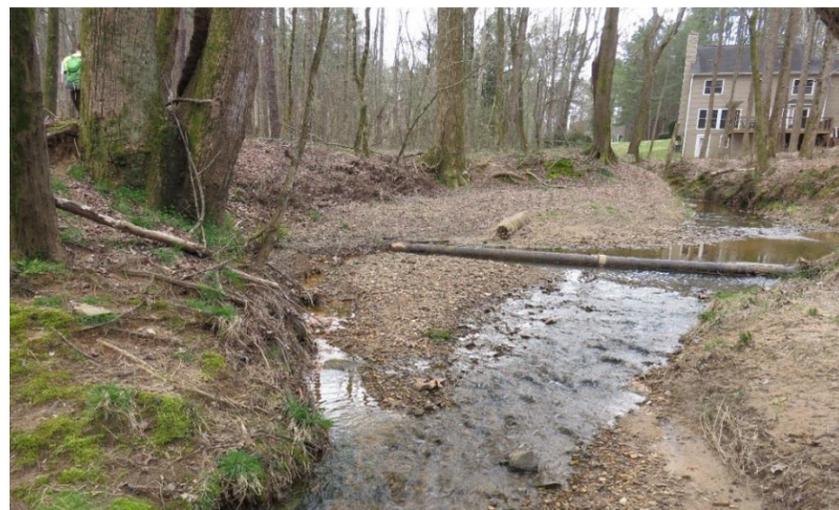
Exposed pipe in the upper part of the stream restoration zone. The stream is sufficiently degraded to expose the push-on joint.

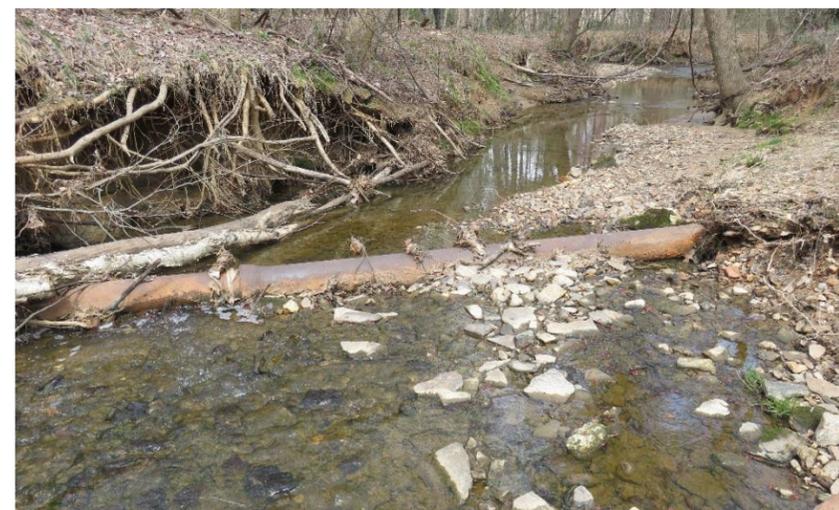
Exposed pipe in the lower part of the stream restoration zone. The stream is sufficiently degraded to expose the push-on joint.

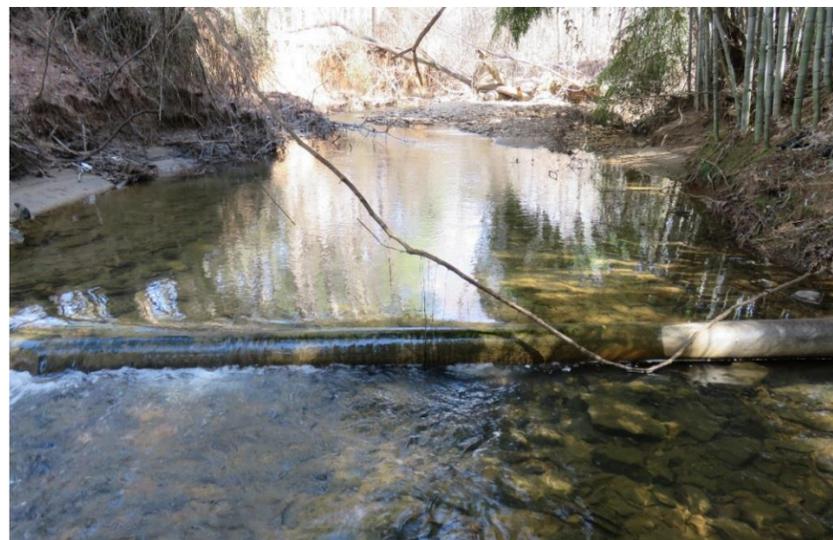
Exposed sanitary sewer pipe. A grade-control structure such as a cross vane can be installed to protect the pipe.

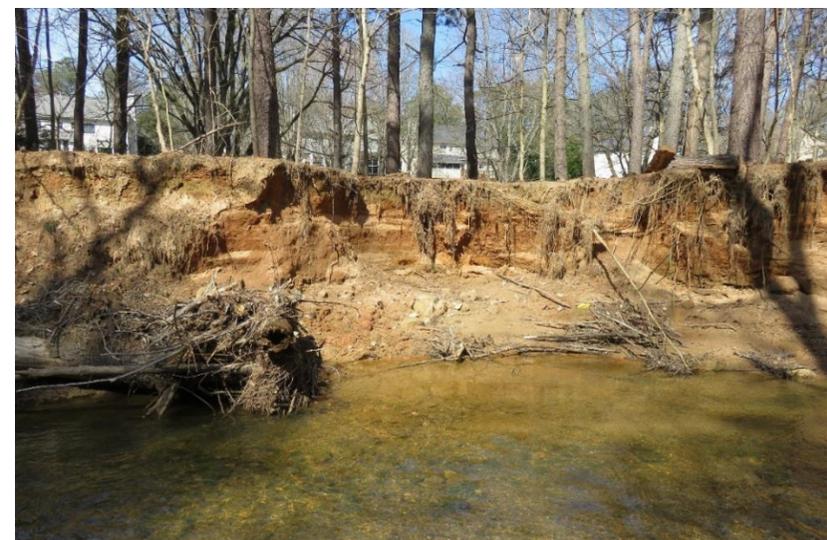
Severely eroded stream bank in section of Long Indian Creek recommended for stream restoration.

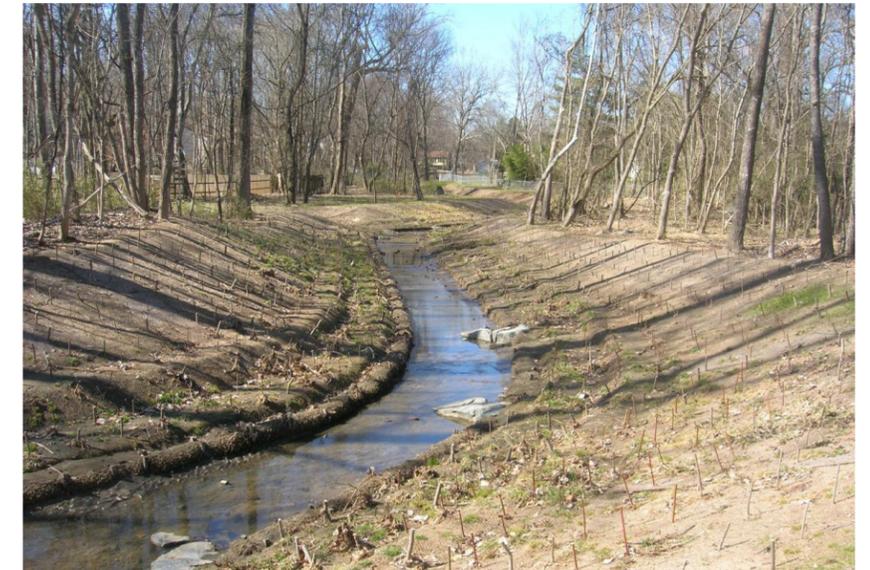
Live staking along stream bank (Kingsport, 2016).

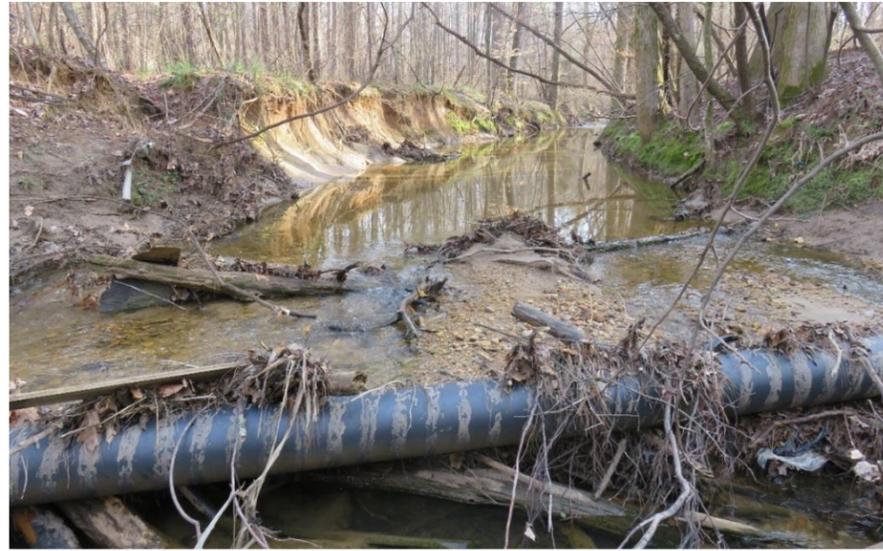
Exposed sanitary sewer pipe near the downstream end of the project.

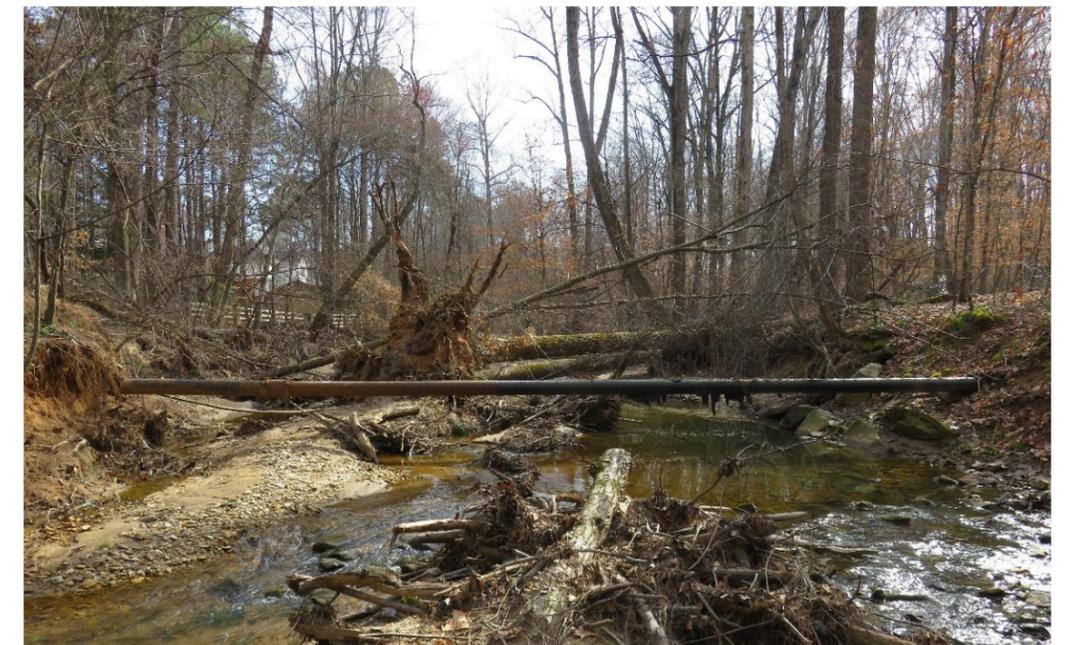
Exposed sanitary sewer pipe near the upstream end of the project. A large debris jam is located just upstream of the pipe which could damage the pipe during a flood event.

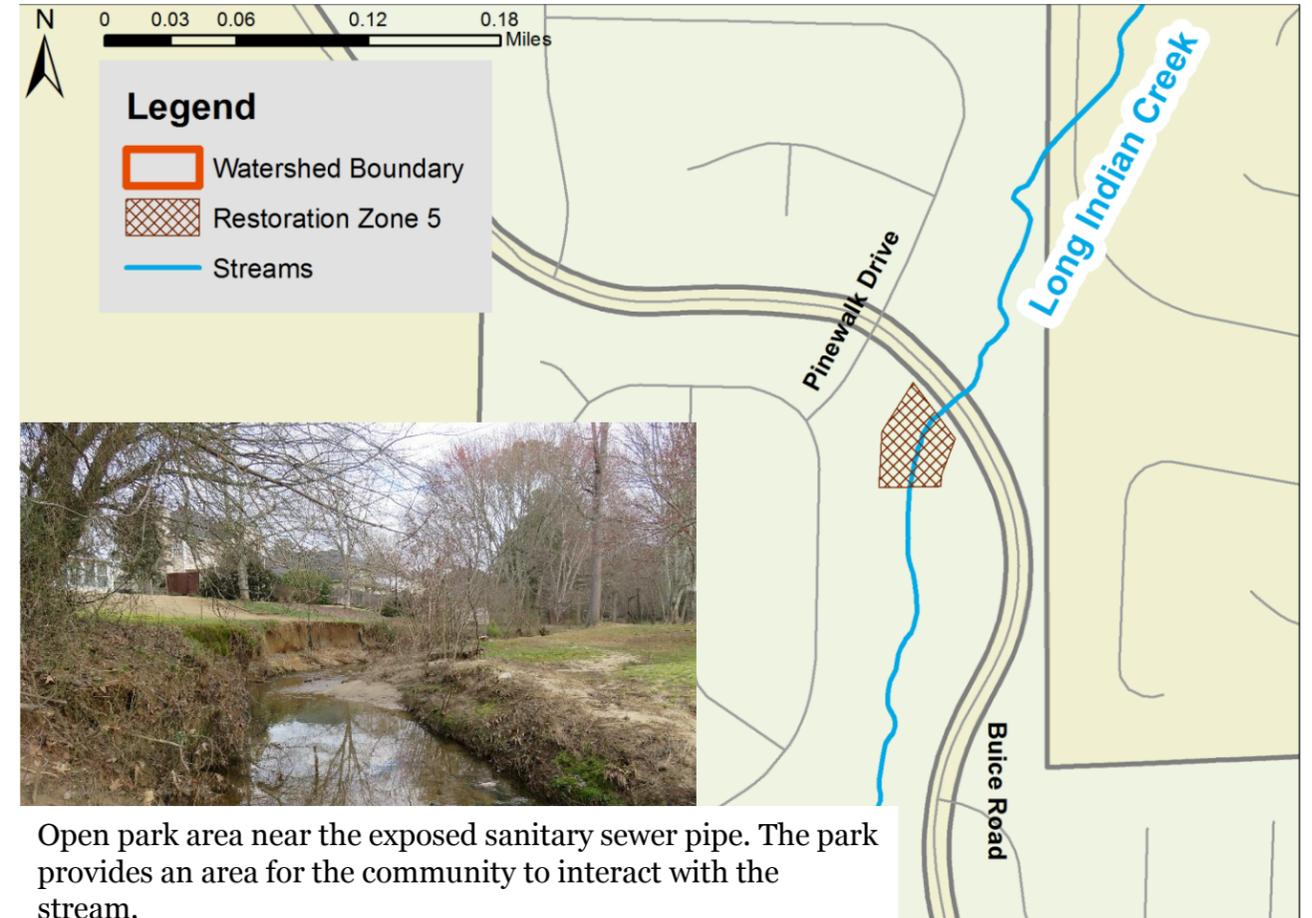
Open park area near the exposed sanitary sewer pipe. The park provides an area for the community to interact with the stream.

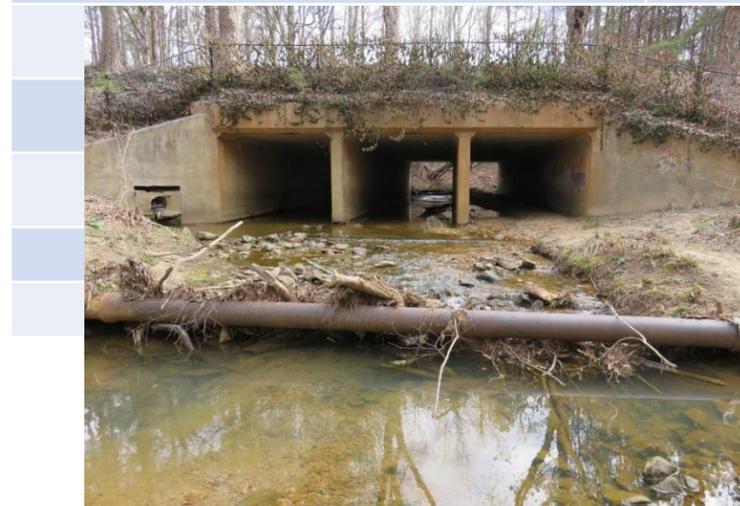
Exposed sanitary sewer pipe. A cross vane can be installed downstream of the pipe to protect it from future damage and improve the aesthetics of the surrounding park.

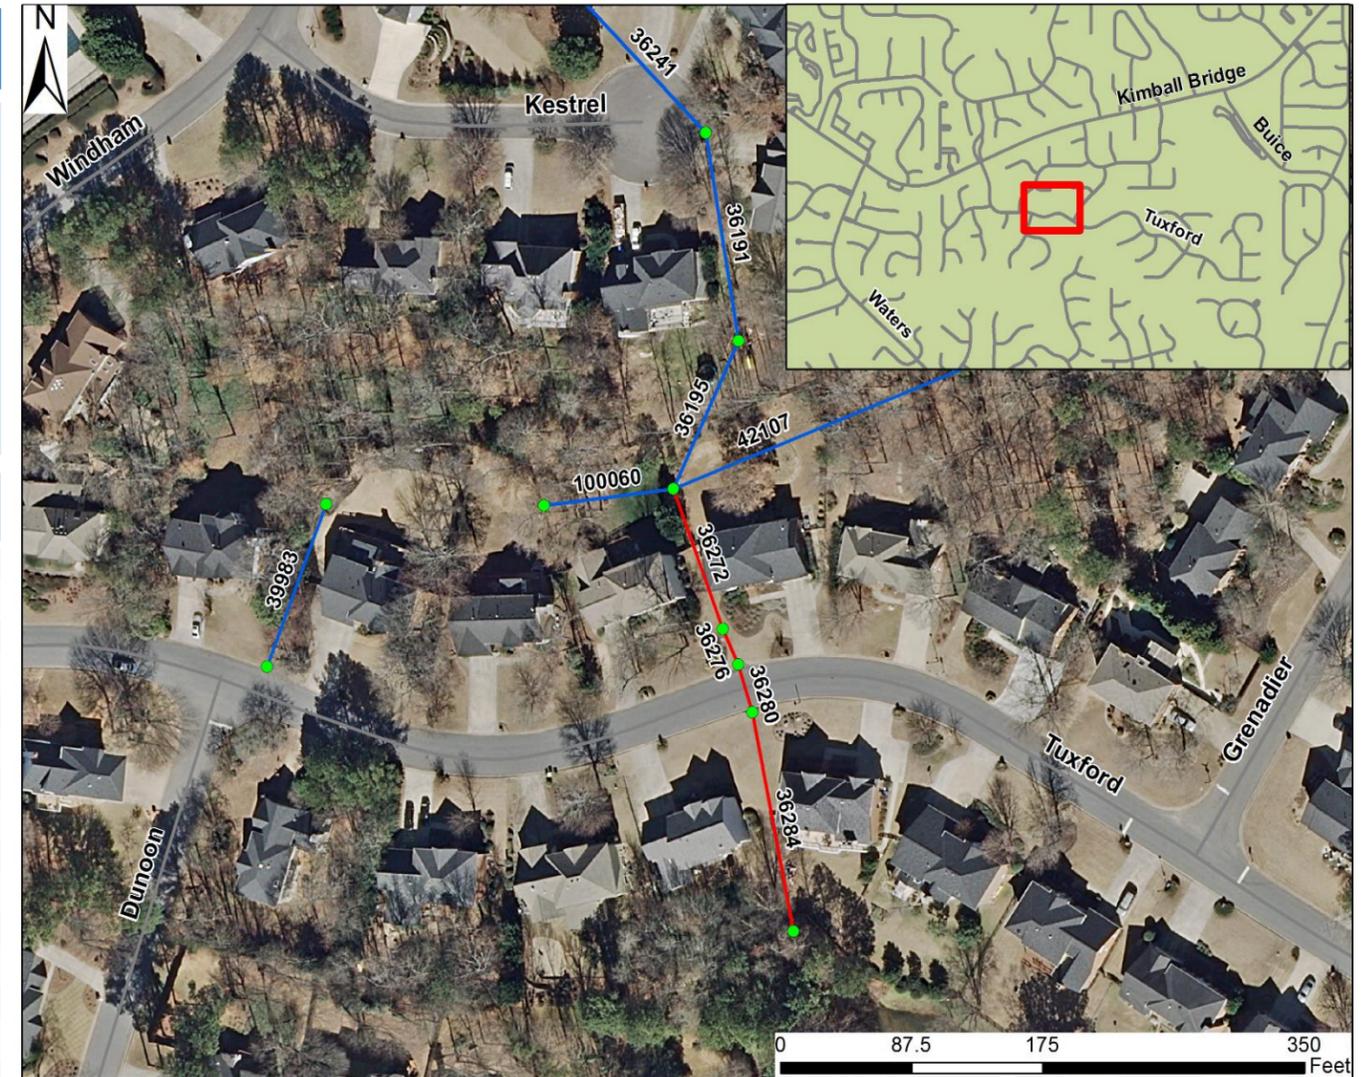
Location of the Tuxford Neighborhood and its existing stormwater system. Red pipes do not meet the 25-year level of service, and blue pipes do meet the 25-year level of service. Pipe Facility ID Numbers are displayed next to each pipe and can be related to the upgrade scenario tables and the system analysis database.

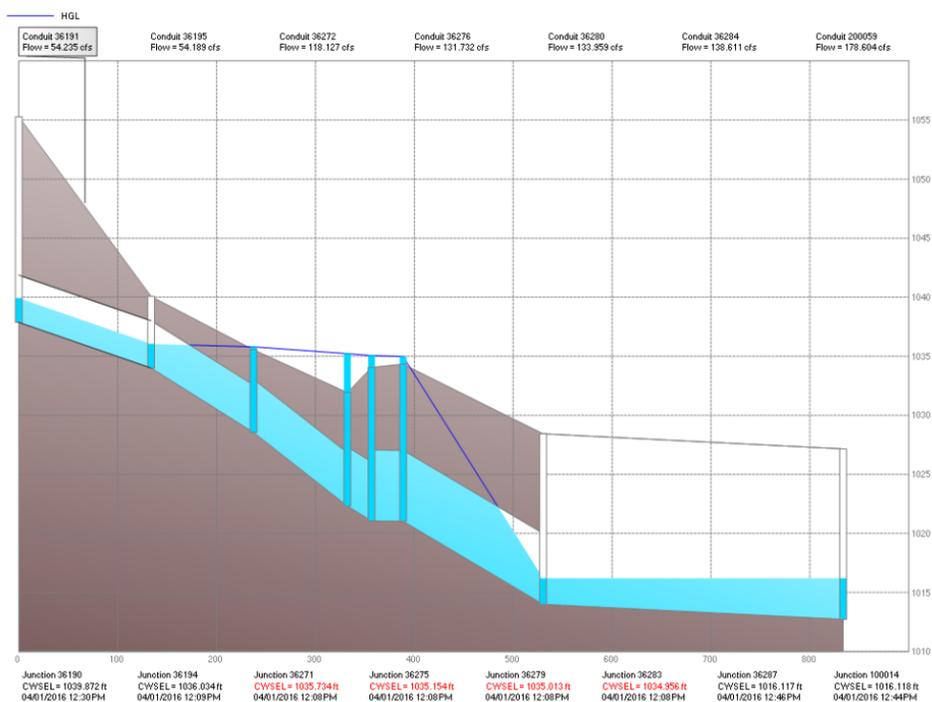
Maximum Hydraulic Grade Line (HGL) for an existing portion of the Tuxford neighborhood stormwater system. Currently, the four most downstream pipes have insufficient capacity.

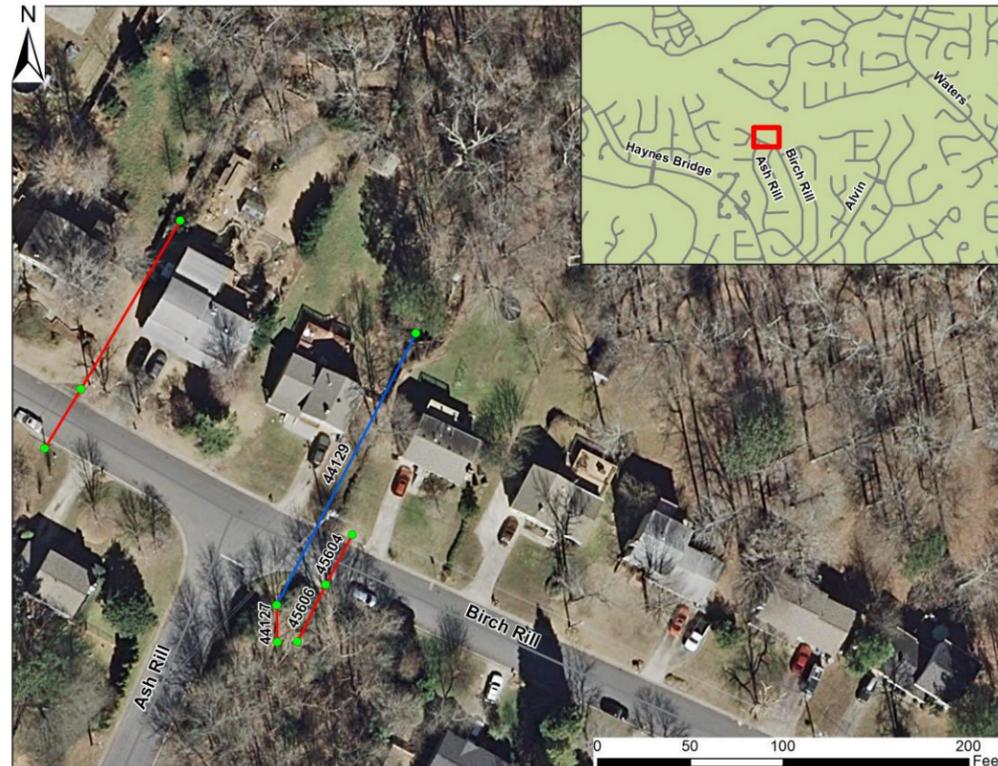
Location of CIP No. LIC_0100_1. Red pipes do not meet the 100-year level of service, and blue pipes do meet the 100-year level of service. Pipe Facility ID Numbers are displayed next to each pipe.

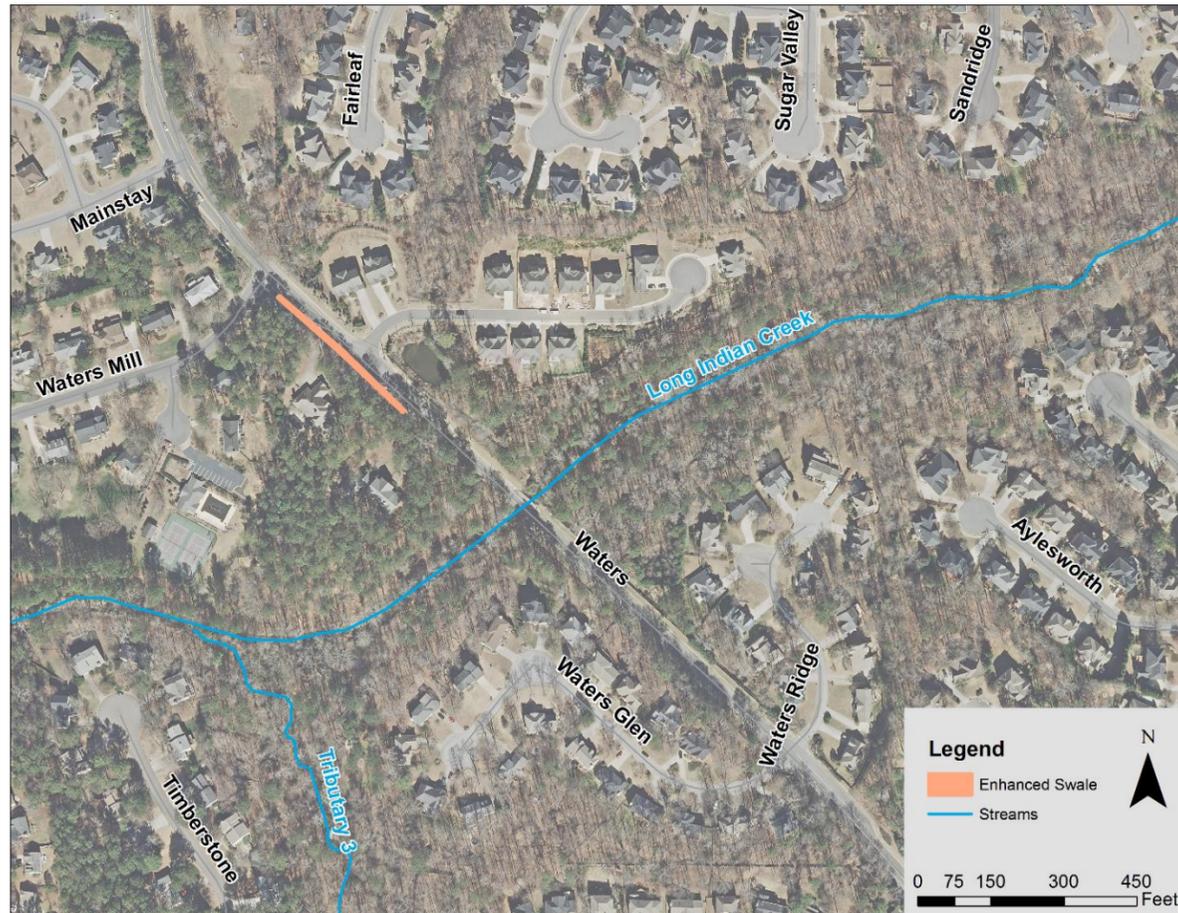
Location of proposed enhanced dry swale along Waters Road. A runoff reduction volume of 50% and a TSS removal rate of 80% is expected for the area treated by the swale.

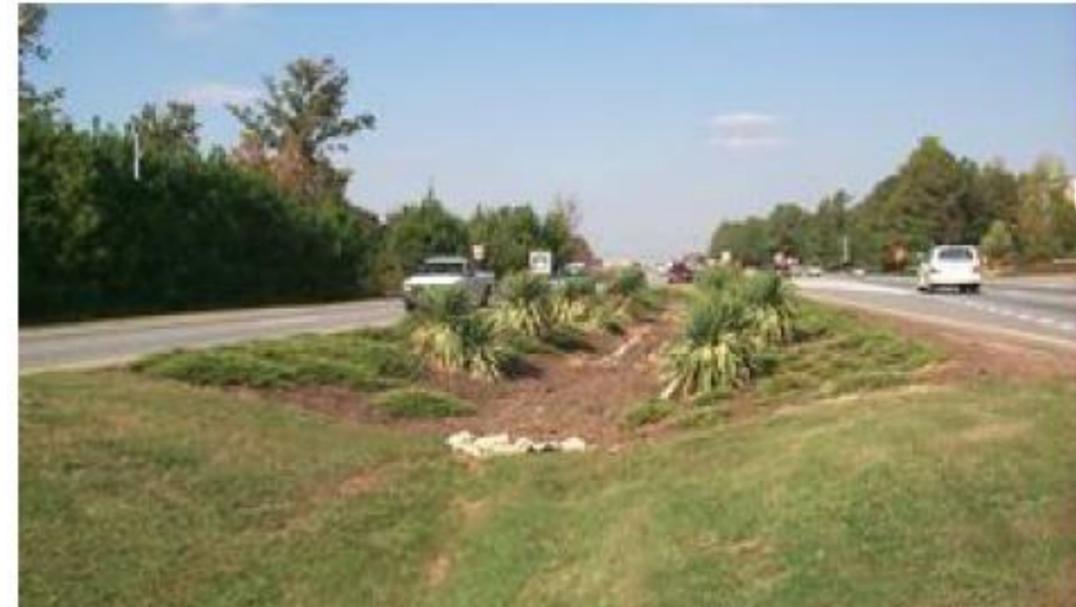
Example of a dry swale from the Georgia Stormwater Management Manual (ARC, 2016)

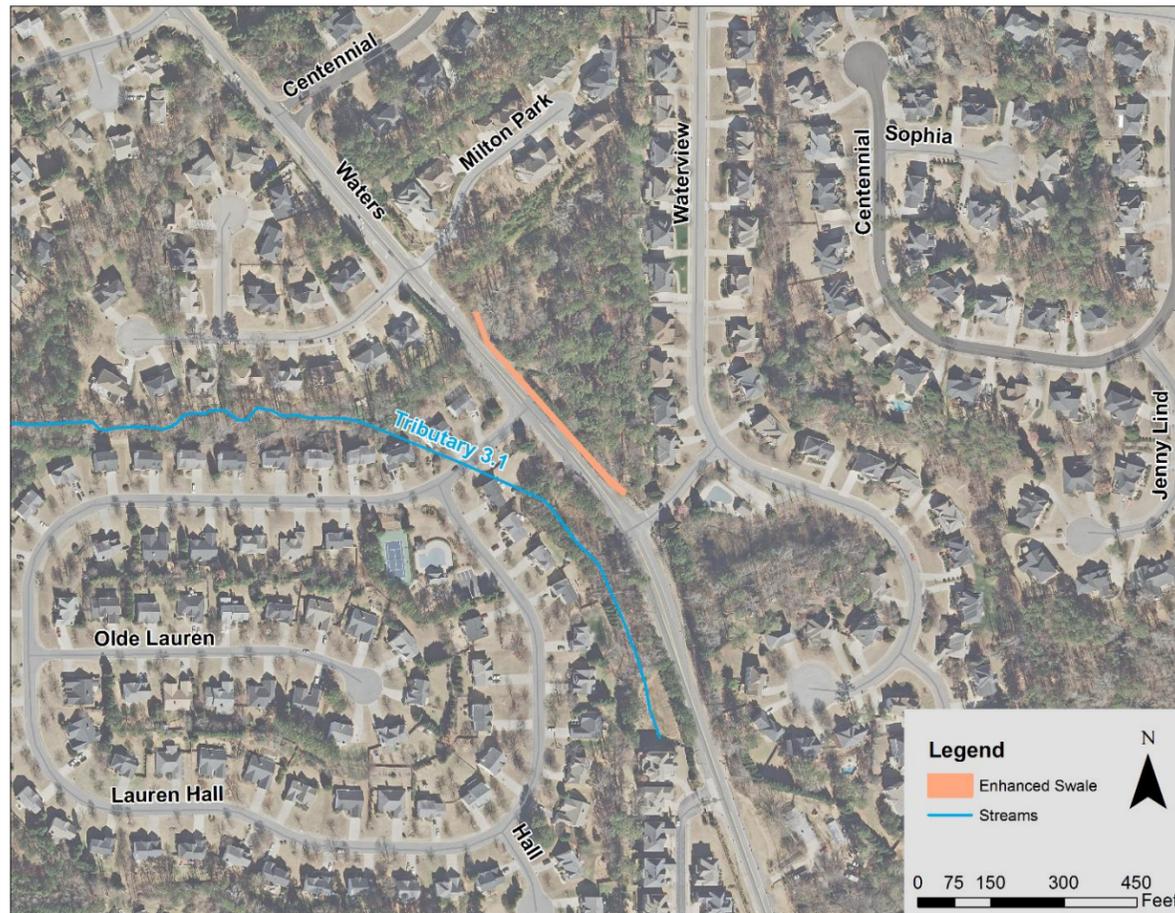
Location of proposed enhanced dry swale along Waters Road. A runoff reduction volume of 50% and a TSS removal rate of 80% is expected for the area treated by the swale.

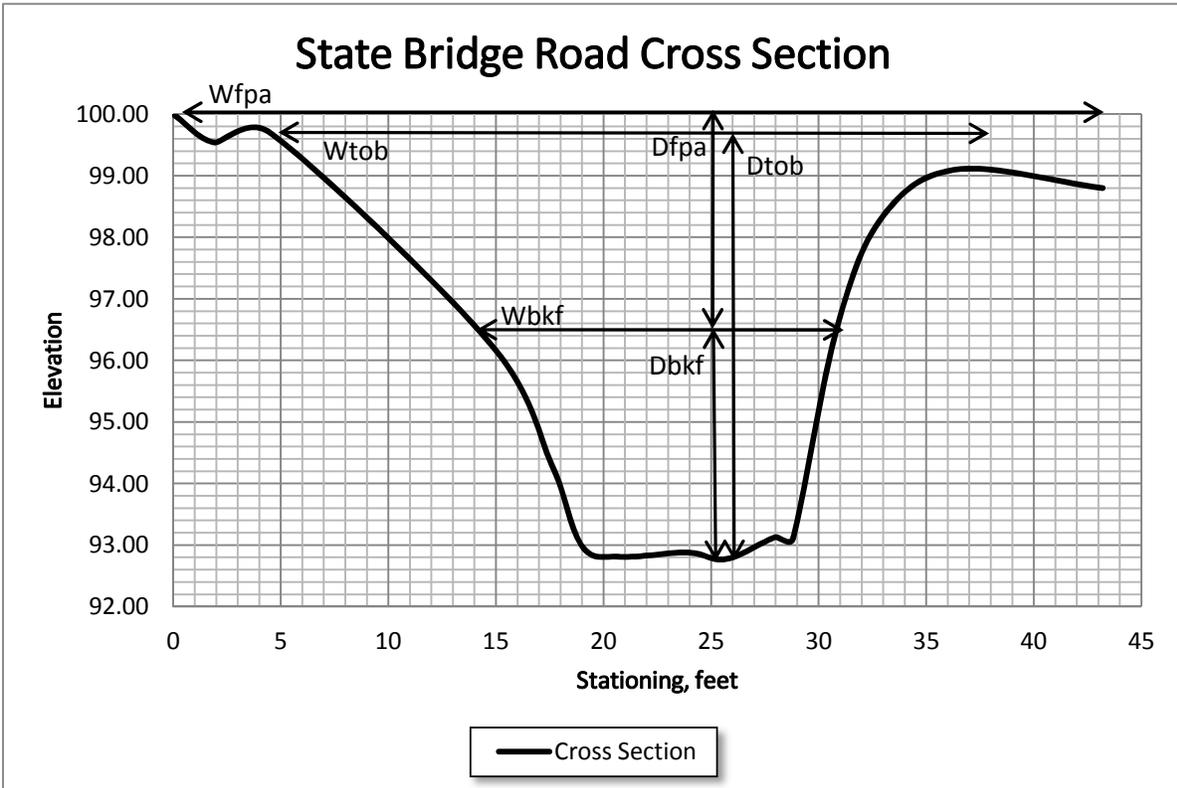
Bankfull Width (WBkf)=	16.1	feet
Bankfull Depth (Dbkf)=	3.65	feet
Floodprone width (Wfpa)=	43.2	feet
Floodprone depth (Dfpa)=	7.30	feet
Bank-top width (Wtob)=	28.40	feet
Bank-top depth (Dtob)=	6.93	feet

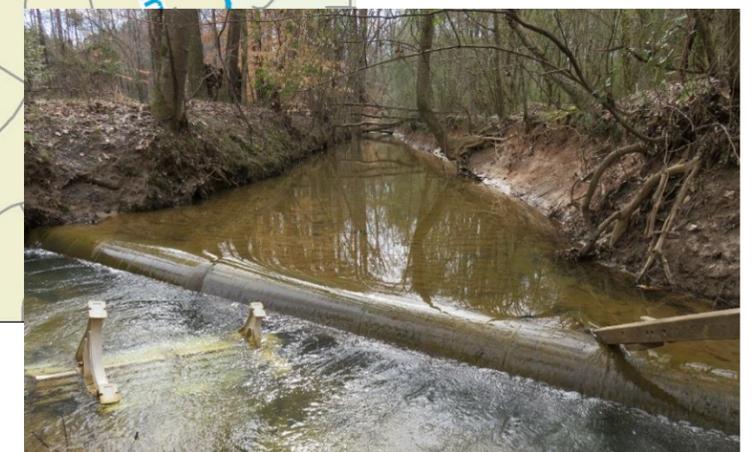
Exposed pipe located at 600 feet upstream of the confluence.

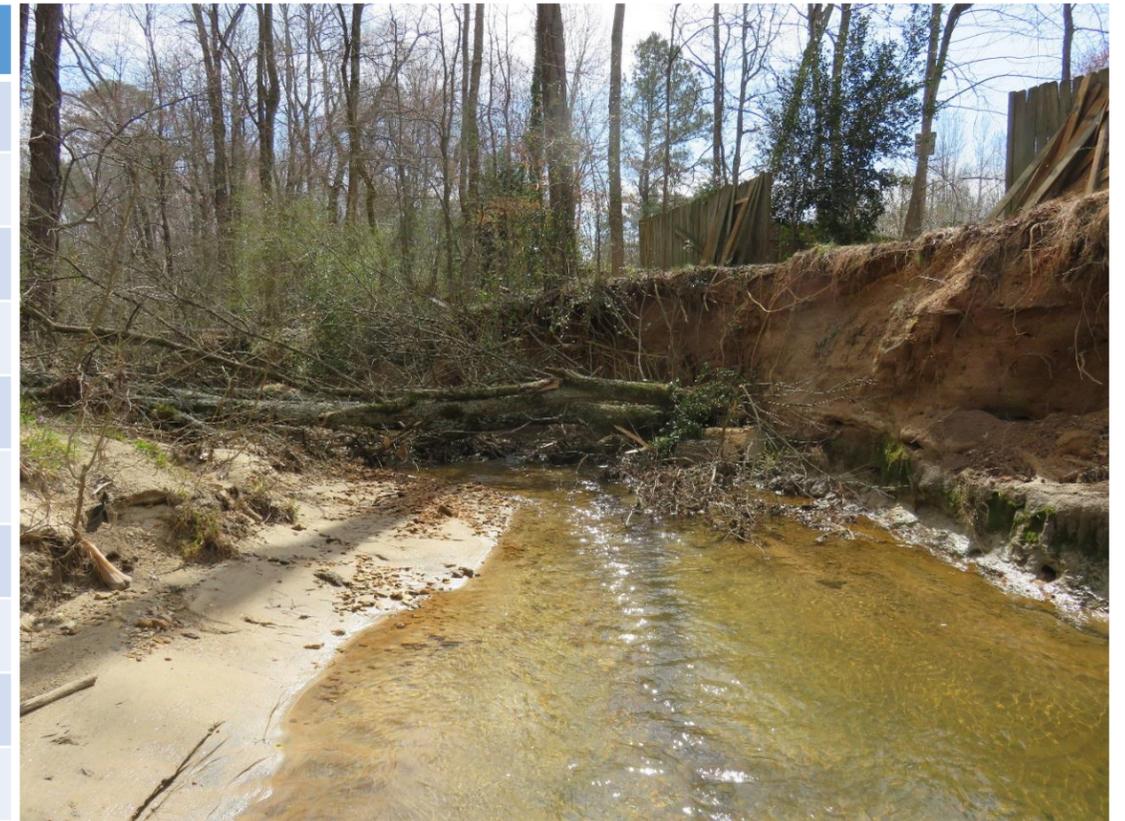
A severely incised bank typical of the lower section of Long Indian Creek.

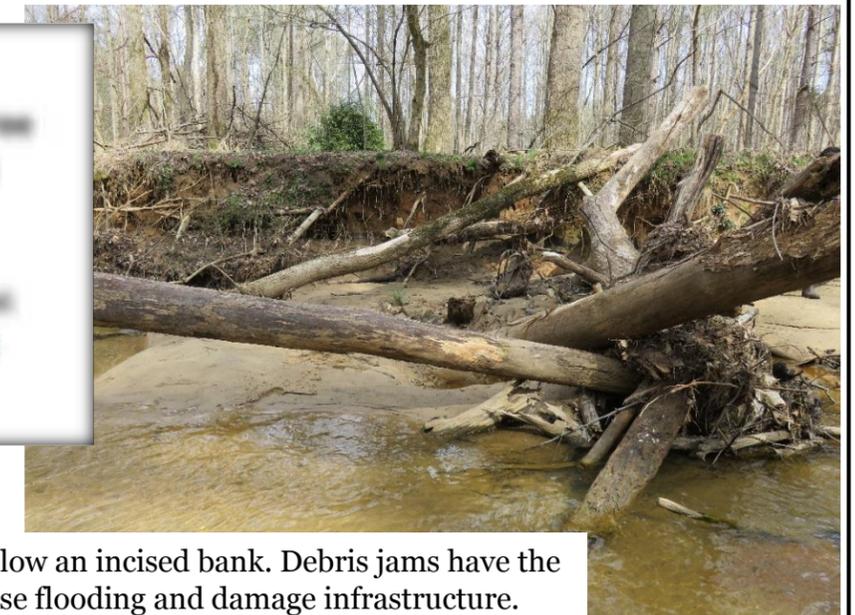
A debris jam below an incised bank. Debris jams have the potential to cause flooding and damage infrastructure.

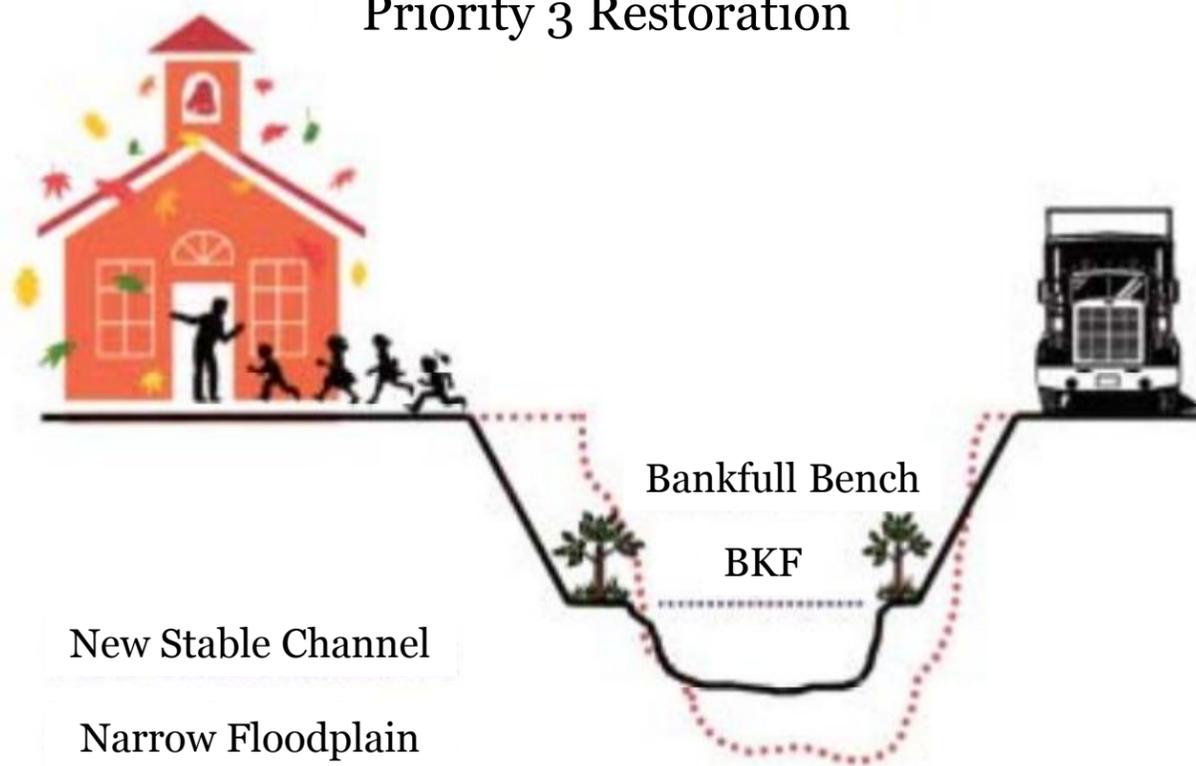
Graphic showing the construction of stabilized banks to help reconnect the stream with its historic floodplain (FWS, 2016).

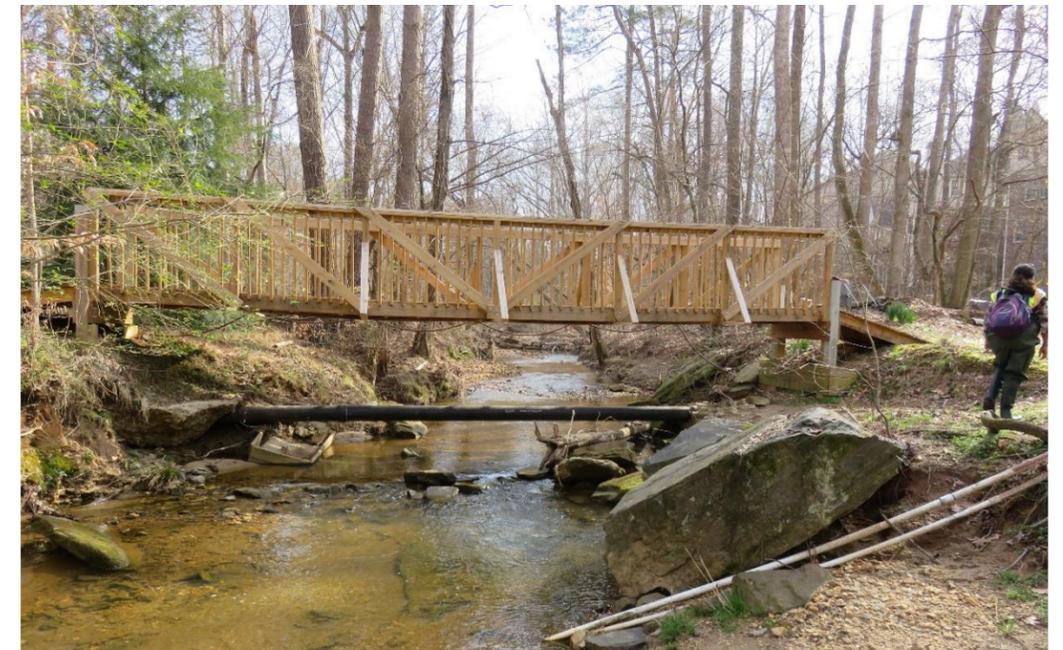
Exposed sanitary sewer pipe near the center of the restoration project. The pipes are attached with a flange joint, and therefore not as susceptible to damage during flood events.

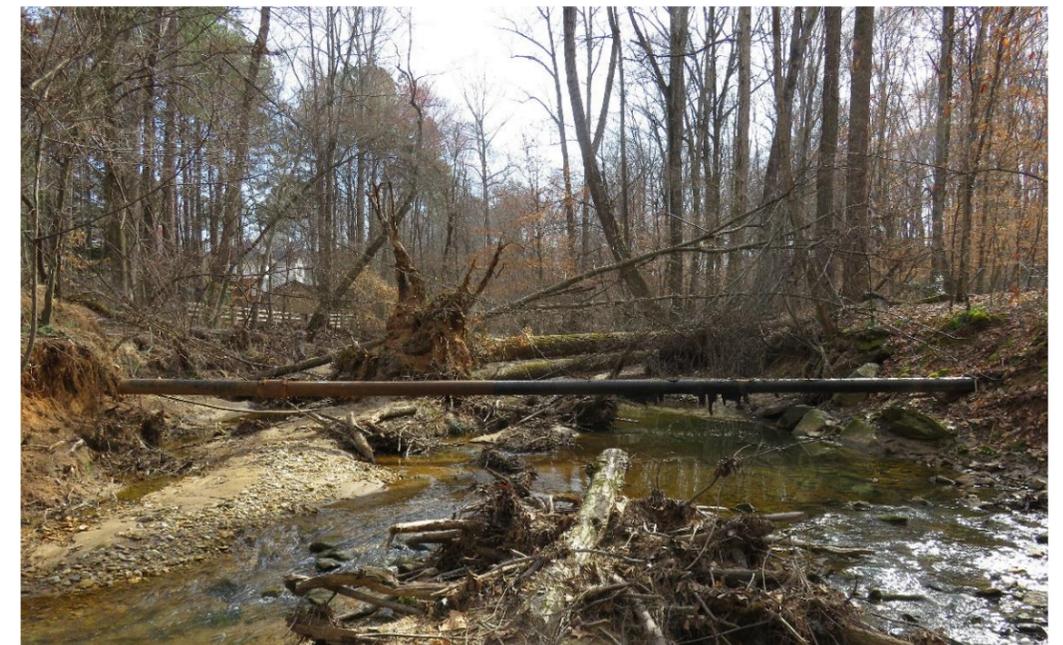
Exposed sanitary sewer pipe near the upstream end of the project. A large debris jam is located just upstream of the pipe which could damage the pipe during a flood event.
