# Webb Bridge Park Drainage Study

City of Alpharetta, Georgia

June 8, 2012

**Manhard**  
CONSULTING

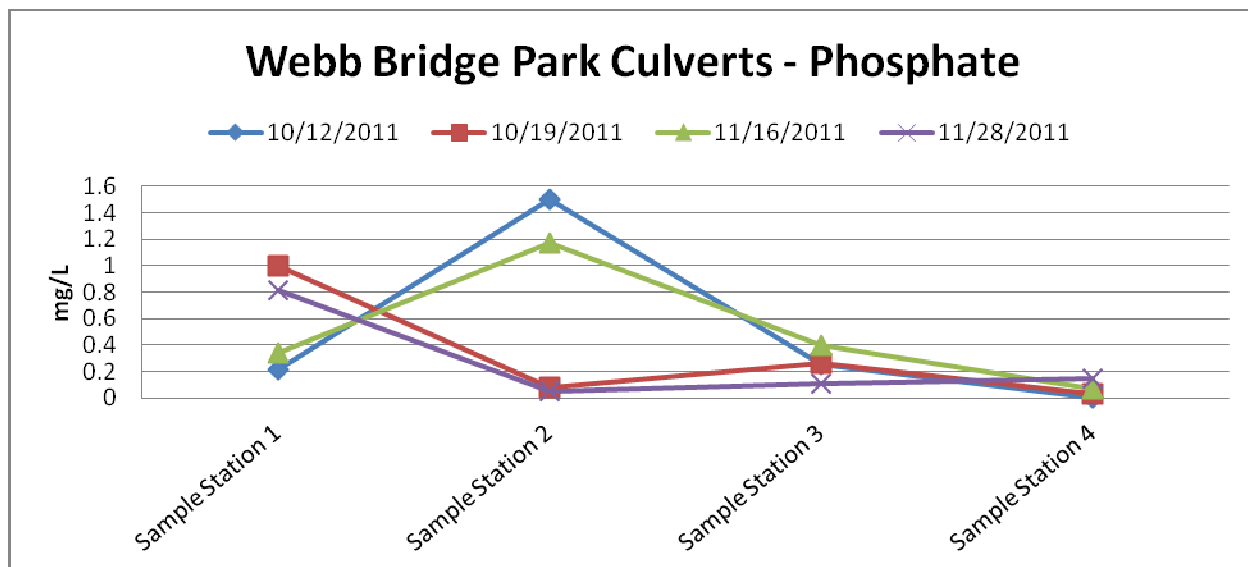
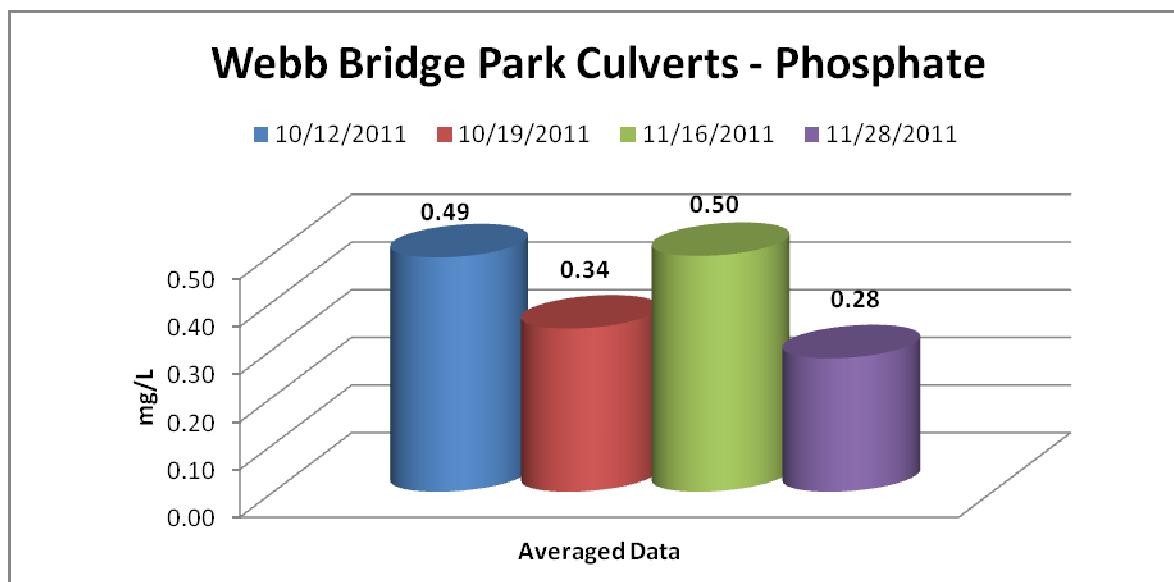
#### ***Phosphorus***

Phosphate concentrations are normally less than 0.1 mg/L in natural stream systems. Stormwater entering into the detention pond (Sample Station 4) from Sample Station 2 (culvert) had two of the highest phosphate concentrations (1.5 and 1.17) during two of the monitoring events. Sample Station 2 flow comes primarily from a private detention pond,

located adjacent to Webb Bridge Park. Sample Station 1, a culvert that drains stormwater from a parking lot within Webb Bridge Park, and Sample Station 3, a culvert that drains a portion of the athletic fields within the Park, had elevated phosphate levels during each sampling event, which ranged from 0.23 to 1 mg/L and 0.11 to 0.4 mg/L. Phosphate levels exiting the detention pond (Sample Station 4) ranged from 0 to 0.15 mg/L. Phosphate levels over 0.1 mg/L will accelerate eutrophication within detention ponds, lakes, and streams.

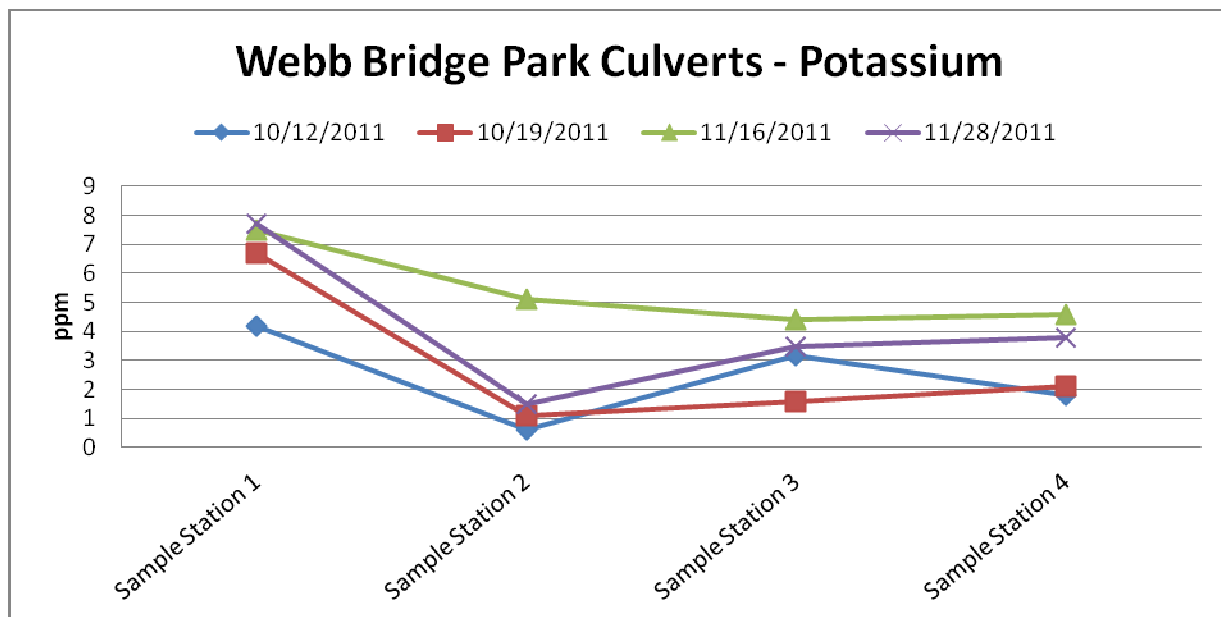
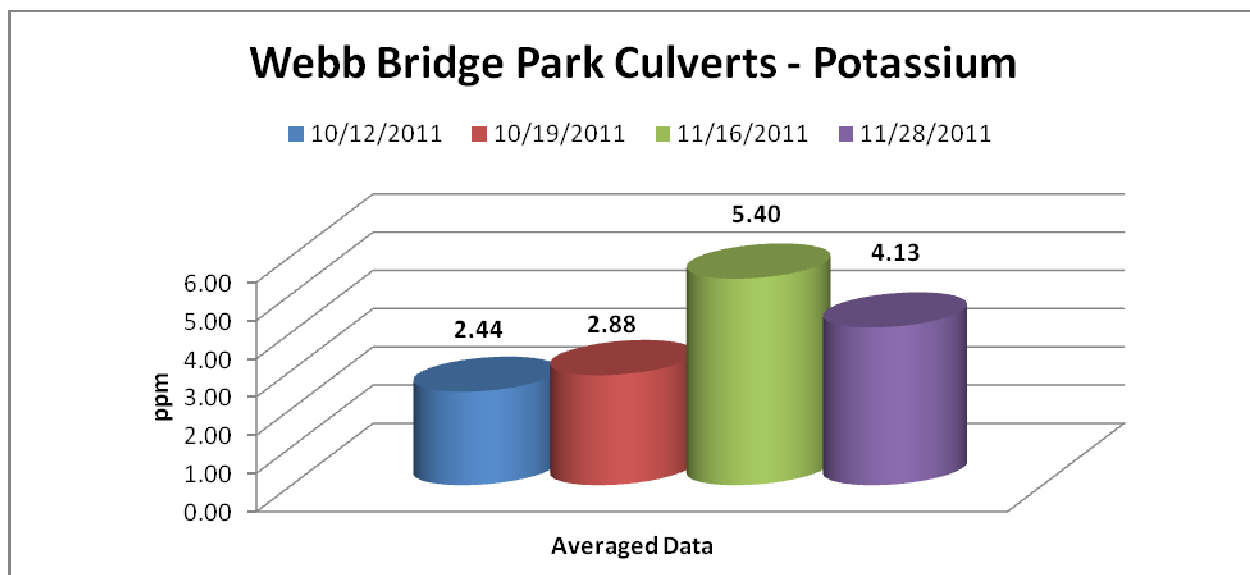
#### **Potassium**

Potassium levels sampled ranged from 0.6 to 7.7 ppm. Natural levels of potassium within streams typically vary from 2 – 3 ppm. Sample Station 1 had the highest potassium readings during each sampling event, which was between 4.2 to 7.7 ppm. Except for the third and fourth sampling events, Sample Station 4 (detention pond) had potassium levels from 1 to 3 ppm exiting the pond into the stream system. The averaged potassium levels (5.40 ppm) were the highest during the third sampling event (November 16, 2011).

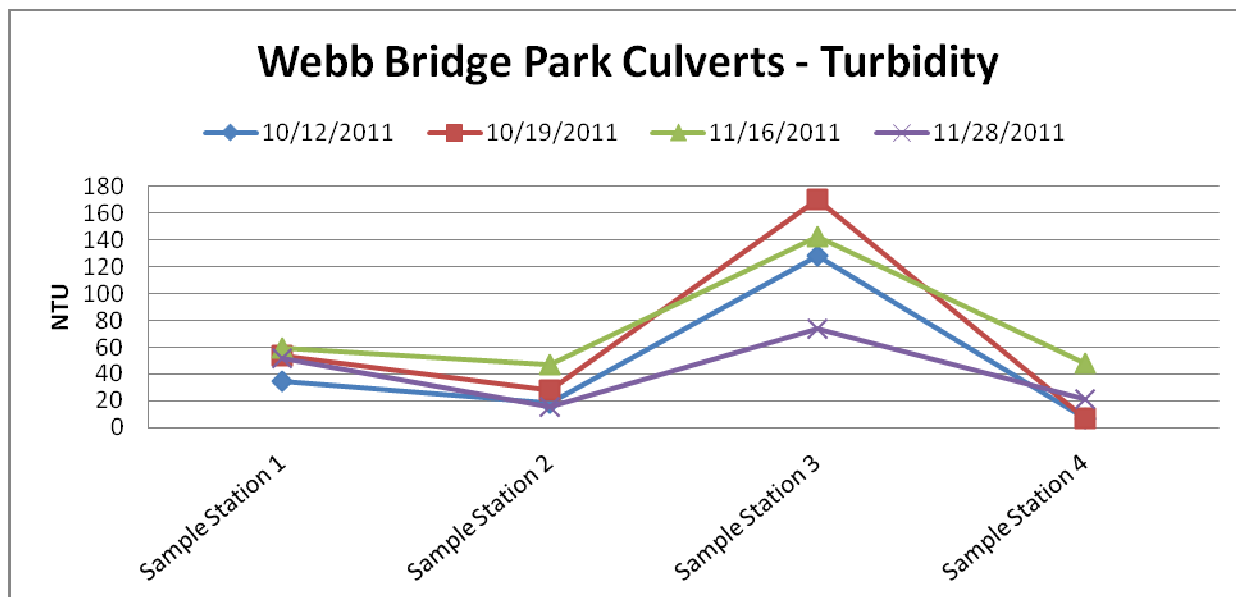
### ***Turbidity***

A majority of the turbidity values for stormwater flowing from the culverts were lower than 50 NTU, except for Sample Station 3. Sample Station 3 had turbidity values that ranged from 73 to 170.19 NTU's for all sampling events. The State considers waters that have 50 NTU's to be cloudy and 100- 500 NTU's or greater to be very cloudy to muddy. Water flowing from the detention pond had turbidity values from 7.1 to 48.01 NTU's, which is considered to be fairly clear water. The averaged turbidity levels (74.11 NTU) were the highest during the third sampling event (November 16, 2011).

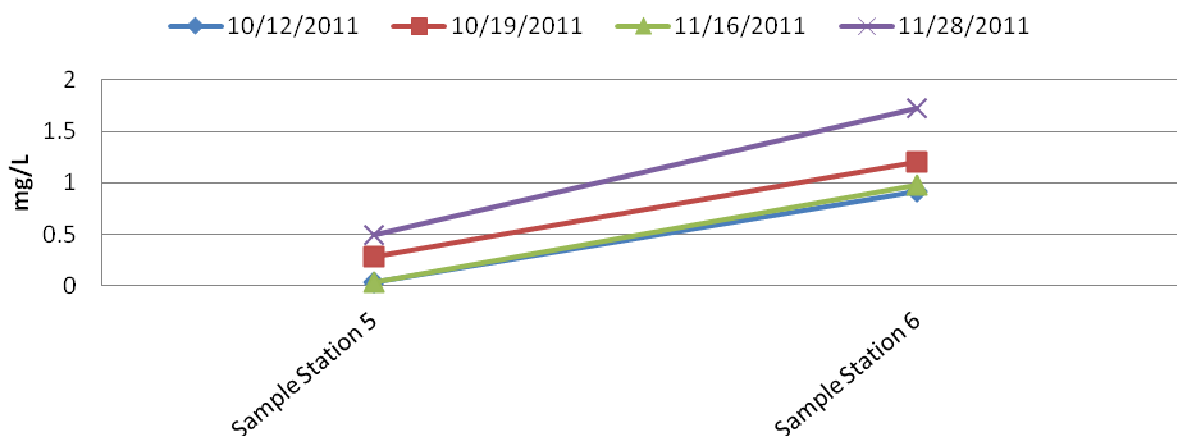
## Thornbury Lake Culverts - Phosphate

Phosphate concentrations are normally less than 0.1 mg/L in natural stream systems. Stormwater entering into Thornbury Lake from Sample Station 6 had two of the highest phosphate concentrations (1.2 and 1.73) during two of the sampling events. Sample Station 5 had elevated phosphate levels during two of the sampling events, which were 0.28 and 0.5 mg/L. All of the averaged phosphate levels in the stormwater flowing into Thornbury Lake are above 0.1 mg/L. Phosphate levels over 0.1 mg/L accelerates eutrophication within wet ponds, lakes, and streams.

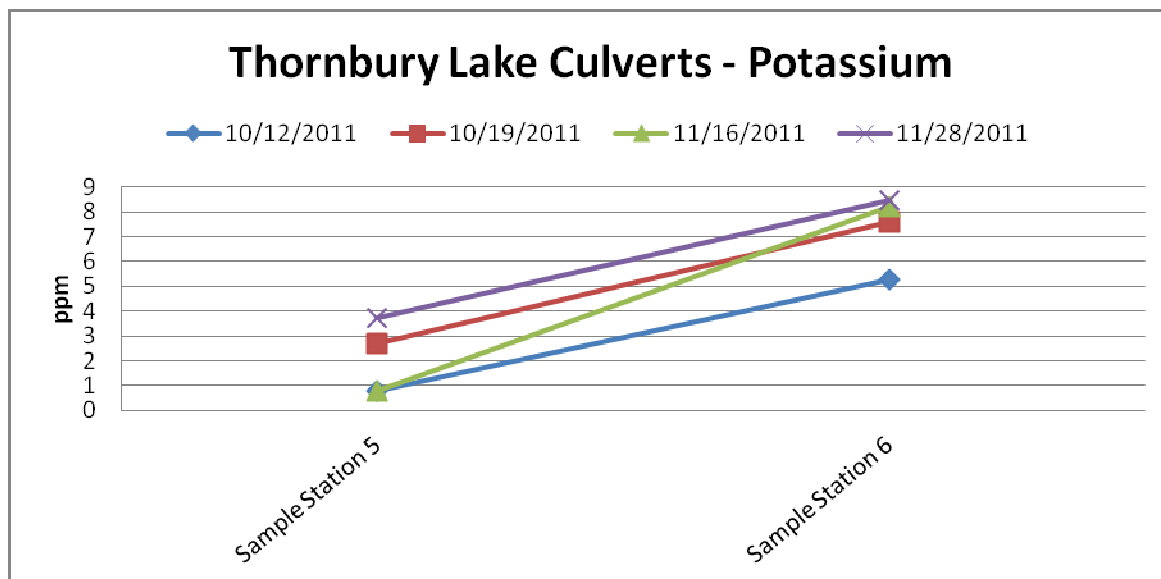
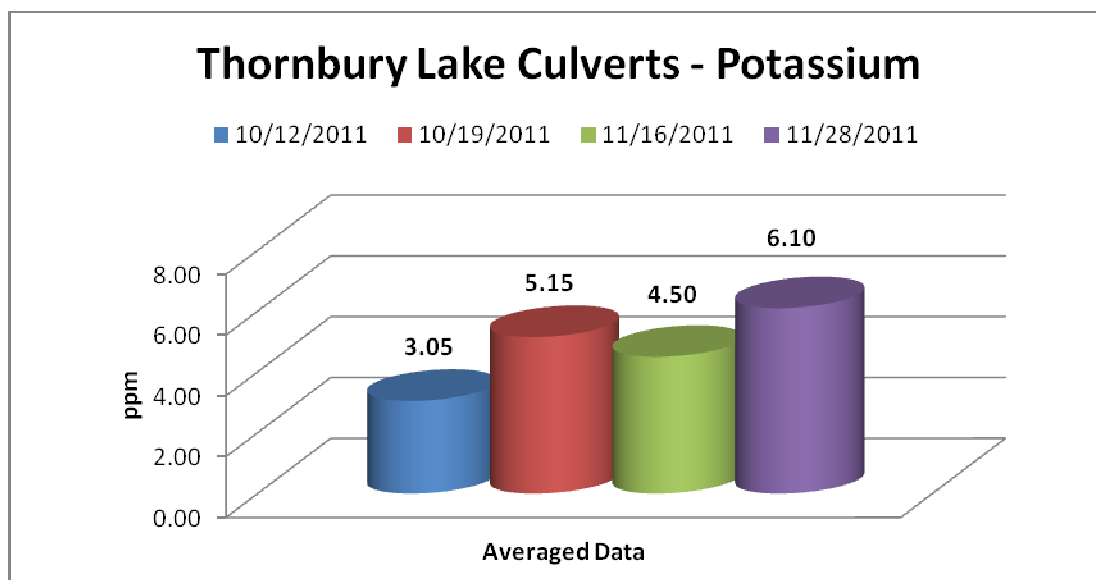
#### ***Potassium***

Potassium levels ranged from 0.8 to 8.5 ppm. Natural levels of potassium within streams typically vary from 2 – 3 ppm. Sample Station 6 had the highest readings for potassium during

each sampling event, which was between 5.3 to 8.5 ppm. Except for the fourth sampling event, Sample Station 5 potassium levels fell between 0.8 to 3 ppm prior to entering Thornbury Lake. The averaged potassium levels (6.10 ppm) were the highest during the fourth sampling event (November 28, 2011).

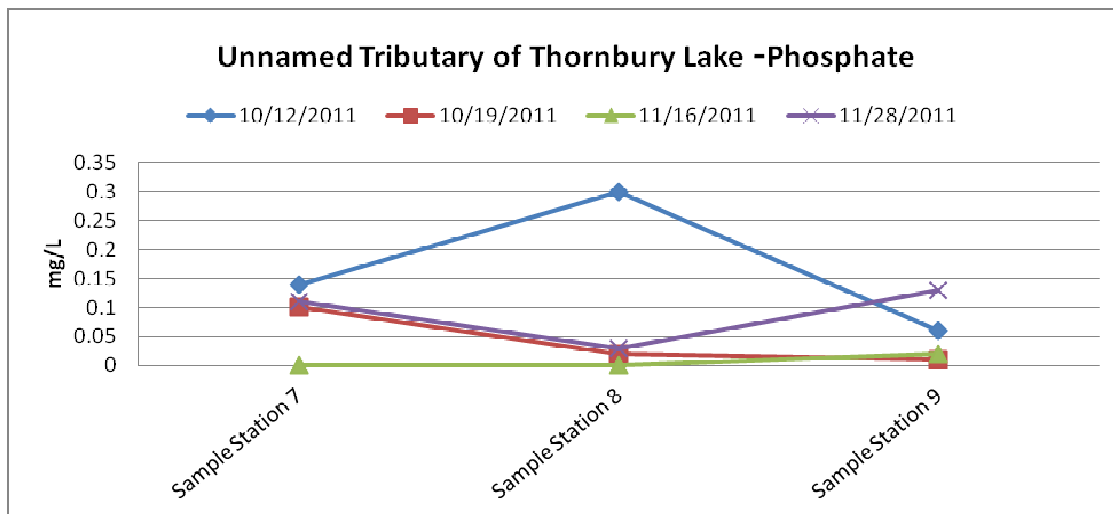
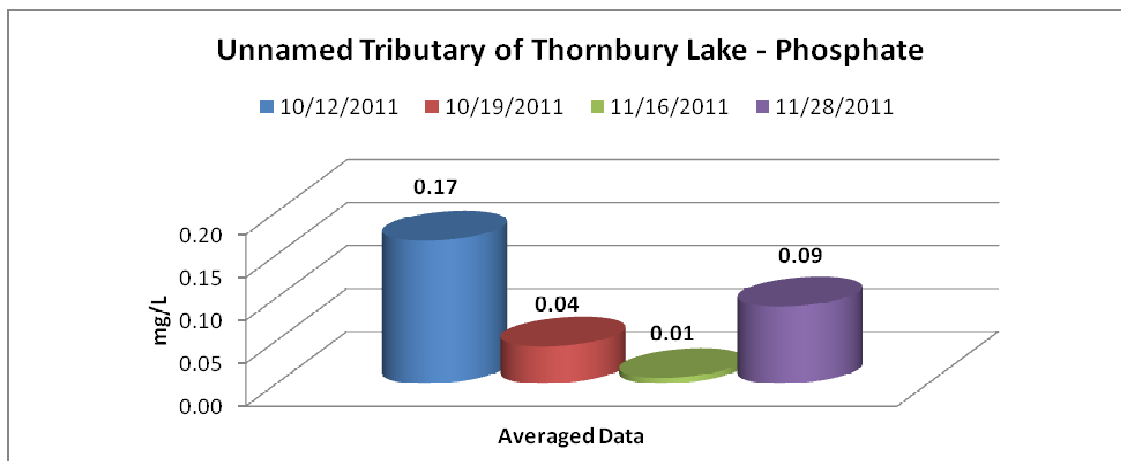
### Phosphorus

Phosphate concentrations are normally less than 0.1 mg/L in natural stream systems. Headwaters flowing into Thornbury Lake from Sample Stations 7 and 8 had two of the highest phosphate concentrations (0.14 and 0.3) during the first sampling event. Sample Station 9 had elevated phosphate levels during the last sampling event, which was 0.13 mg/L. All of the averaged phosphate levels within the stream flowing through Thornbury Lake were within acceptable limits except for during the first sampling event, which yielded levels above 0.1

mg/L. Phosphate levels over 0.1 mg/L will accelerate eutrophication within wet ponds, lakes, and streams.

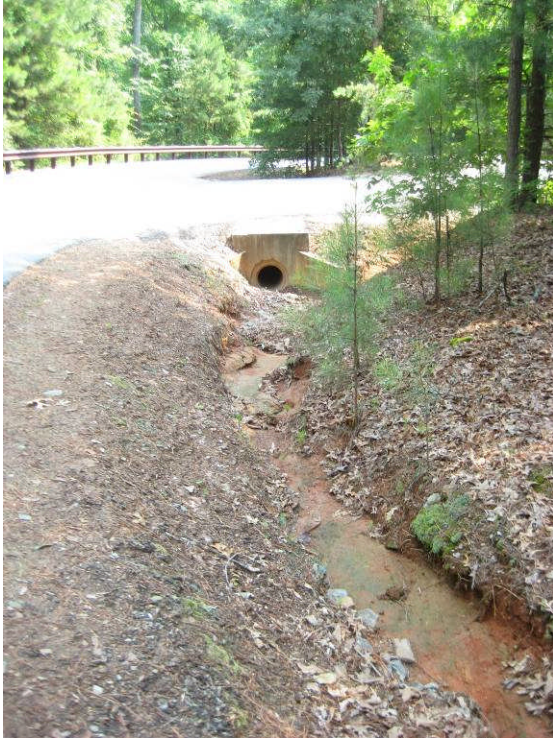
PHOTO A: drainage ditch along access road

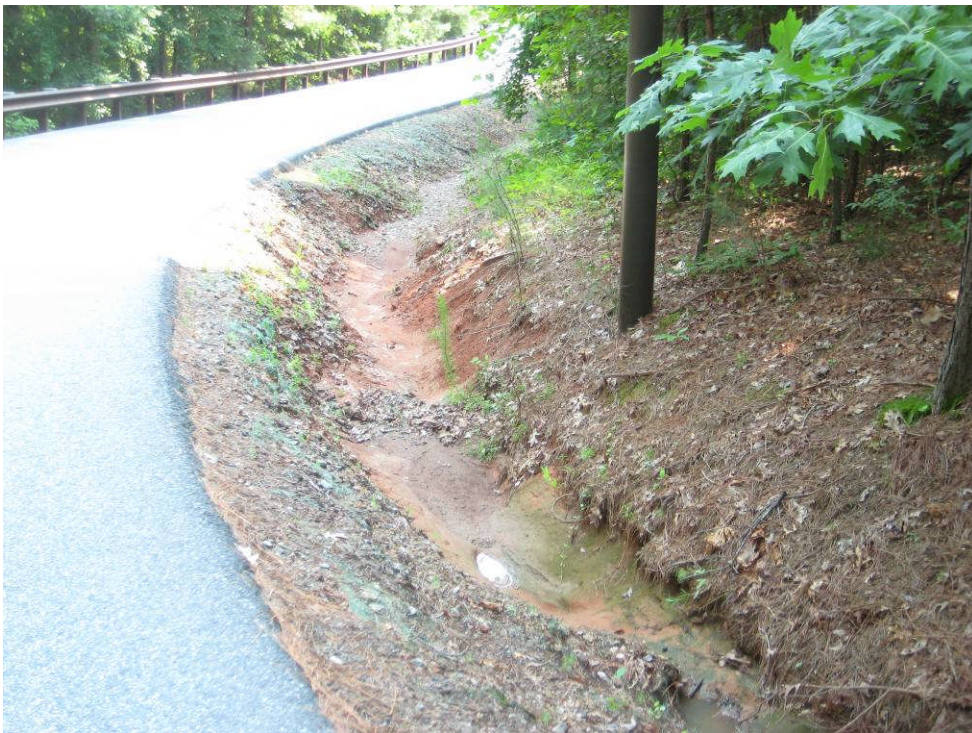
PHOTO B: drainage ditch along access road

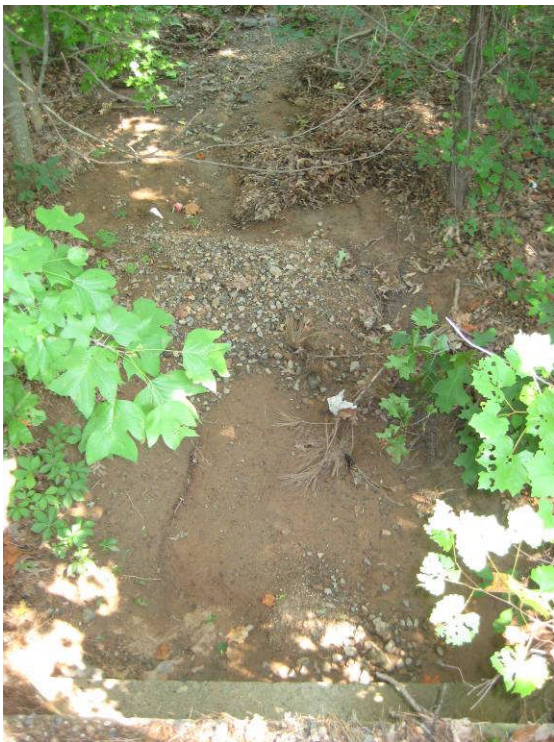
PHOTO C: erosion at outfall of 24-inch RCP

Approximately 14 square yards of Type 3 riprap should be placed at the pipe outfall to provide erosion control for the affected area. A synthetic filter fabric should be installed between the riprap and soil foundation.

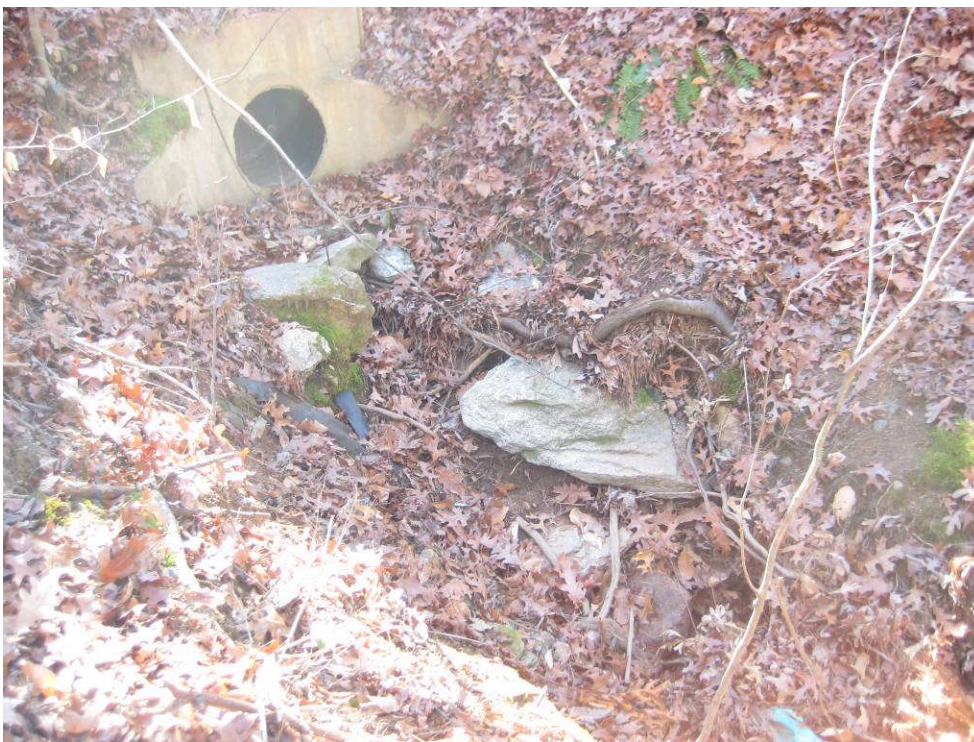
PHOTO C2: erosion at outfall of 18-inch HDPE pipe

Approximately 20 square yards of Type 3 riprap should be placed at pipe outfall to provide erosion control for the affected area. A synthetic filter fabric should be installed between the riprap and soil foundation.

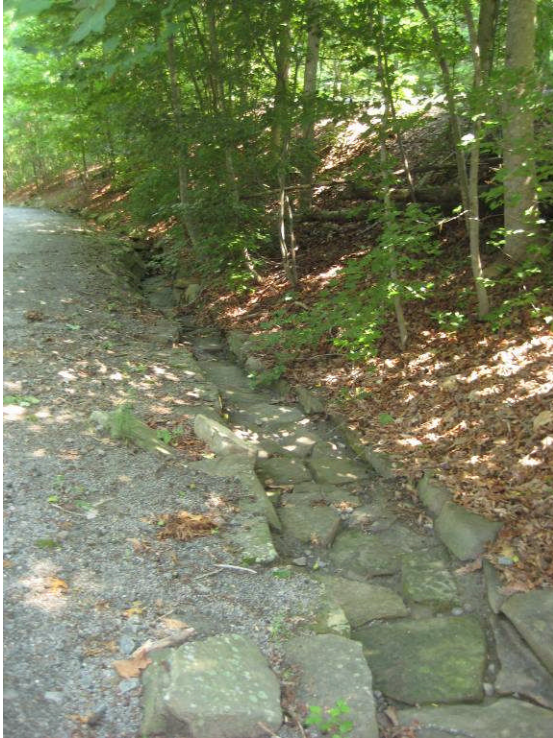
PHOTO E: rock-lined ditch along trail

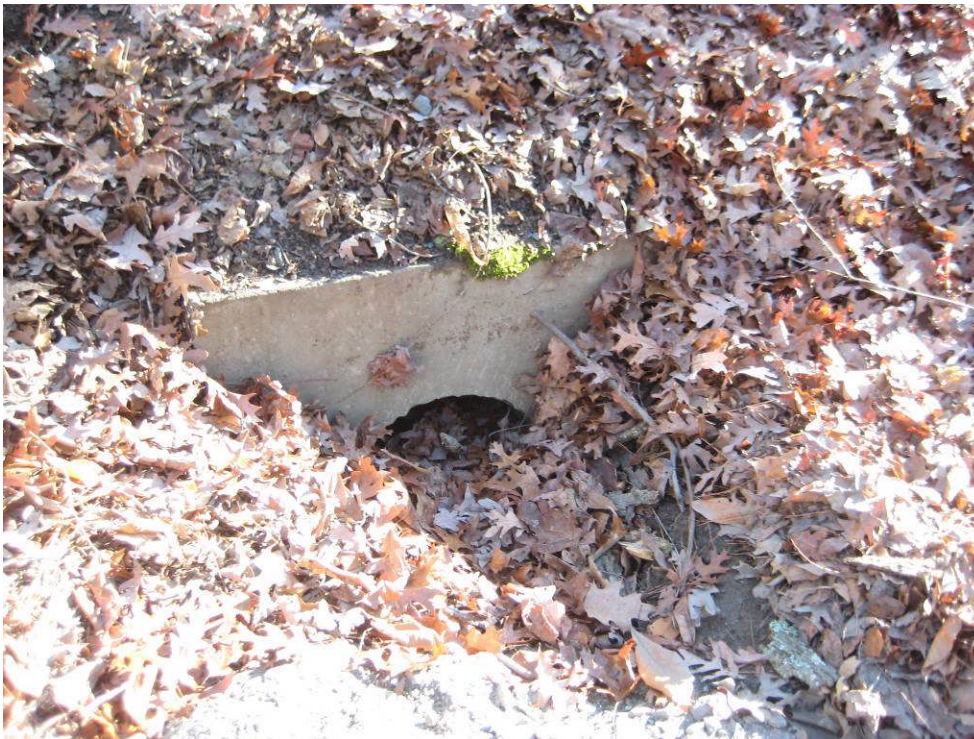
PHOTO E2: downstream face of clogged 18-inch HDPE pipe

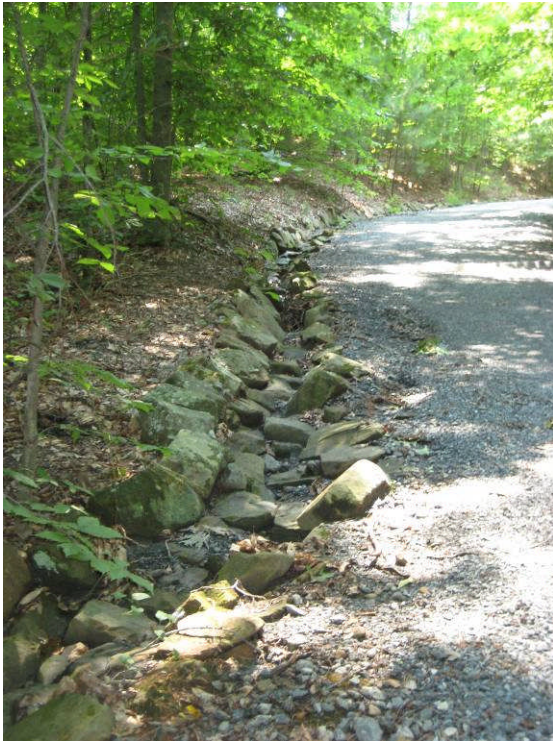
PHOTO F: rock-lined ditch along trail

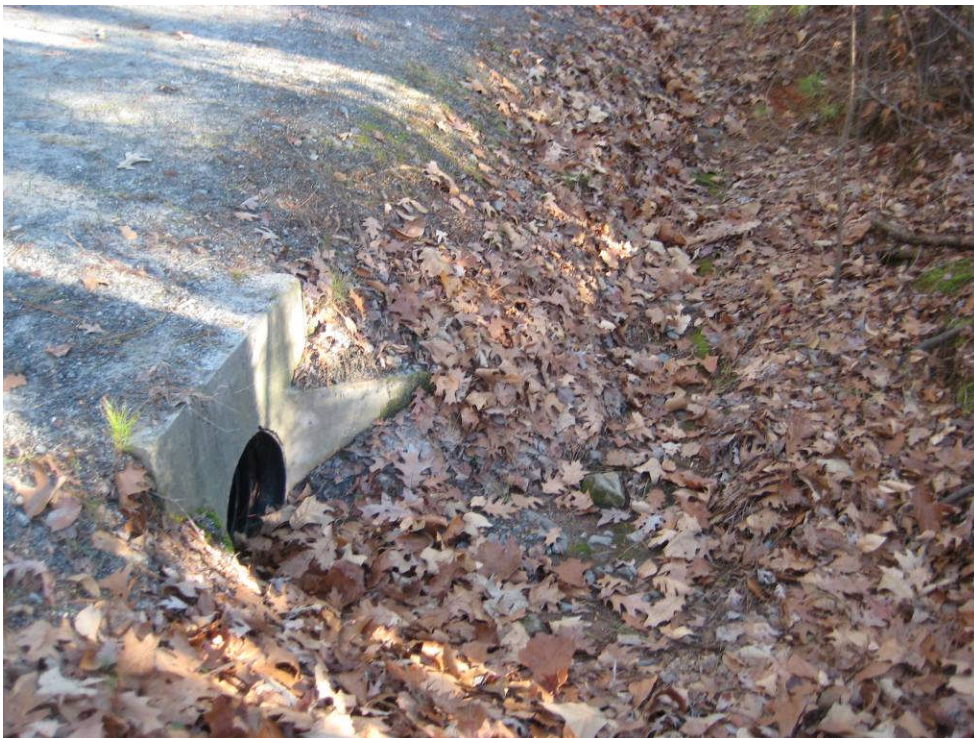
PHOTO F2: upstream face of 18-inch HDPE pipe under trail

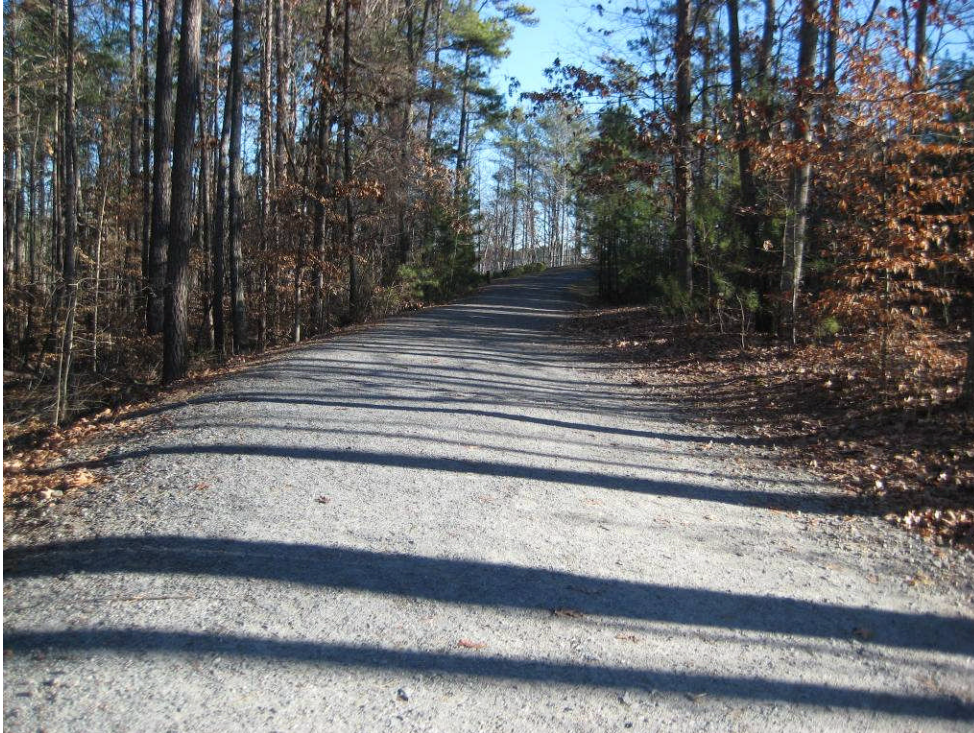
PHOTO F4: at location of photo F2, looking downslope along trail to the west

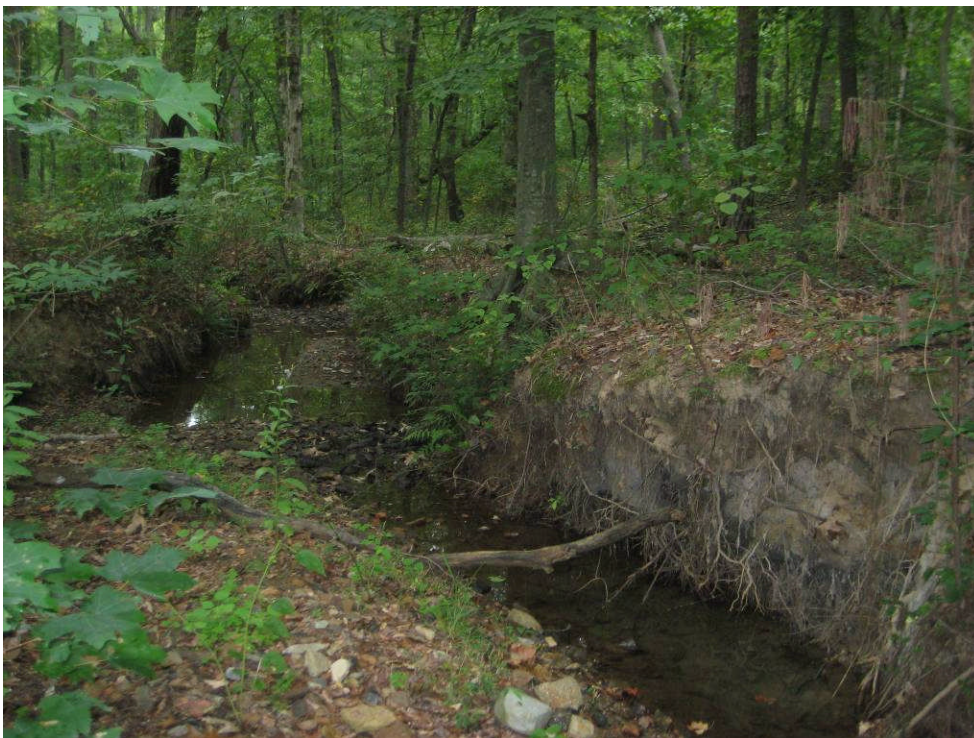
PHOTO F5: looking northeast along trail; location where runoff begins to drain away from private property (to the northwest) and back towards park (to the southeast)

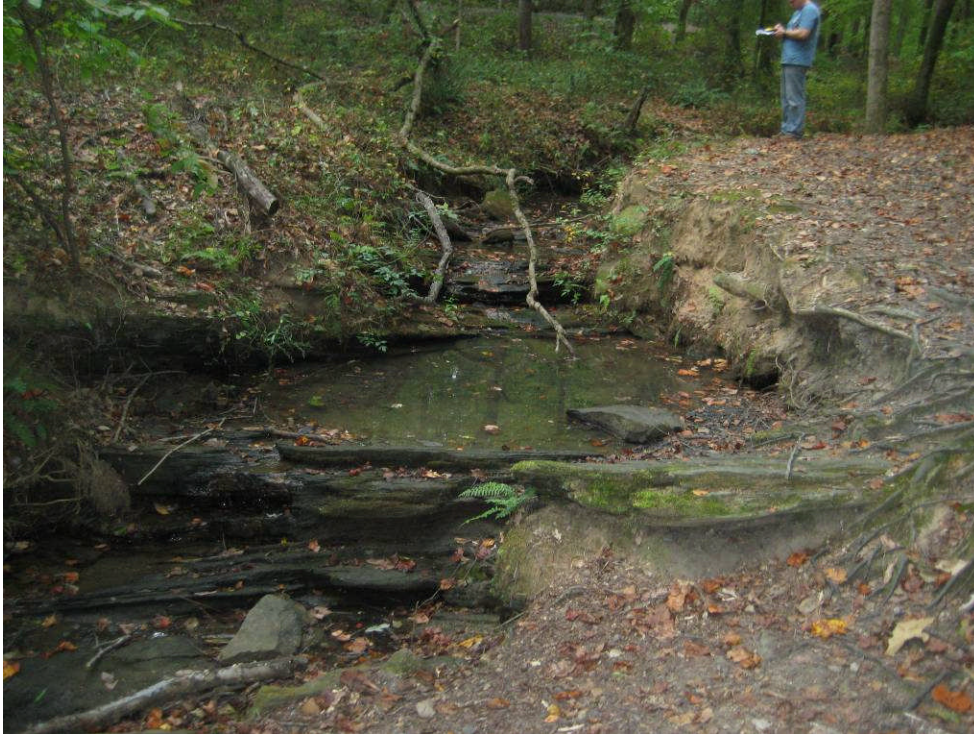
PHOTO G: standing on left bank, looking downstream from 48-inch RCP crossing

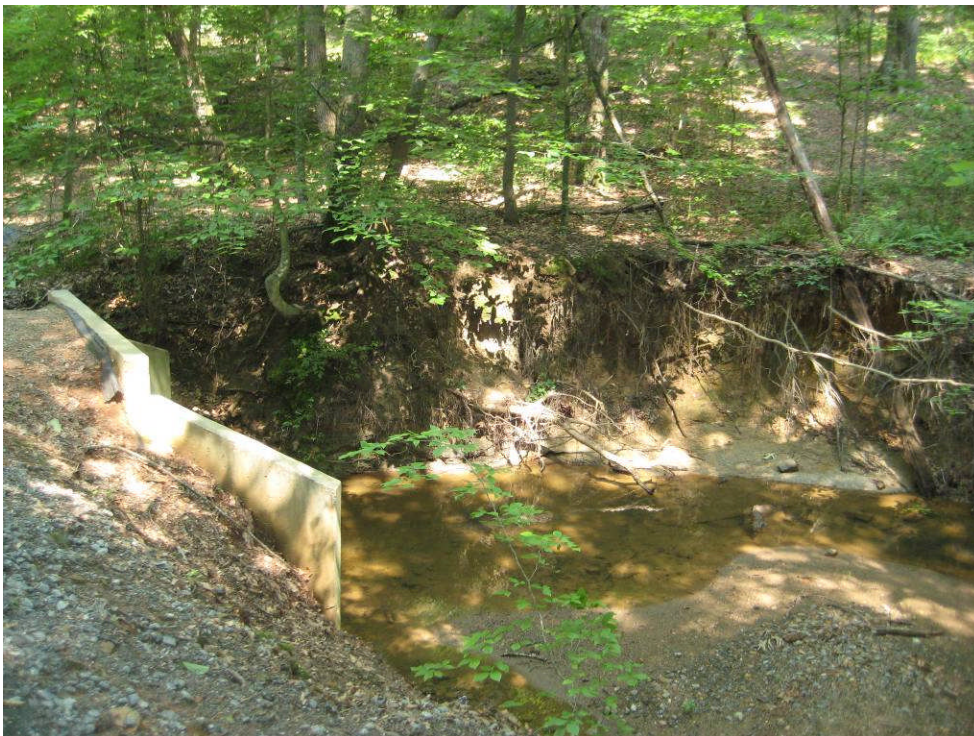
PHOTO R: upstream face of poorly aligned 60-inch RCP

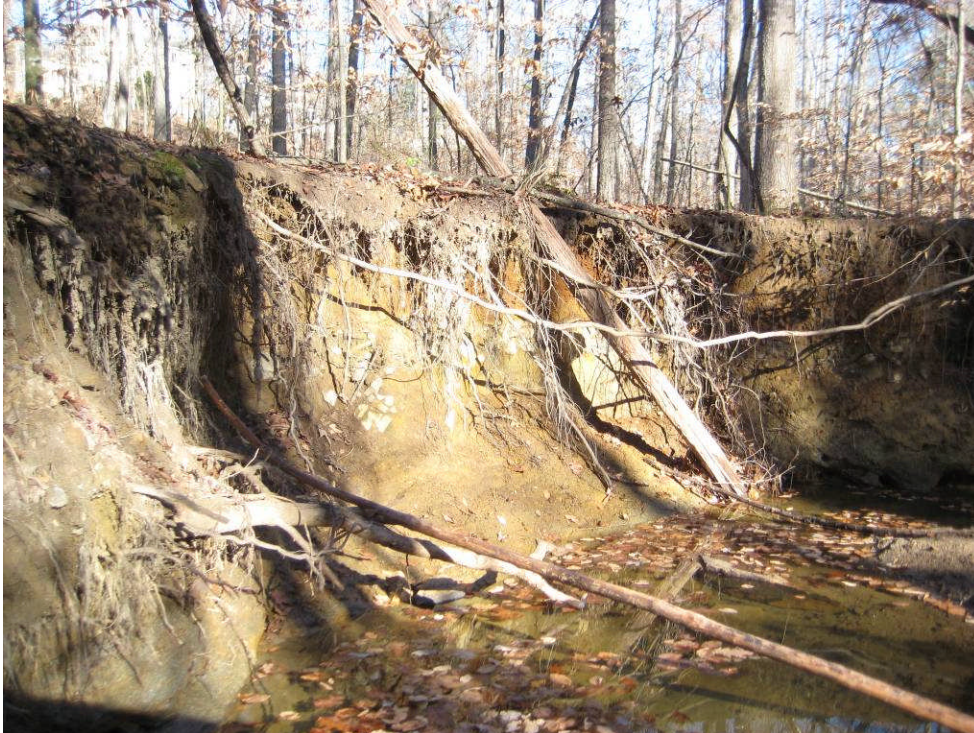
PHOTO S: looking at severely eroded left bank, just downstream of 60-inch RCP

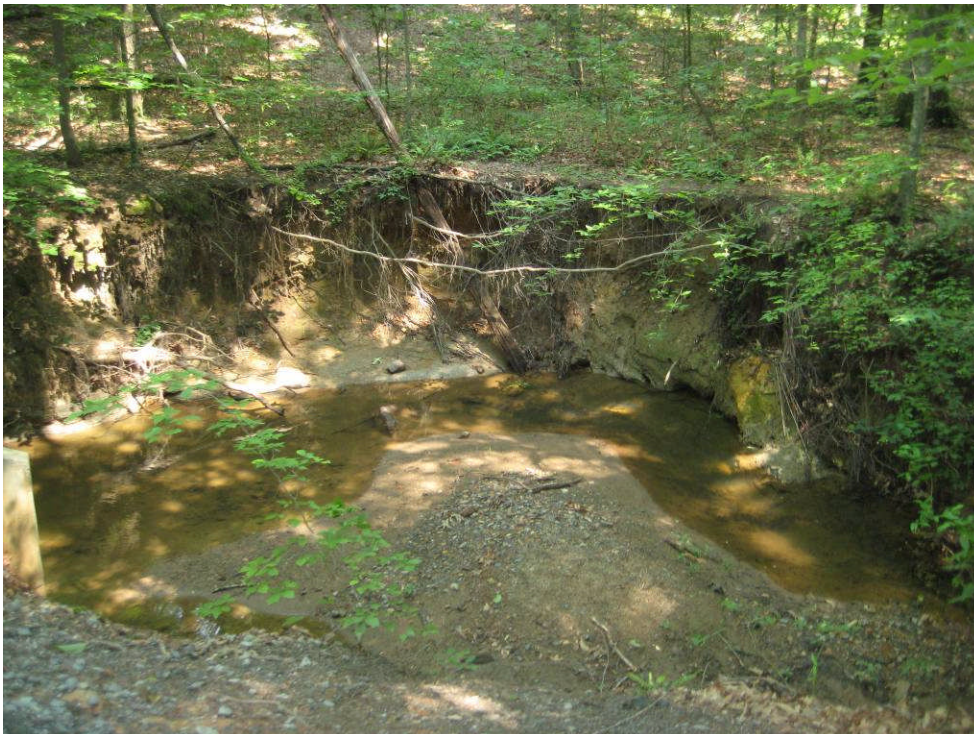
PHOTO S2: standing at downstream face of 60-inch RCP, looking at left bank which makes a 90-degree turn immediately downstream of culvert

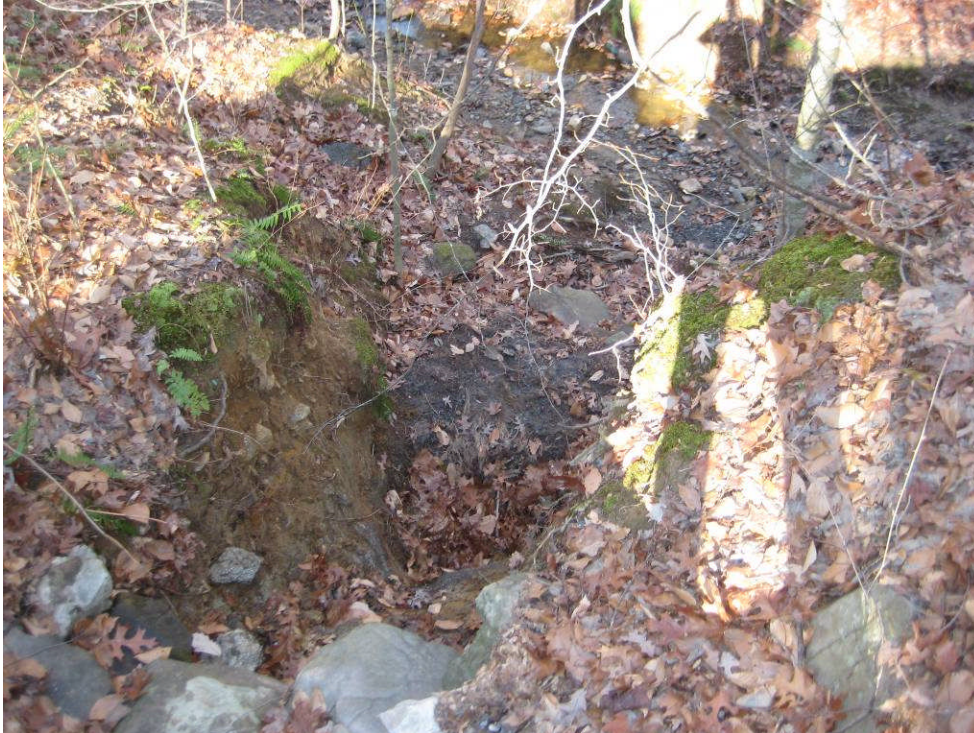
PHOTO T2: standing on headwall of 24-inch HDPE pipe, looking at steep, eroded ditch section between pipe outfall and stream

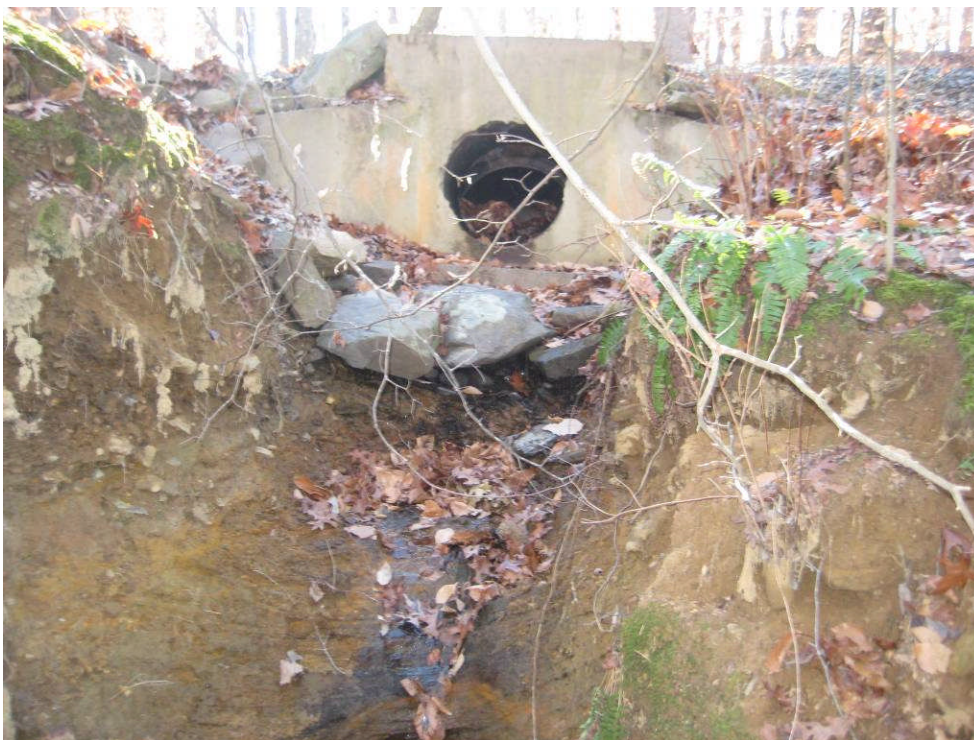
PHOTO T3: standing on headwall of 24-inch HDPE pipe, looking at steep, eroded ditch section between pipe outfall and stream

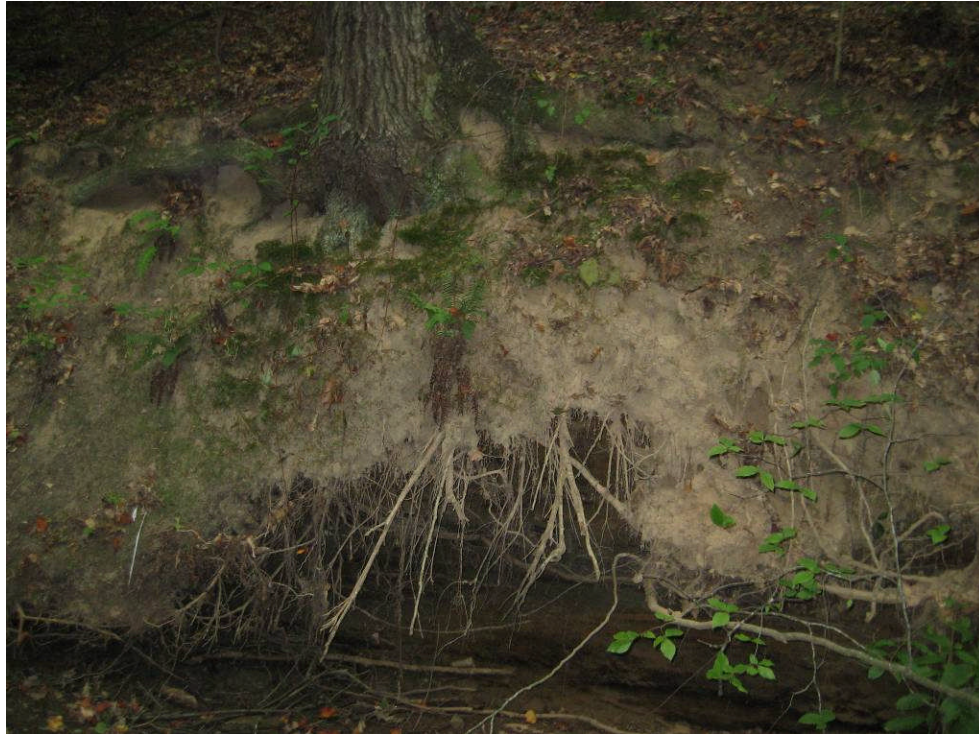
PHOTO V: erosion undermining tree root systems on right bank

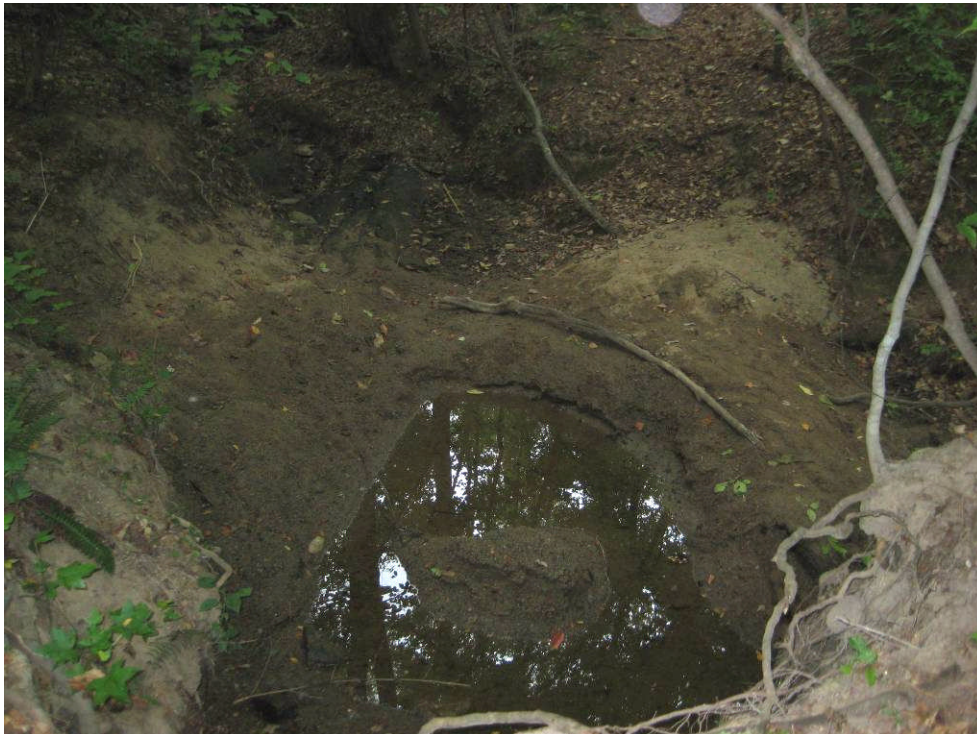
PHOTO Y: scour hole in channel

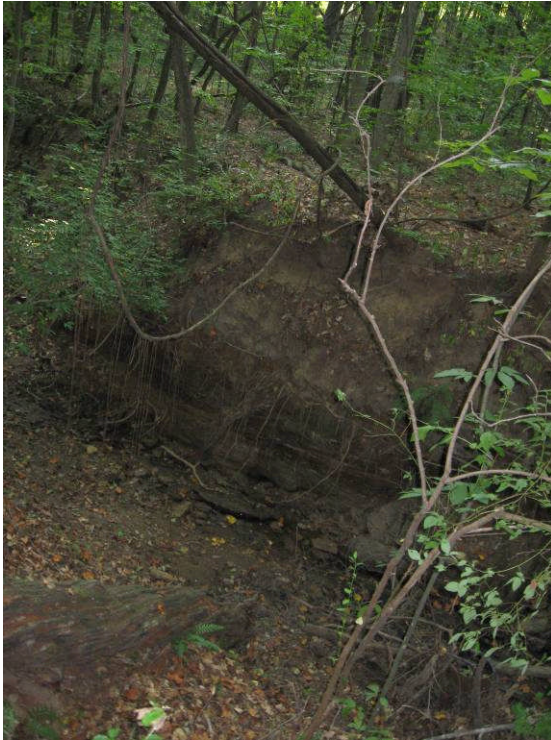
PHOTO DD: a lot of bank erosion occurring in this area; located upstream of oxbow and second footbridge crossing

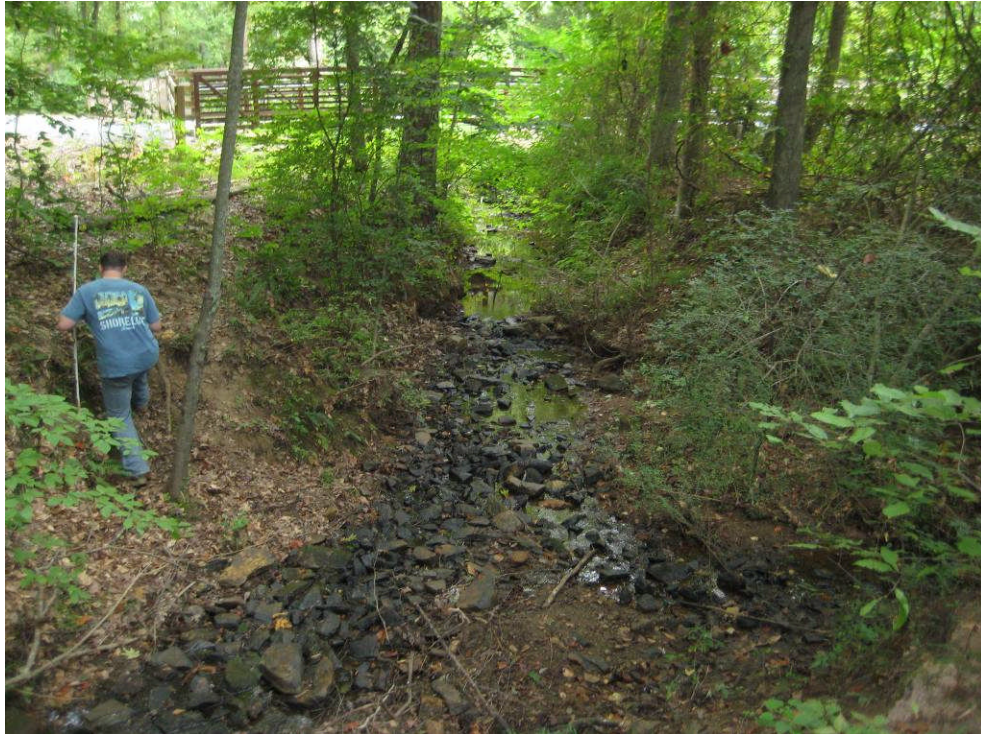
PHOTO NN: standing on right bank of park's primary western channel, at confluence with park's eastern channel; looking downstream

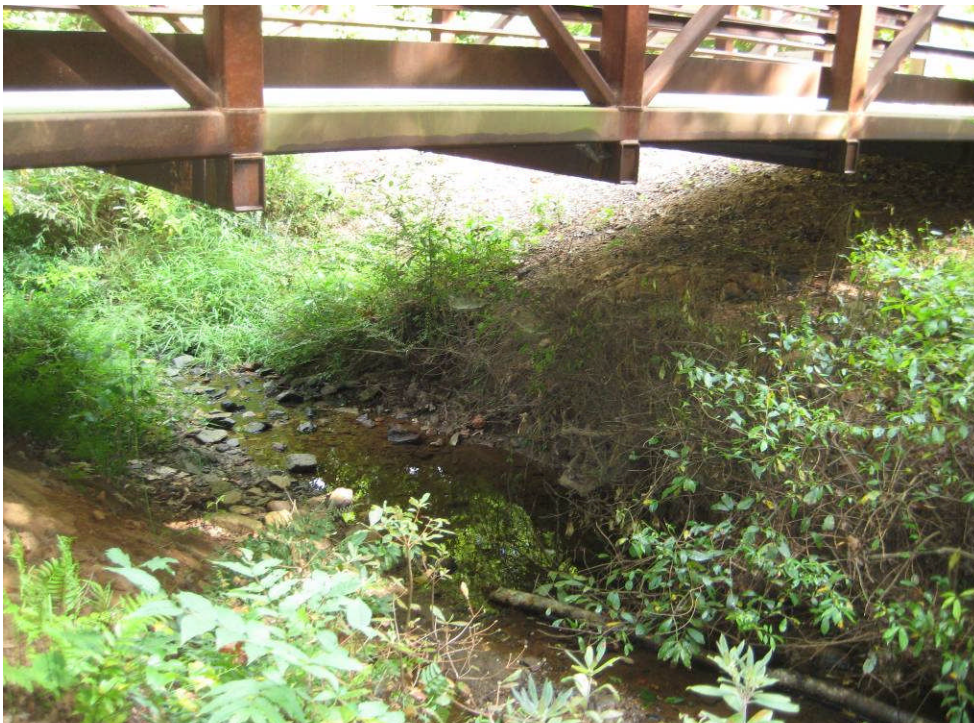
PHOTO – OO: channel under metal pedestrian bridge, which crosses channel approximately 75 feet downstream of confluence of park's primary western and eastern streams

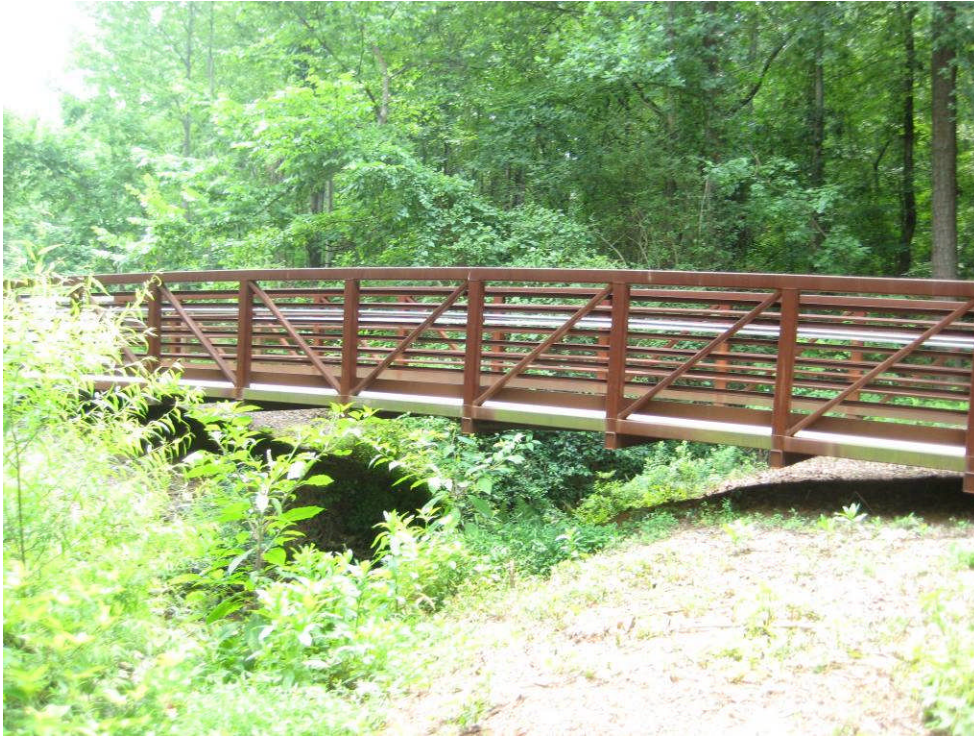
PHOTO – PP: metal pedestrian bridge, which crosses channel approximately 75 feet downstream of confluence of park's primary western and eastern streams

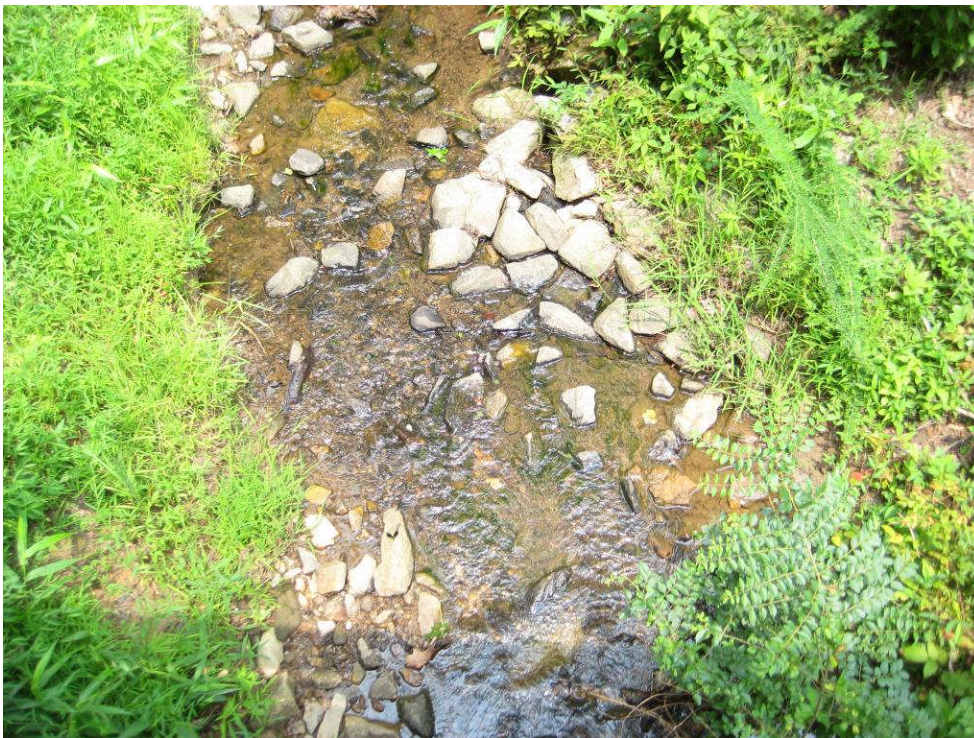
PHOTO – QQ: view of downstream channel from metal pedestrian bridge
