# Webb Bridge Park Drainage Study

City of Alpharetta, Georgia

June 8, 2012

**Manhard**  
CONSULTING

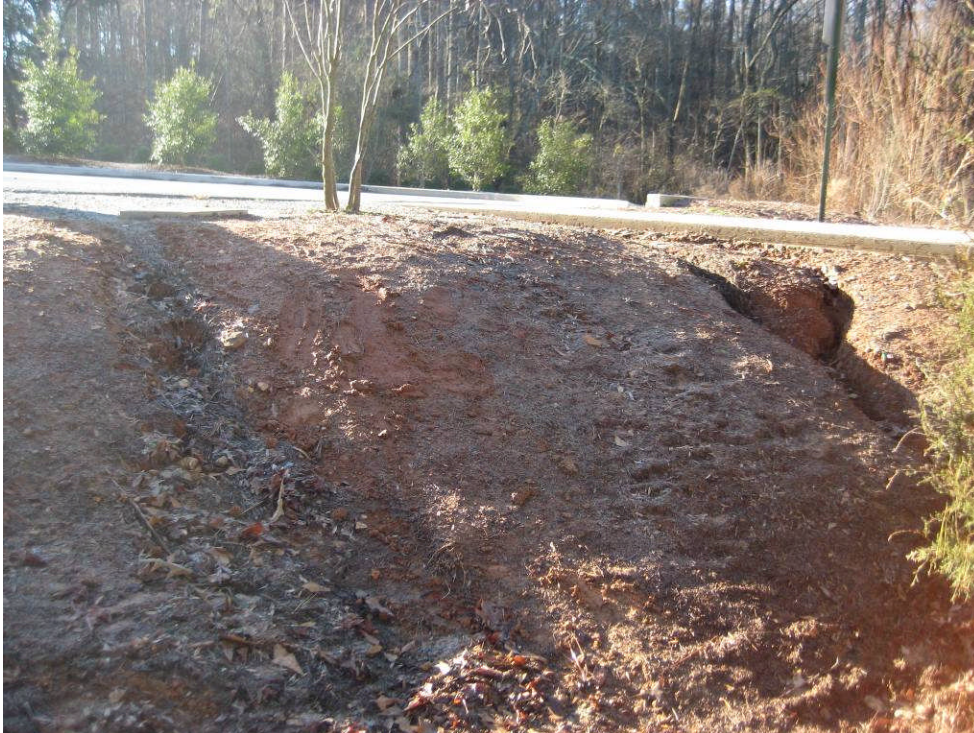
PHOTO – QQ1: rills/ditches in bare soil at northwest edge of Park's Phase III parking lot

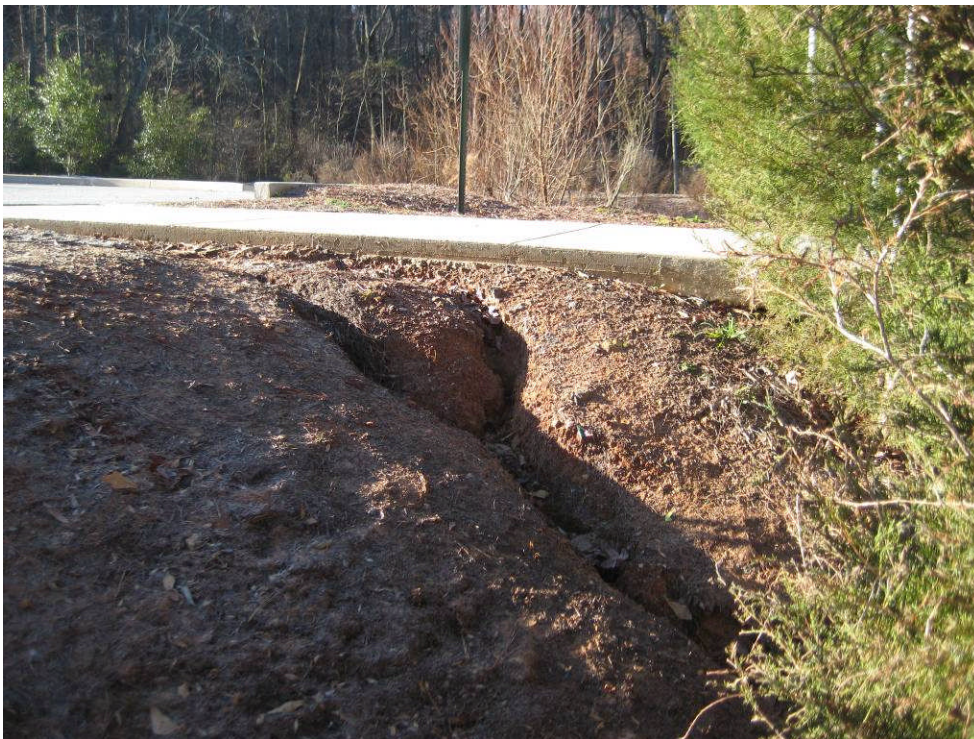
PHOTO – QQ2: rills/ditches in bare soil at northwest edge of Park's Phase III parking lot

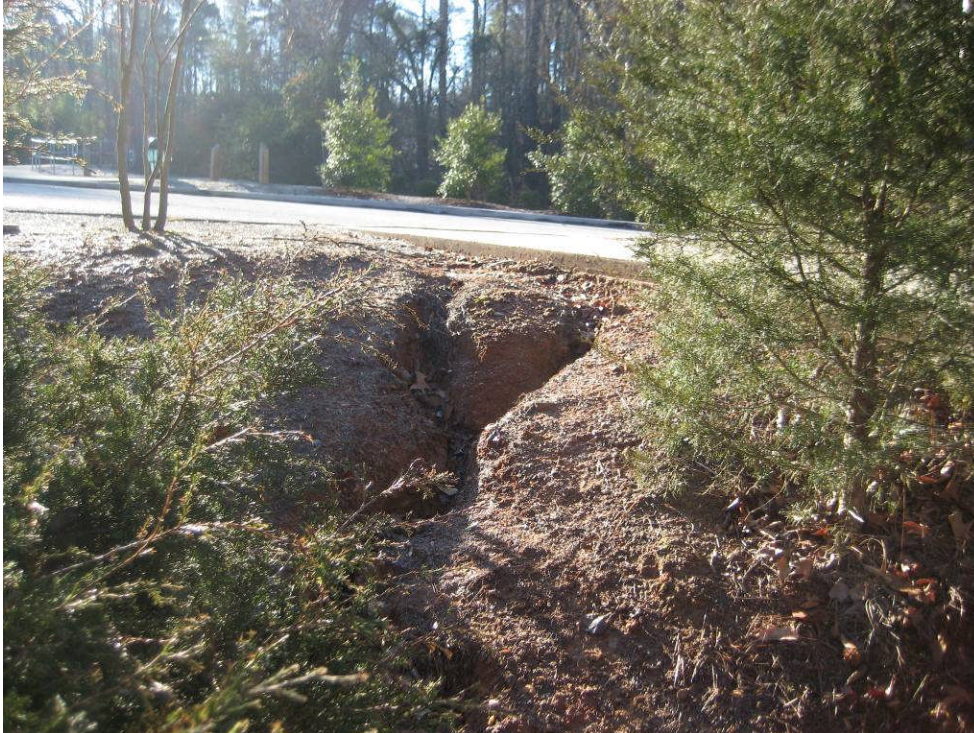
PHOTO – QQ3: rills/ditches in bare soil at northwest edge of Park's Phase III parking lot

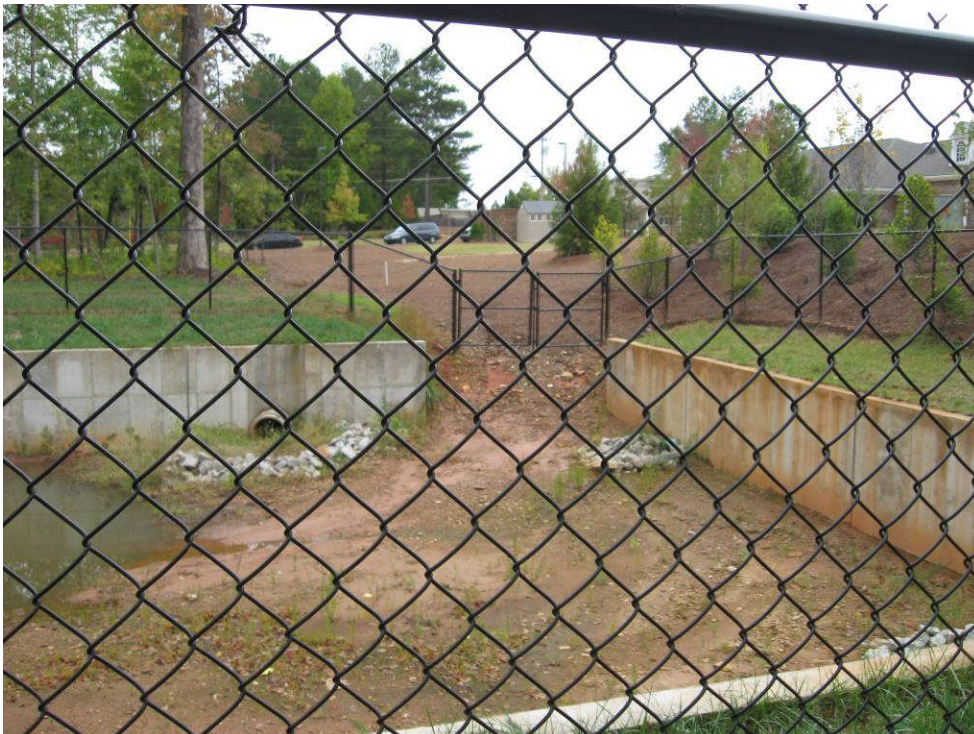
PHOTO – RR: concrete detention pond located behind residential development constructed in 2011; pond is located on private property, just upstream of the park's wet pond

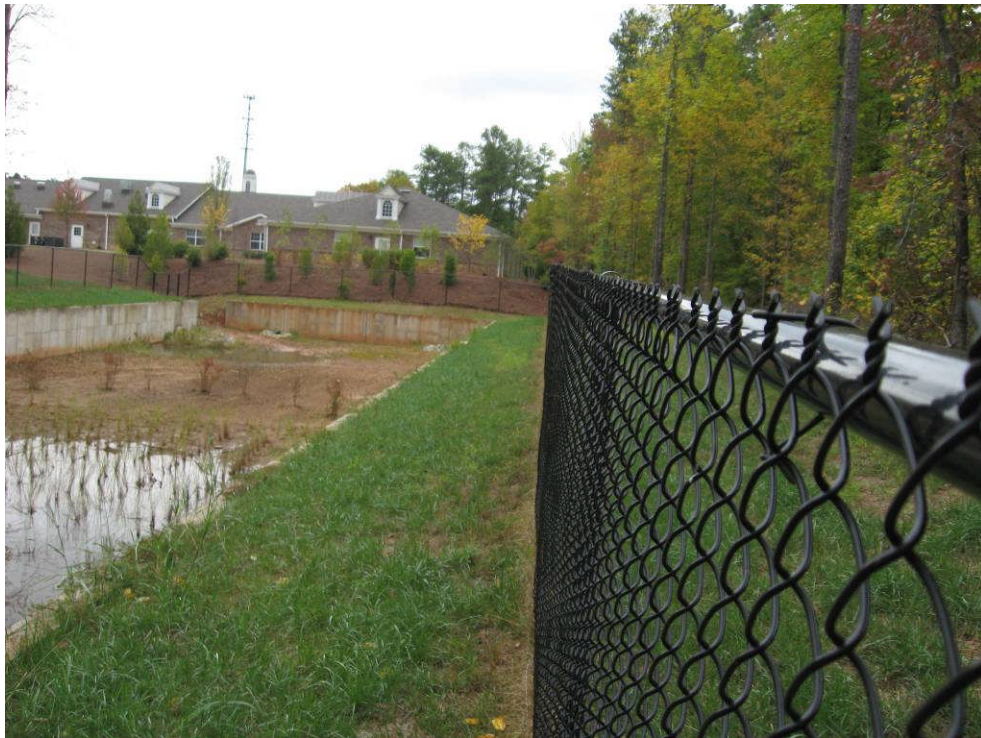
PHOTO – SS: concrete detention pond located behind residential development constructed in 2011; pond is located on private property, just upstream of the park's wet pond; looking south towards homes

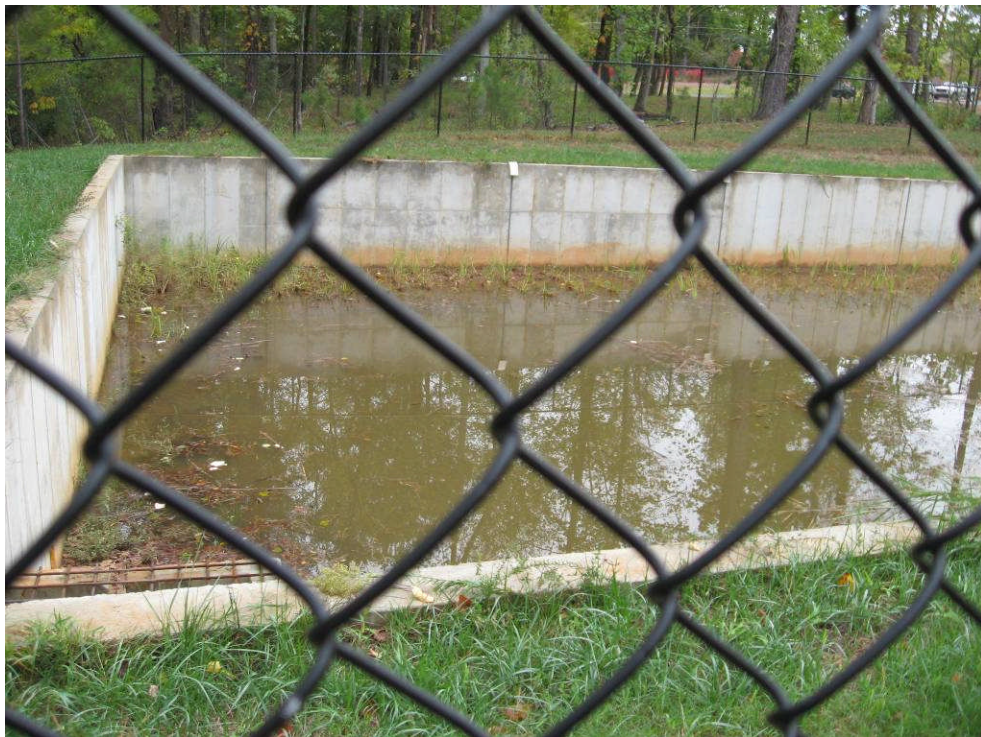
PHOTO – TT: concrete detention pond located behind residential development constructed in 2011; looking at pond outlet structure which discharges into pipe upstream of park's wet pond

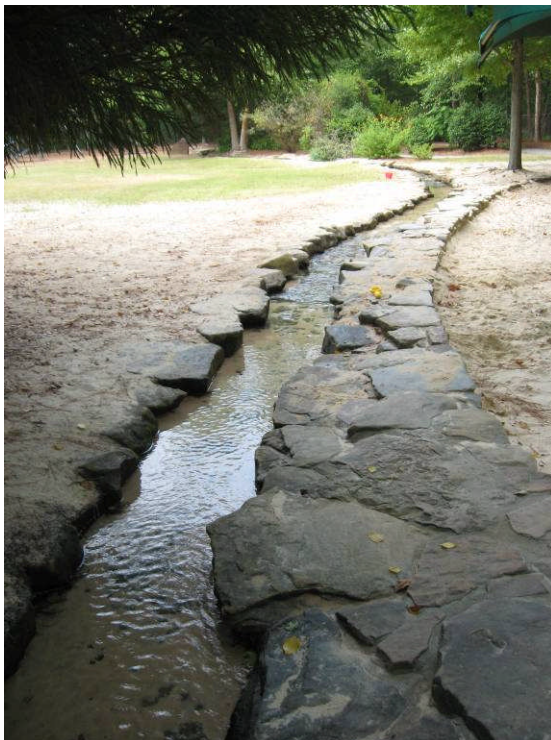
PHOTO – UU: rock channel in playground area, looking downstream (looking southwest); large sandbox area located on right of photo

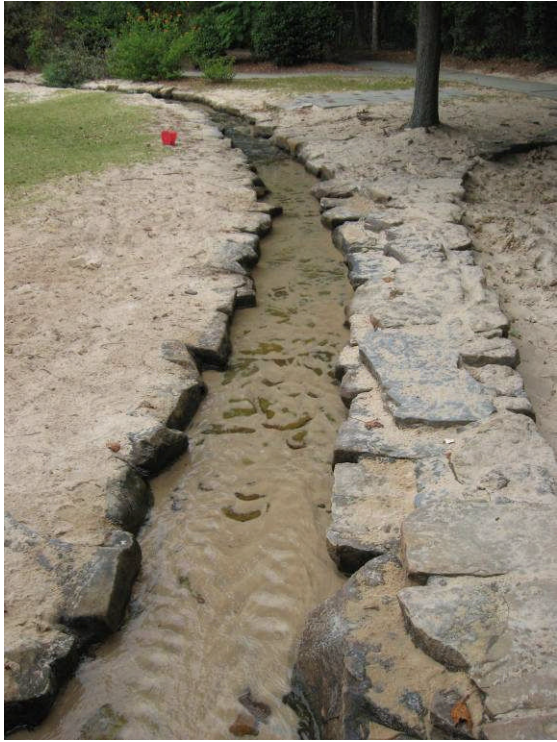
PHOTO – VV: rock channel in playground area, looking downstream (looking southwest); large sandbox area located on right of photo

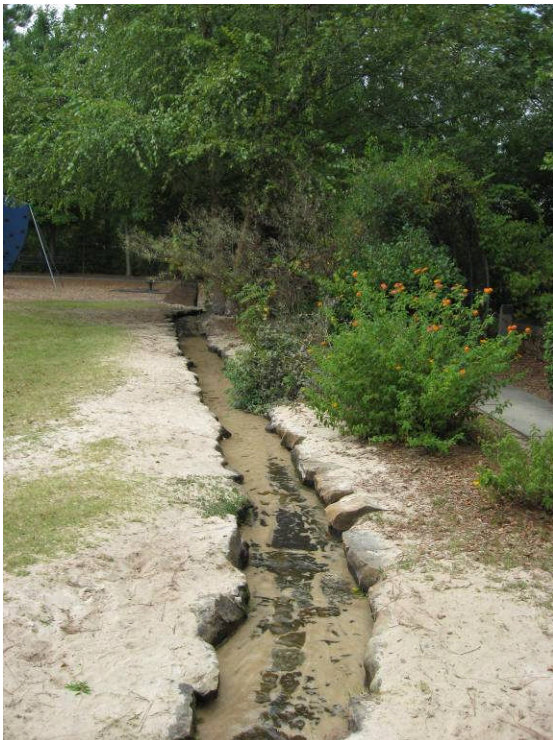
PHOTO – WW: rock channel in playground area, looking downstream (looking southwest) towards outlet, which discharges into pipe system and ultimately into park's wet pond

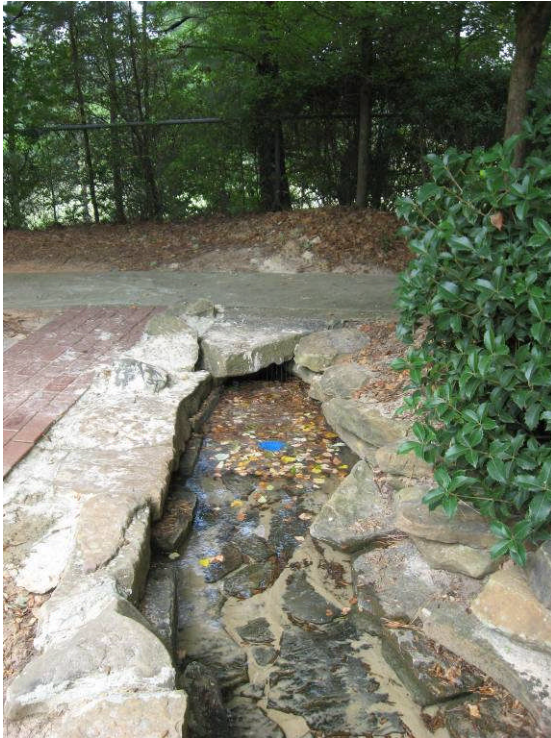
PHOTO – XX: outlet of rock channel in playground area

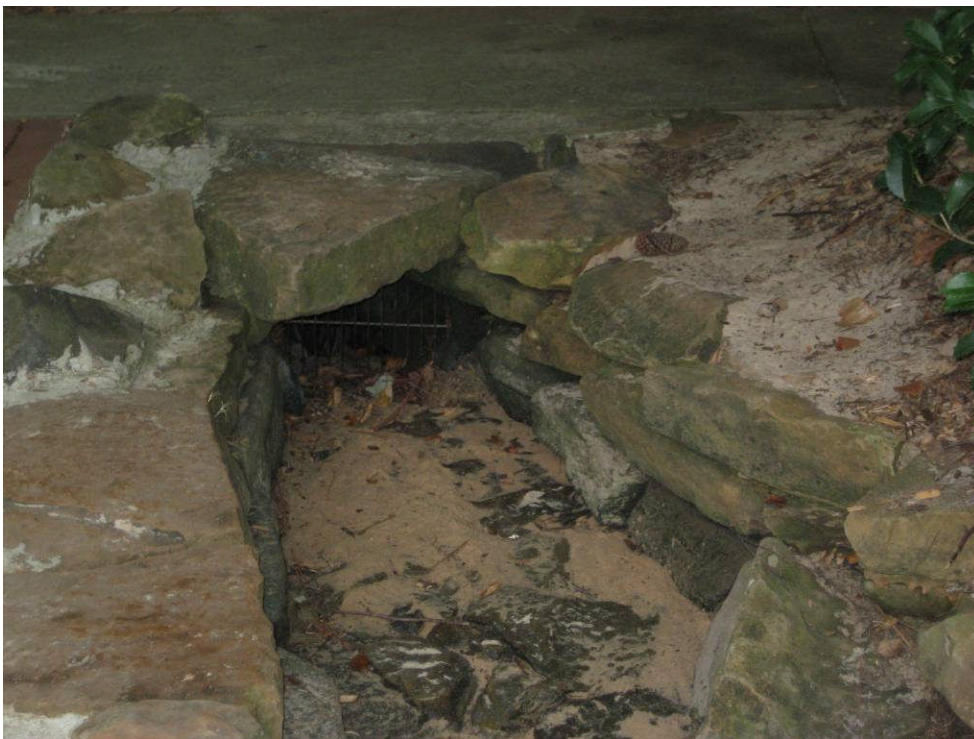
PHOTO – YY: outlet of rock channel in playground area; small metal grate visible under header rock

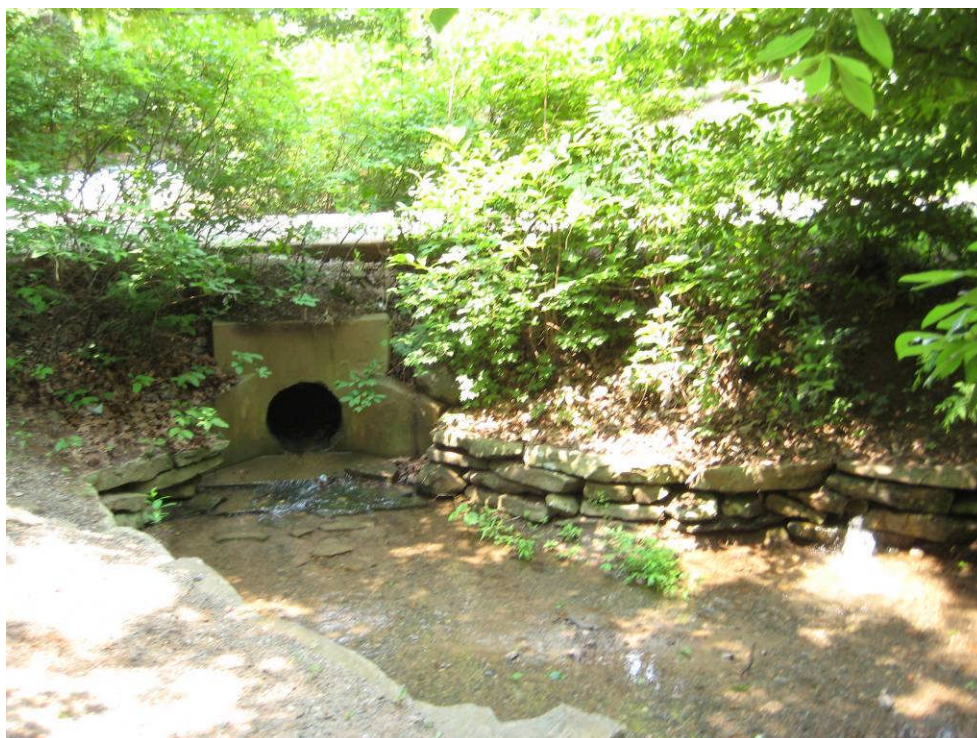
PHOTO – ZZ: 18-inch HDPE pipe outlet from pipe system that conveys runoff from playground area and the two northern baseball fields (June 2011)

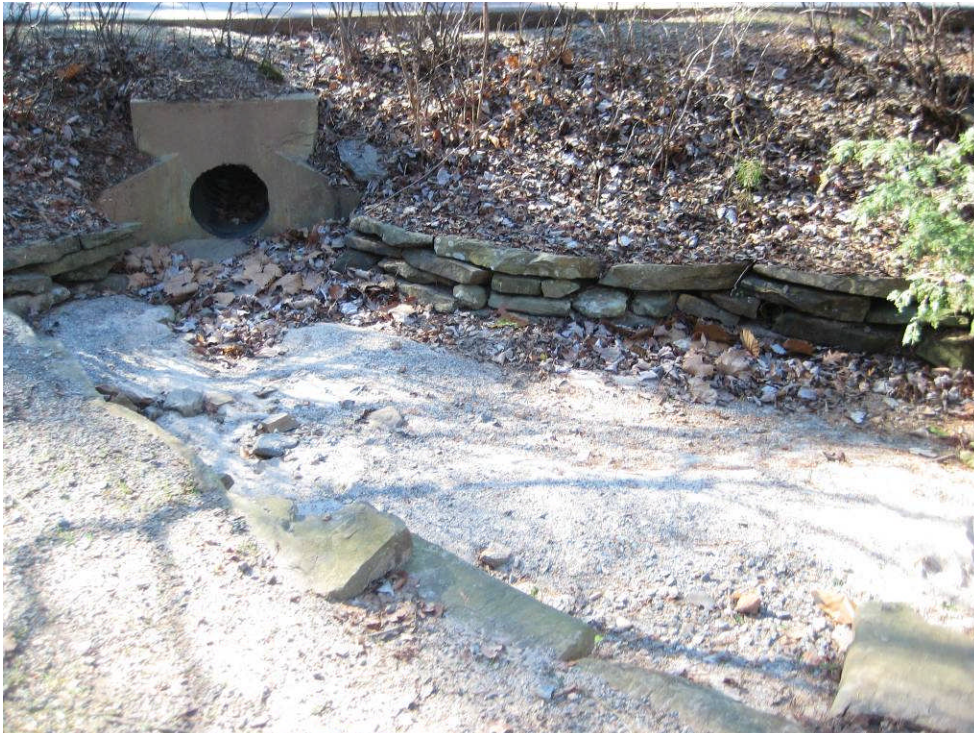
PHOTO – ZZ2: 18-inch HDPE pipe outlet from pipe system that conveys runoff from playground area and the two northern baseball fields (January 2012); same location as Photo ZZ

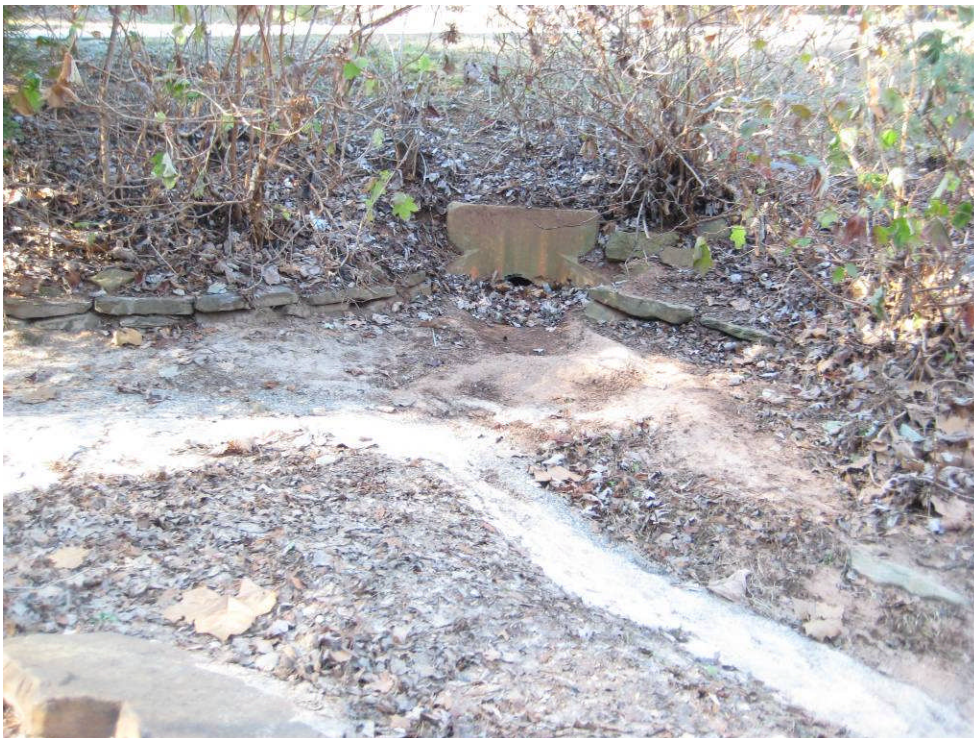
PHOTO – ZZ3: channel filled with sand, downstream of Photo ZZ2

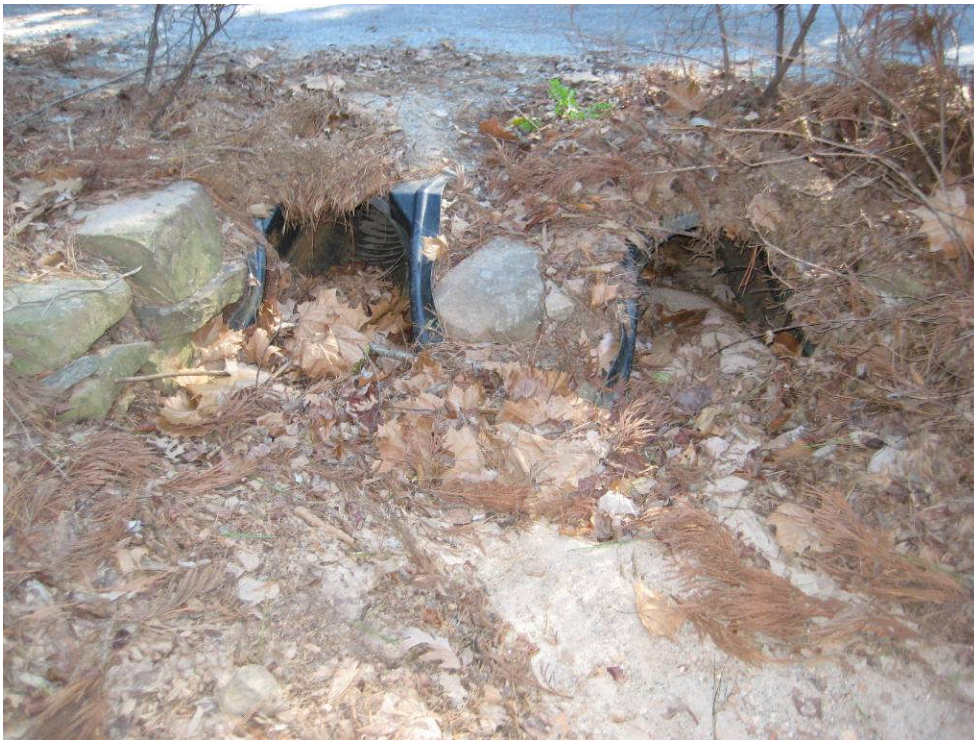
PHOTO – ZZ4: looking at upstream face of double 18-inch HDPE pipes that run under trail to ditch which discharges into pond

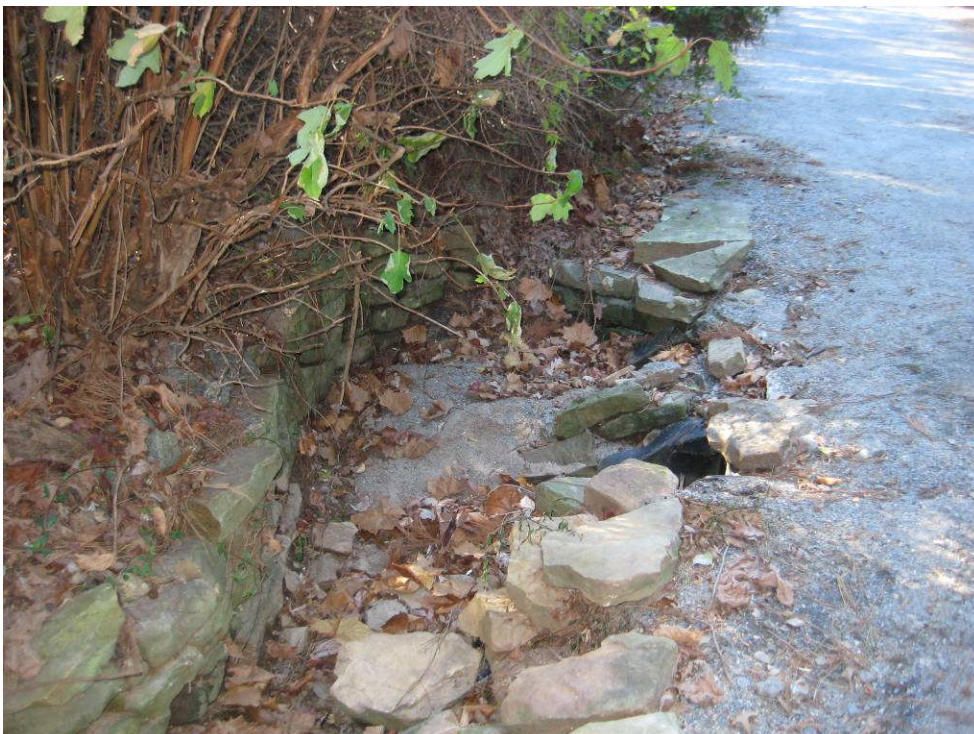
PHOTO – ZZ5: looking upslope at gravel ditch that drains south side of trail; outfall of double 18-inch HDPE pipes, shown in Photo ZZ4, enter ditch from right-hand side of photo; ditch continues downstream directly to pond

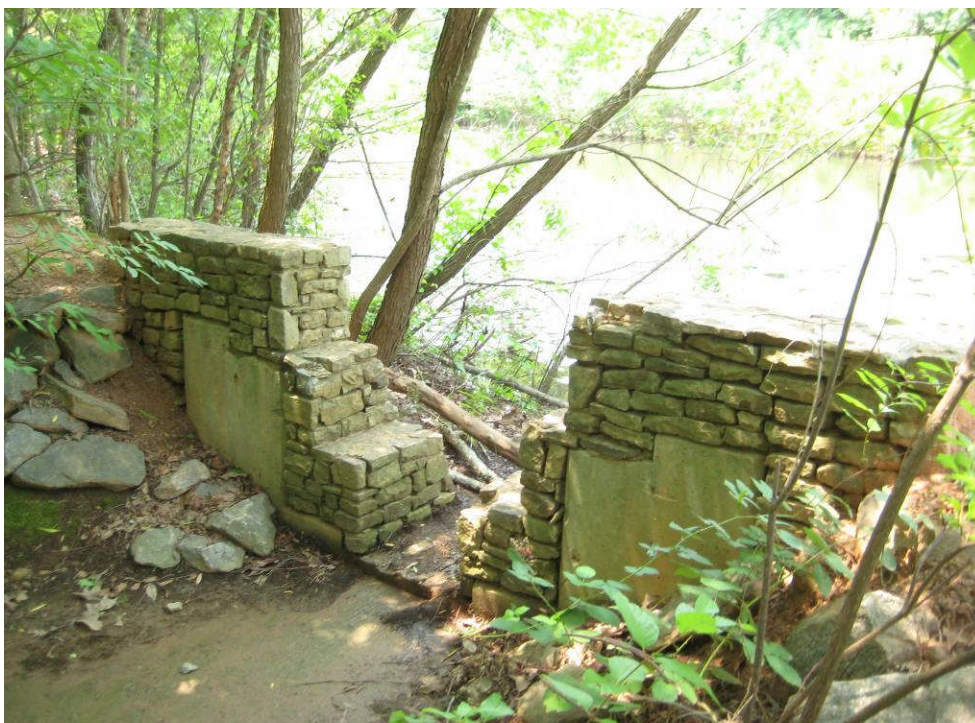
PHOTO – CCC: downstream face of stone weir structure that serves as primary outlet from park pond

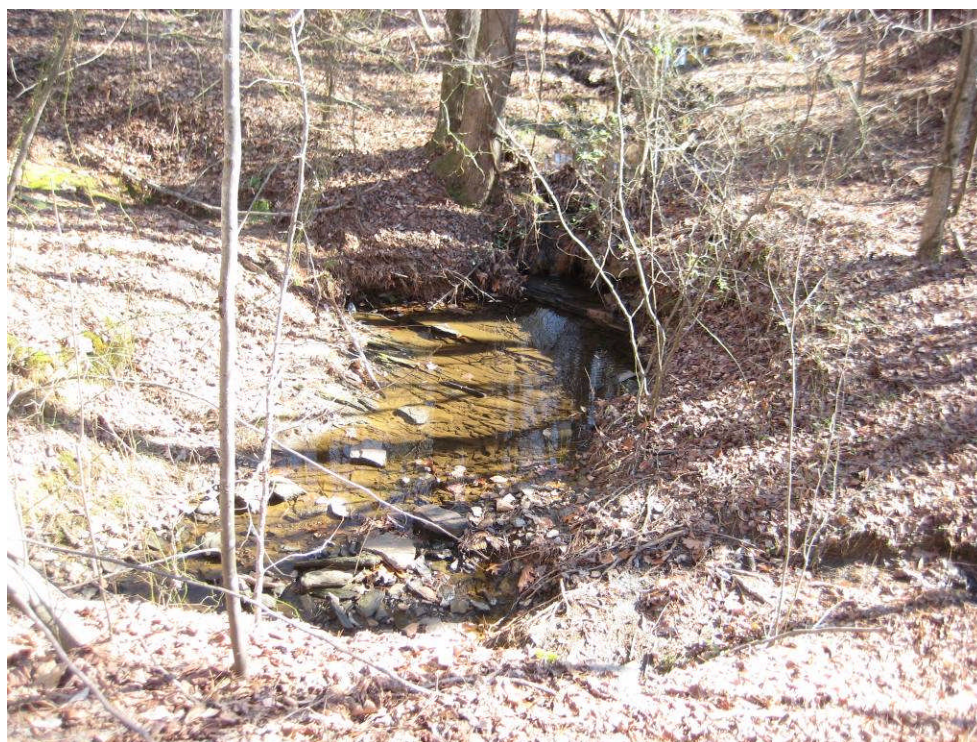
PHOTO – CCC2: localized scour upstream of pipe crossing under trail

Approximately 22 square yards of Type 3 riprap should be placed just upstream of culvert inlet, to provide erosion control for the affected area. A synthetic filter fabric should be installed between the riprap and soil foundation.

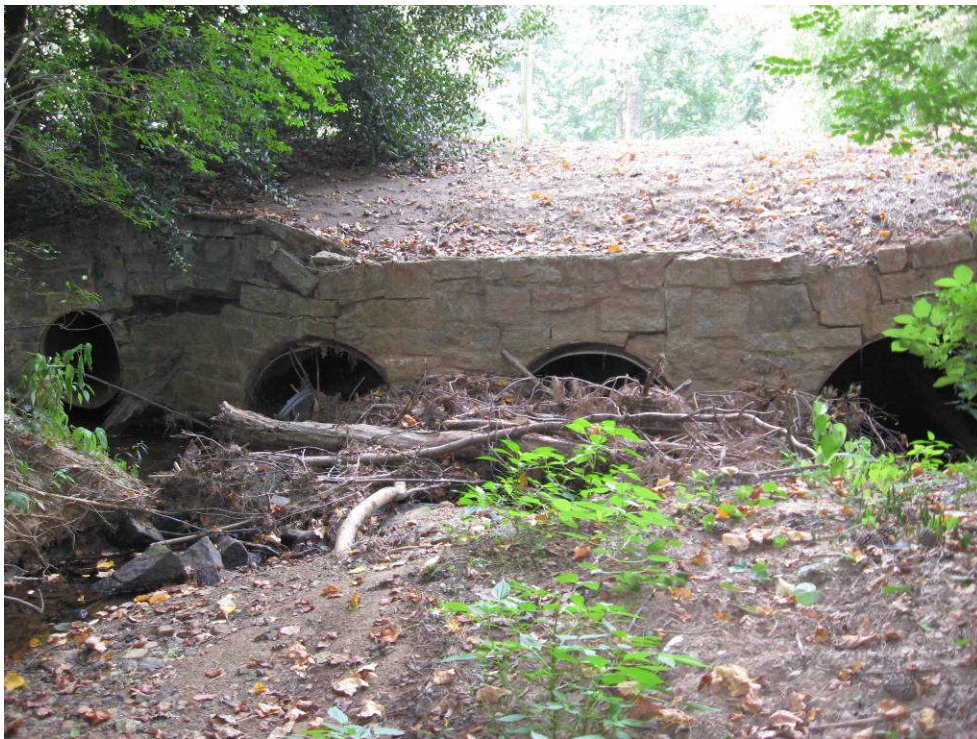
PHOTO – GGG: upstream face of Shirley Bridge Road culvert, triple 54-inch CMPs (taken in August 2011)

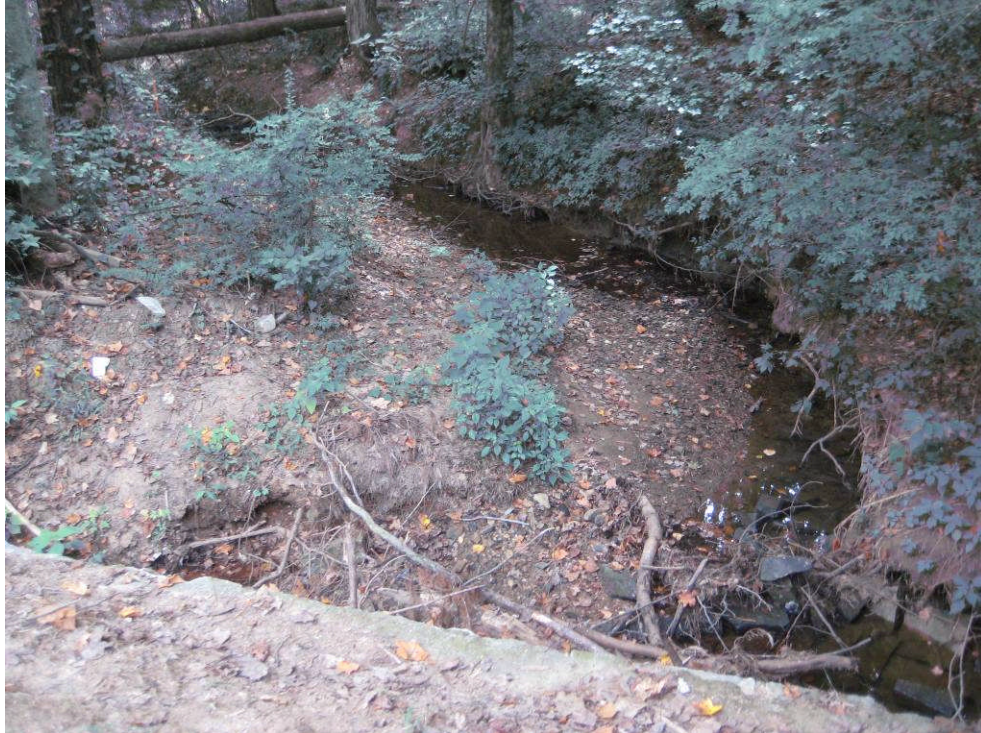
PHOTO – III: standing on Shirley Bridge Road culvert, looking at woody debris that has accumulated in channel

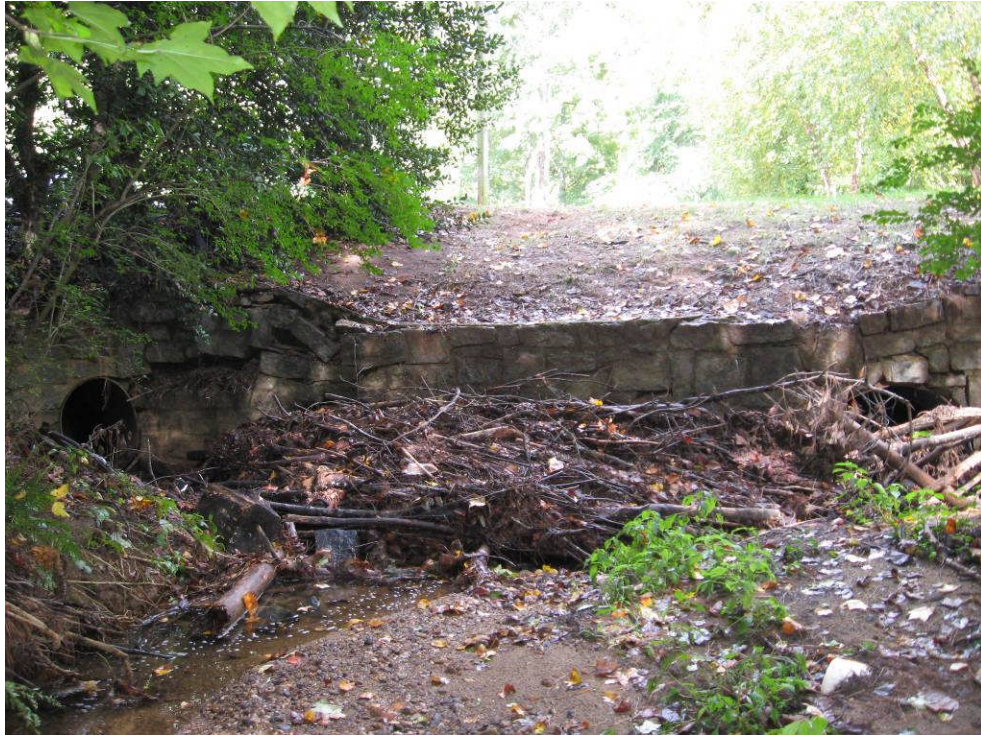
PHOTO – JJJ: upstream face of Shirley Bridge Road culvert, triple 54-inch CMPs (taken in October 2011)

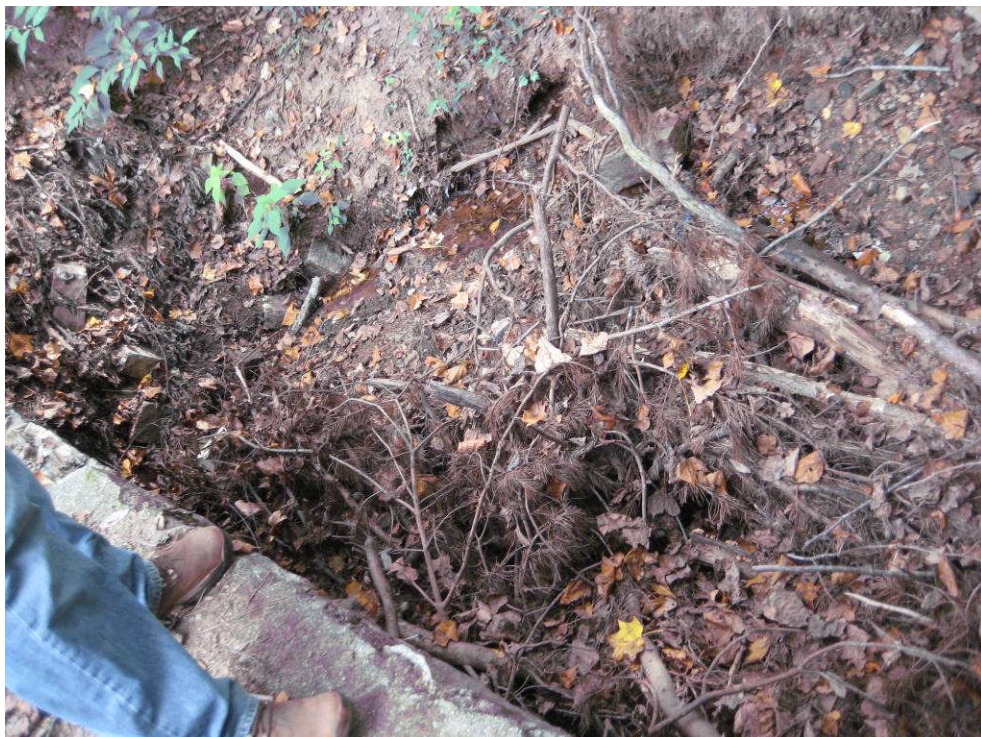
PHOTO – KKK: standing on Shirley Bridge Road culvert, looking at woody debris that has accumulated in channel

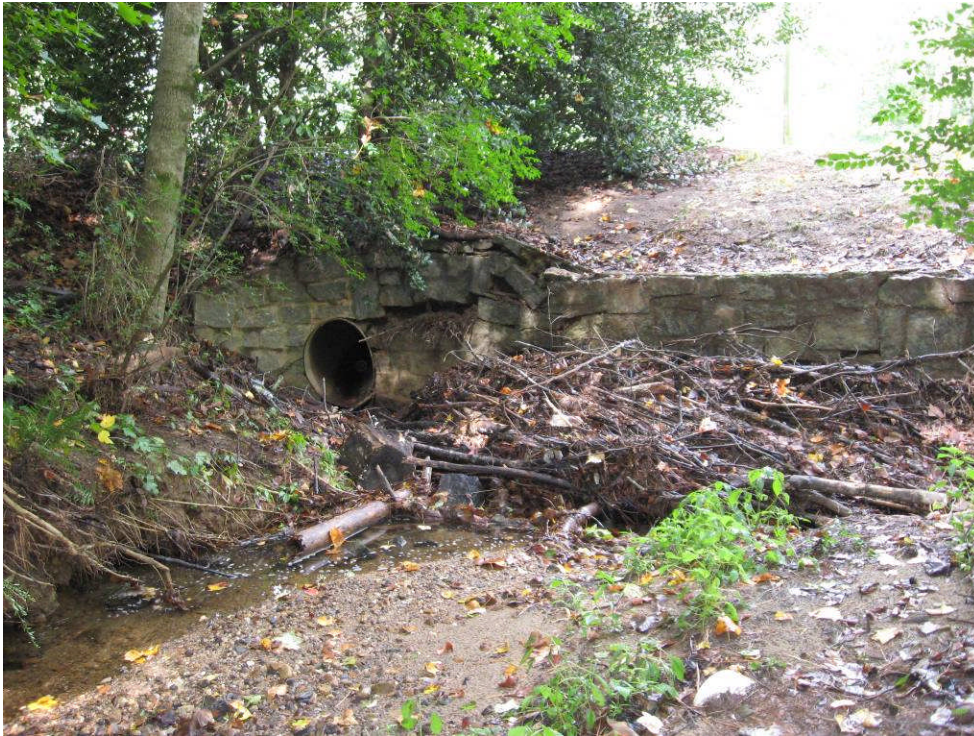
PHOTO – LLL: upstream face of Shirley Bridge Road culvert, triple 54-inch CMPs (taken in October 2011)

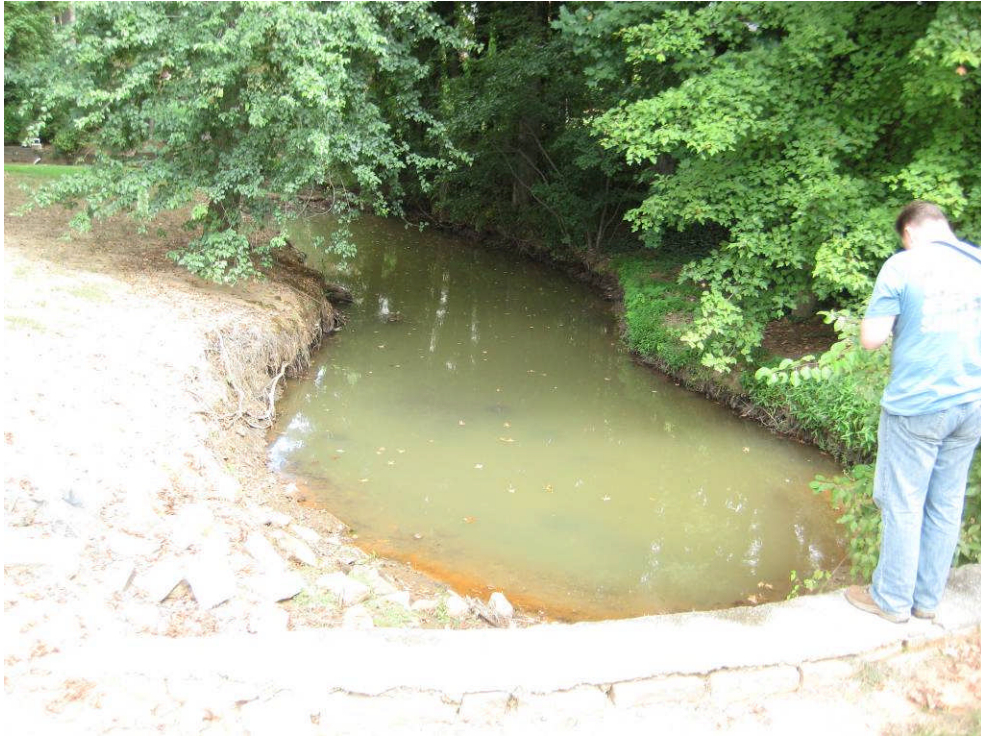
PHOTO – NNN: standing on Shirley Bridge Road culvert, looking downstream where stream from park (and other upstream contributory drainage areas) enters Lake Windward (taken in September 2011)

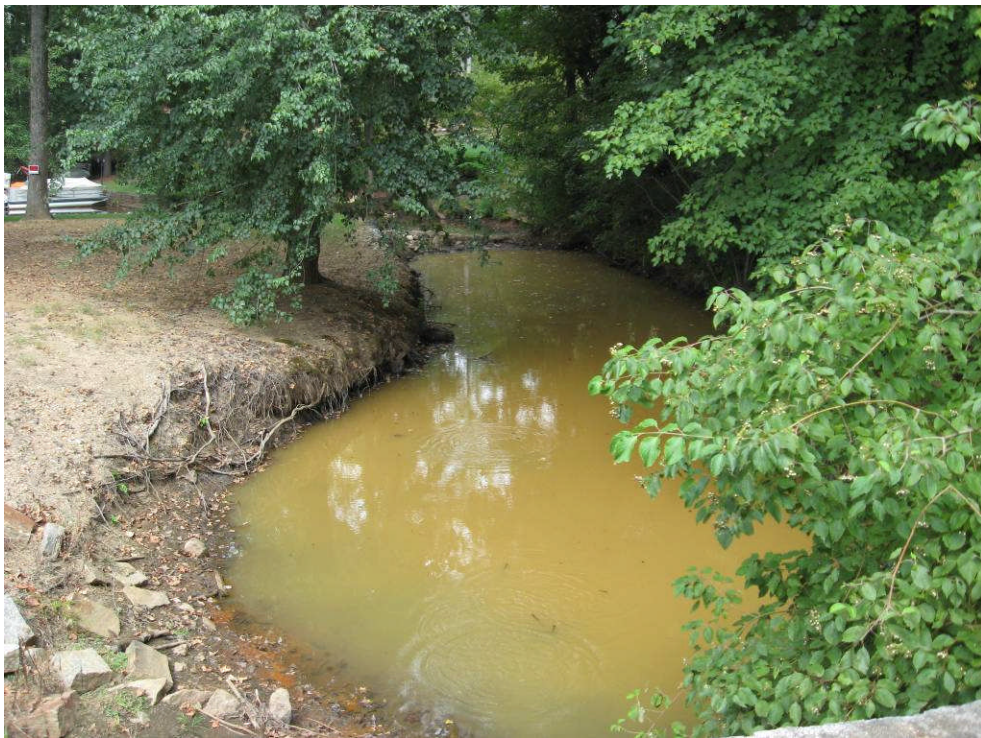
PHOTO – OOO: standing on Shirley Bridge Road culvert, looking downstream where stream from park (and other upstream contributory drainage areas) enters Lake Windward (taken in August 2011); in-stream gabion structure in far background

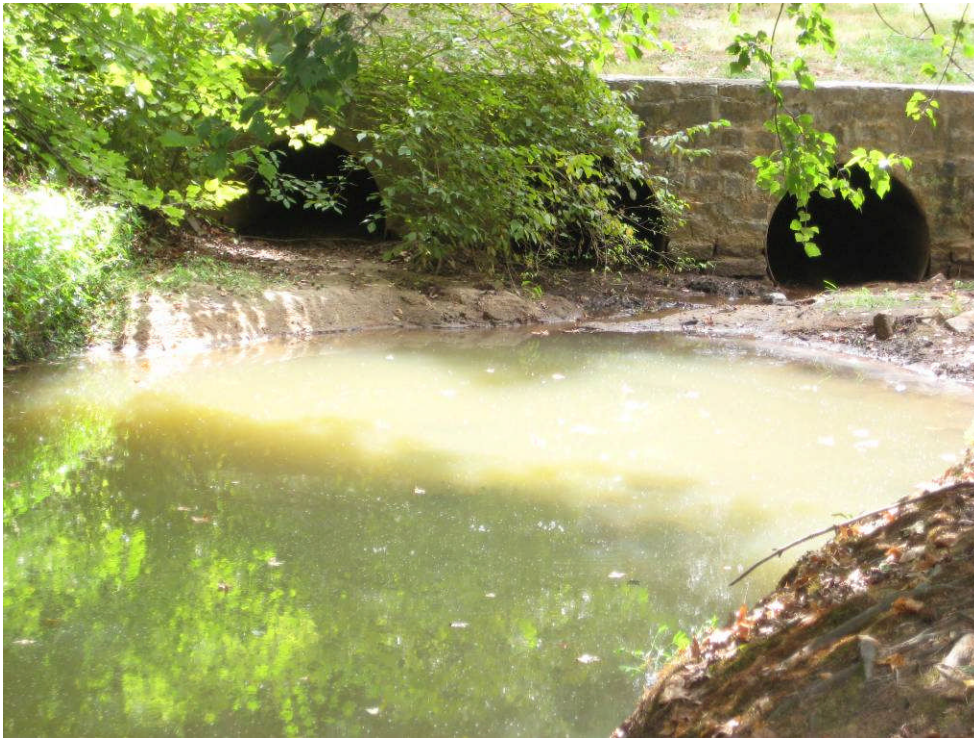
PHOTO – PPP: downstream face of Shirley Bridge Road culvert; sediment has settled out where channel has been widened in the vicinity of the culvert

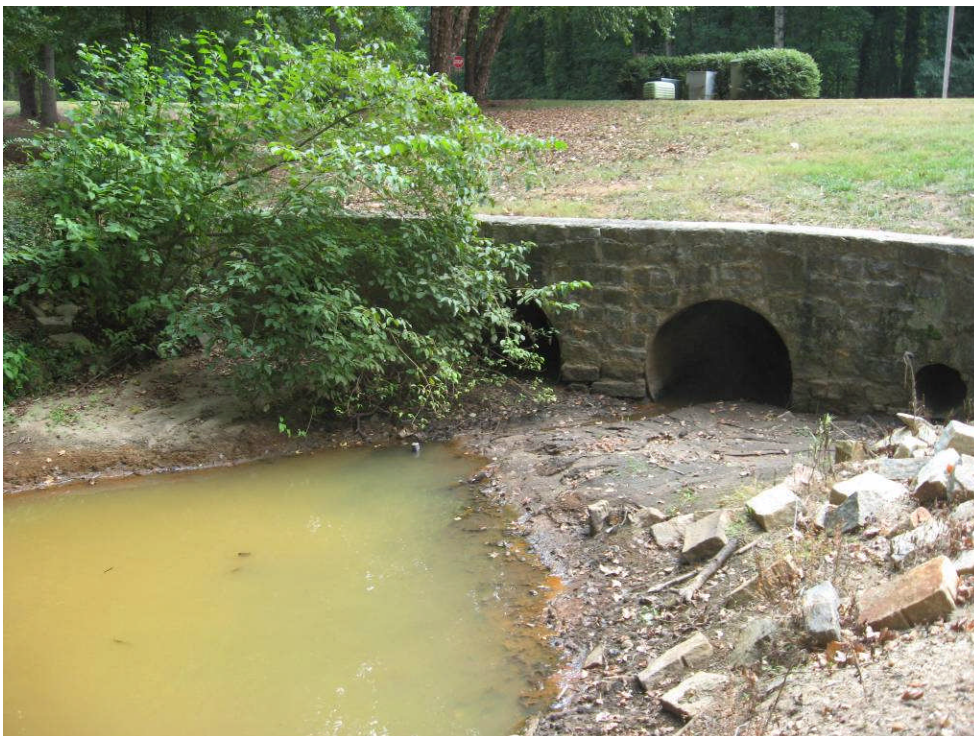
PHOTO – QQQ: downstream face of Shirley Bridge Road culvert; sediment has settled out where channel has been widened in the vicinity of the culvert

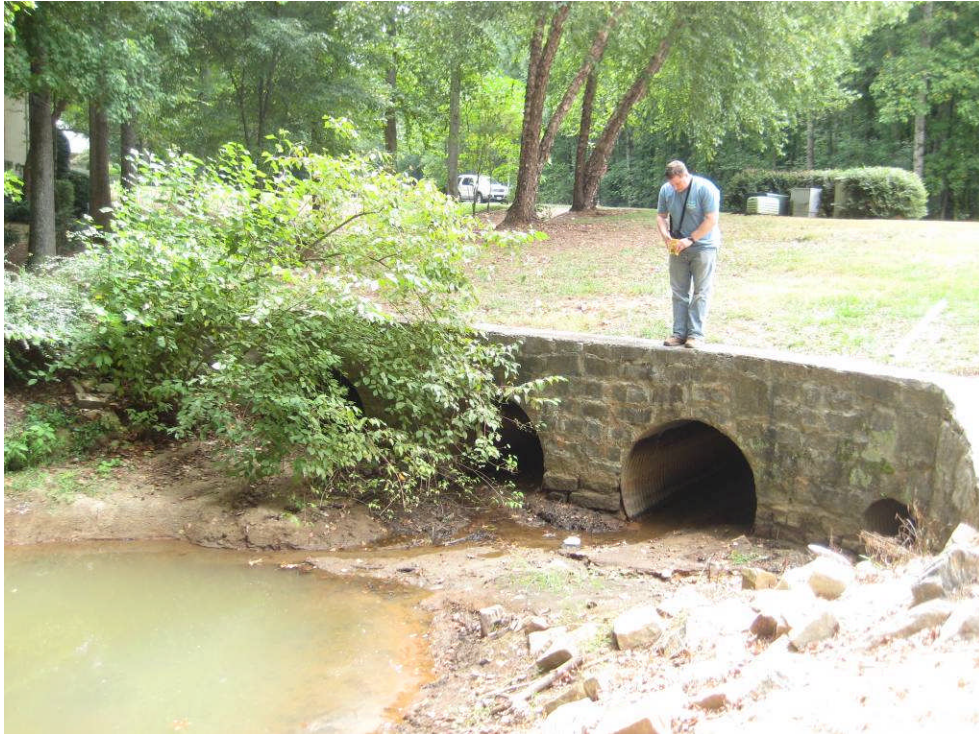
PHOTO – RRR: downstream face of Shirley Bridge Road culvert; sediment has settled out where channel has been widened in the vicinity of the culvert

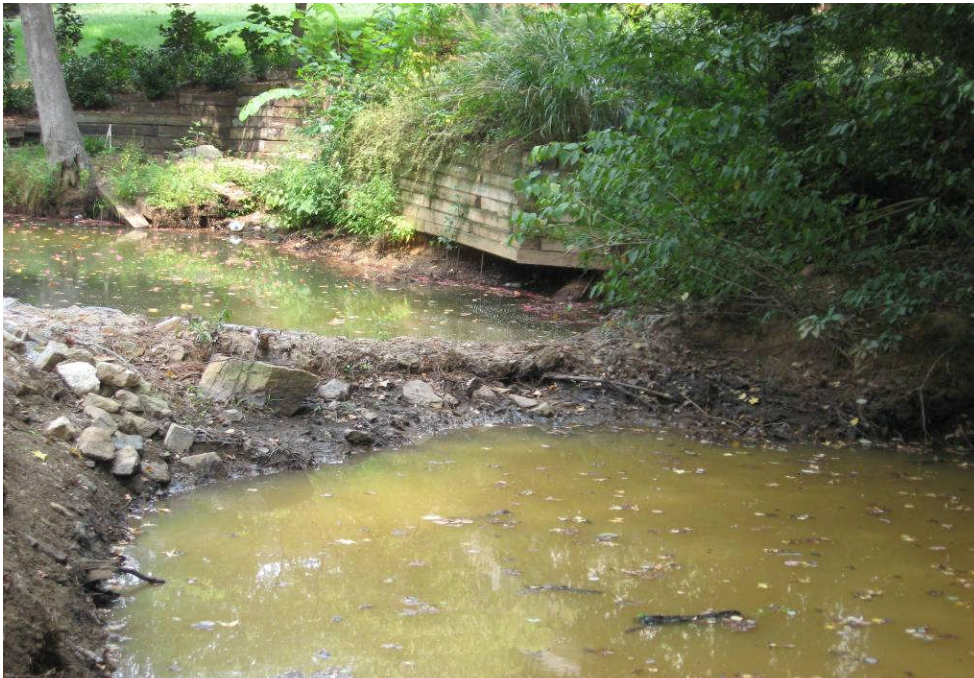
PHOTO – SSS: in-stream gabion structure, located approximately 100 feet downstream of Shirley Bridge Road culvert; looking downstream (taken in August 2011)

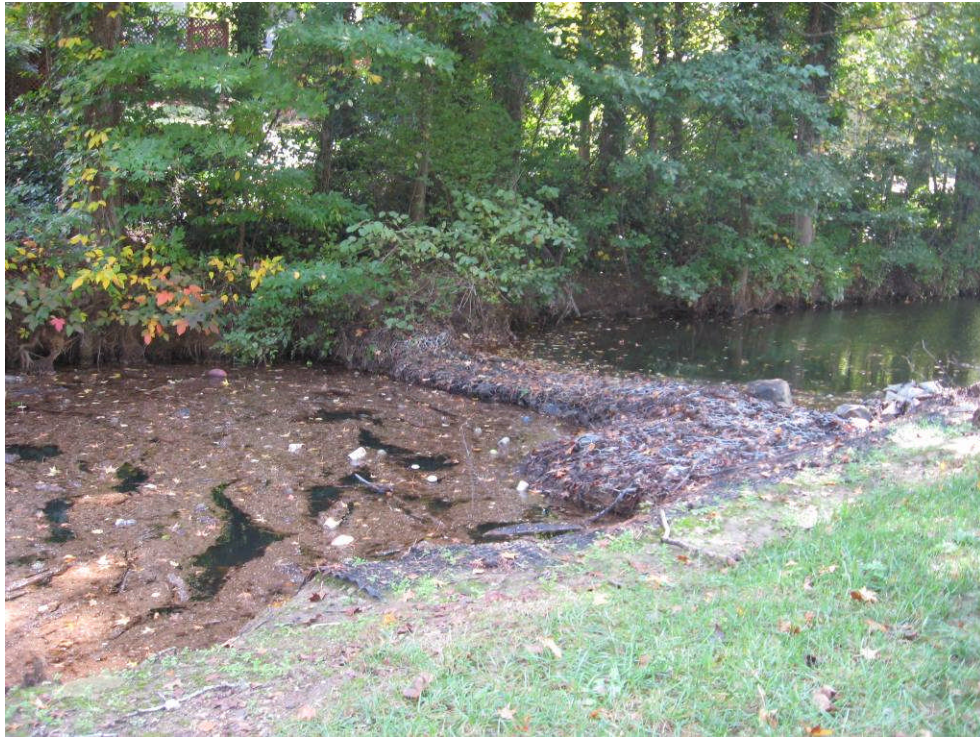
PHOTO – TTT: in-stream gabion structure, located approximately 100 feet downstream of Shirley Bridge Road culvert; looking at downstream aspect of structure (taken in October 2011)

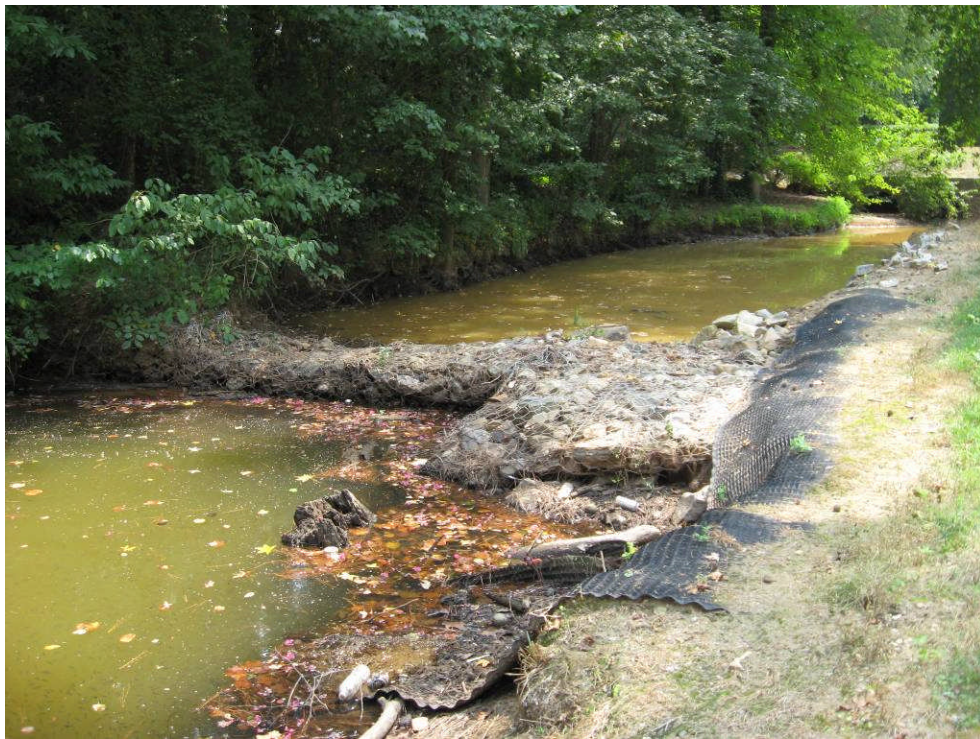
PHOTO – UUU: in-stream gabion structure, located approximately 100 feet downstream of Shirley Bridge Road culvert; looking at downstream aspect of structure (taken in August 2011)

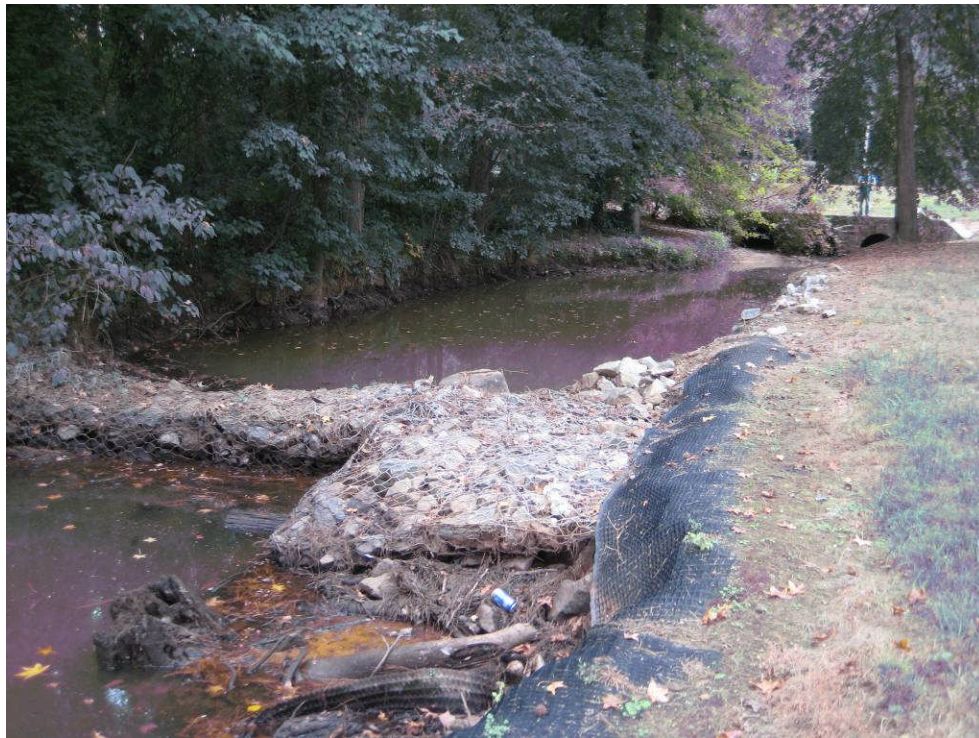
PHOTO – VVV: in-stream gabion structure, located approximately 100 feet downstream of Shirley Bridge Road culvert; looking at downstream aspect of structure (taken in September 2011)
