# Webb Bridge Park Drainage Study

City of Alpharetta, Georgia

June 8, 2012

**Manhard**  
CONSULTING

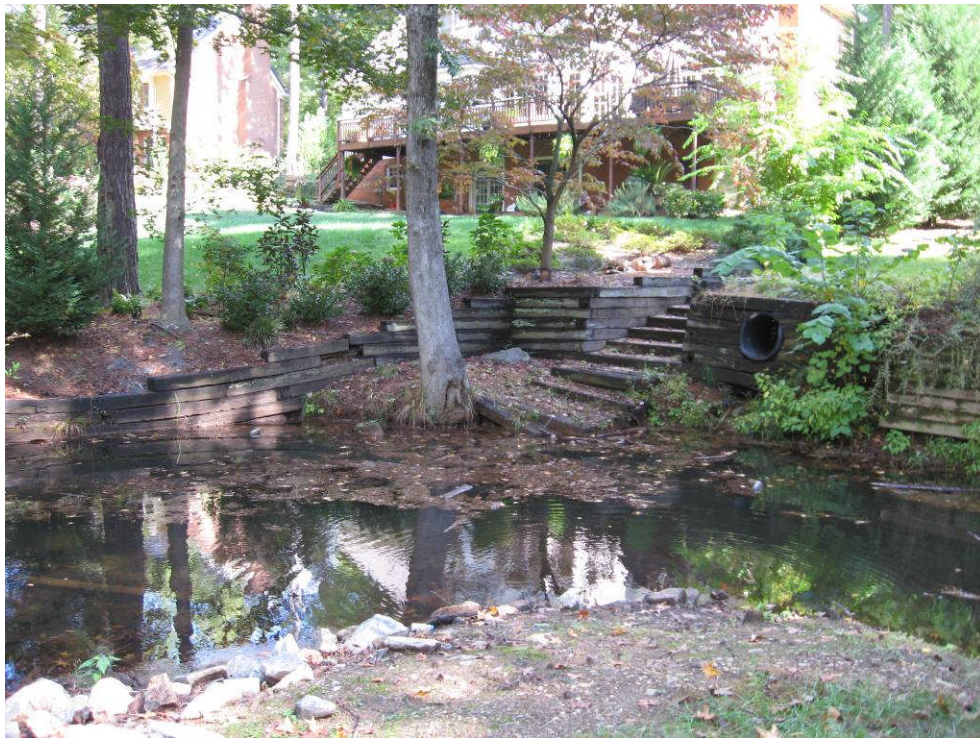
PHOTO – WWW: looking towards home located on right overbank, just downstream of in-stream gabion structure (taken in October 2011)

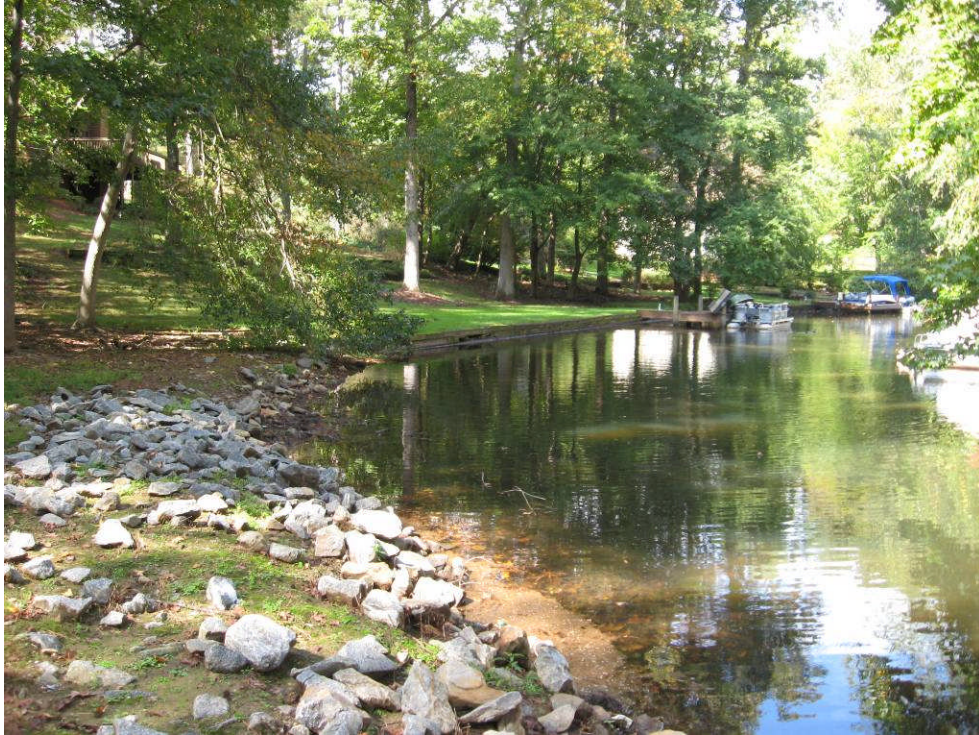
PHOTO – XXX: standing on left bank, approximately 120 feet downstream from Shirley Bridge Road culvert; looking towards Lake Windward

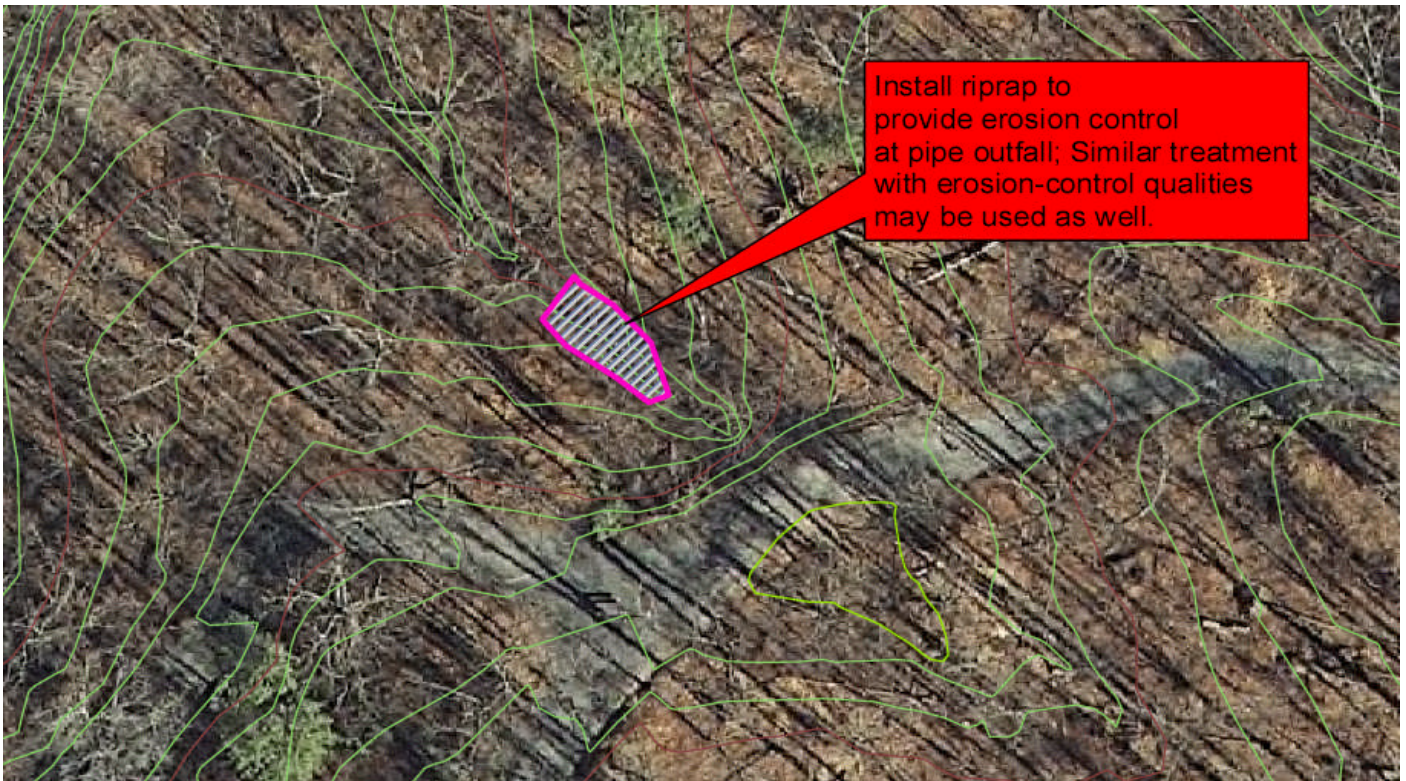
Existing Conditions: Localized erosion has occurred down

Approximately 20 square yards of Type 3 riprap should be placed at pipe outfall, to provide erosion control for the area. A synthetic filter fabric should be installed between the riprap and soil foundation.

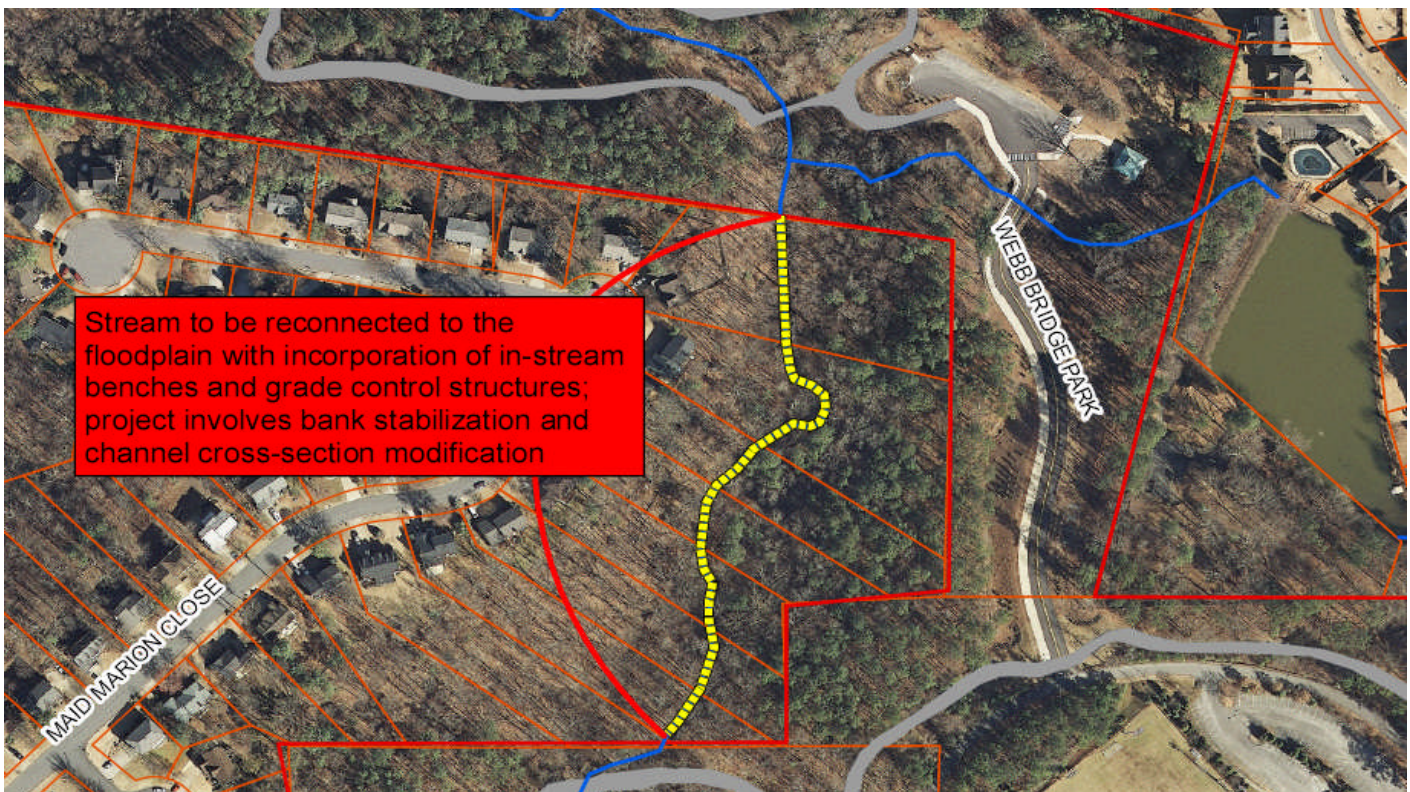
Key photos associated with project:                  n/a  
Visible Impairment:     X     Yes                  No  
Visible Impairment Description: Surface of parking areas has become  
loose, contributing to solids runoff  
Measured Impairment:                  Yes     X     No  
Measured Impairment Description:

Existing Conditions: Three parking lots within the park were originally constructed with the intent of incorporating pervious pavement. The pavement has not infiltrated runoff as designed and essentially performs as traditional impervious pavement. Additionally, the gravel on the top layers has become loose, contributing to the solids loading in the park's streams and pond.

The City has indicated a desire to pave the parking lots with traditional pavement at some point in the future. This project includes three options for repaving the lots. The first involves repaving only the parking spaces with a highly porous pervious pavement, which will serve to infiltrate stormwater runoff and eliminate future gravel runoff from those areas. For the sake of pricing, Flexipave ([www.kbius.com](http://www.kbius.com)) was used for this scope. It is highly recommended that the City ascertain the applicability, performance specifications and available product test results prior to the use of any pervious pavement products. The second option involves paving the same areas as the first option, with the City staff performing the labor. The third option involves paving all three lots, in their entirety, with traditional asphalt pavement.
